## CONDITION REPORT

Report No: 2016274450

DATE  
20/02/2024

| Manufacturer | RENAULT | Registration Number | JD79RVGP |

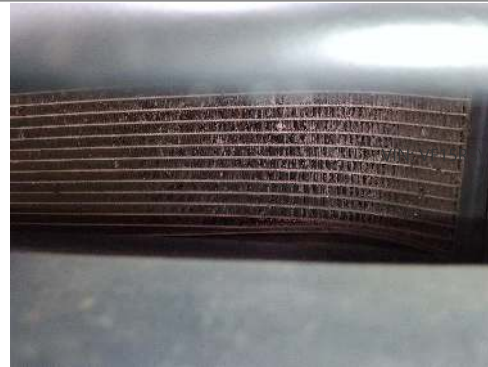
| Damage | Repair Way |
|---|---|
| Engine | Aircon condenser dented |

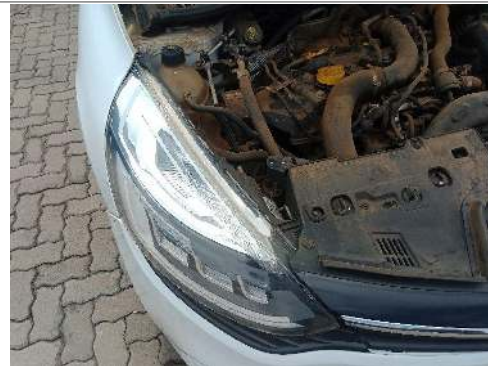
| Damage | Repair Way |
|---|---|
| Headlight Right Damaged | Replace |

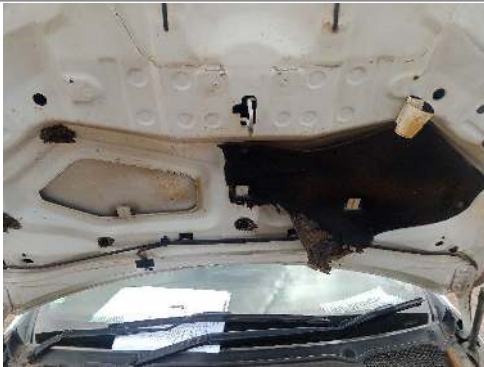
| Damage | Repair Way |
|---|---|
| Under bonnet insulation cover Damaged | Replace |

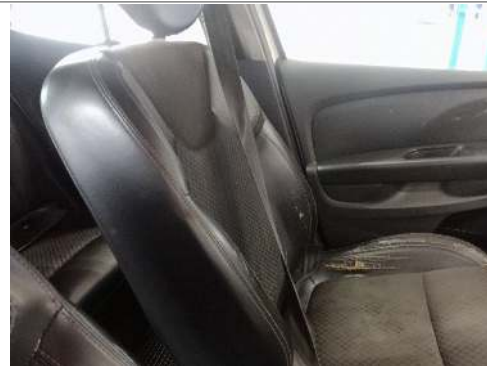
| Damage | Repair Way |
|---|---|
| Seat Belt Front Left Defective | Replace |

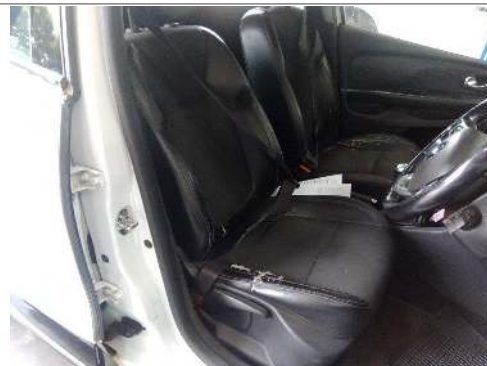
| Damage | Repair Way |
|---|---|
| Seat Front Right Damaged | Repair |

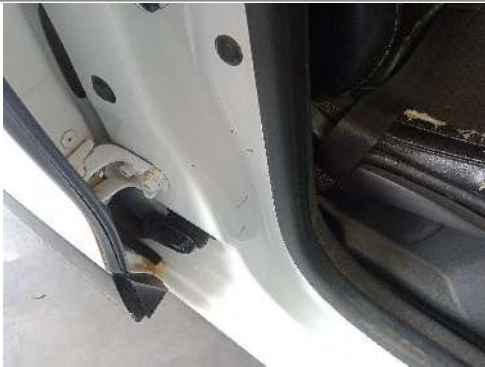
| Damage | Repair Way |
|---|---|
| B • Pillar Right Paintwork • Scratched | Repair |

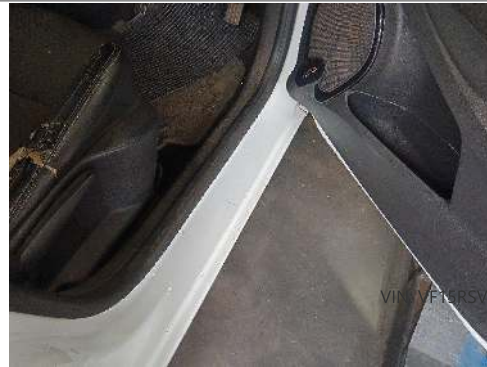
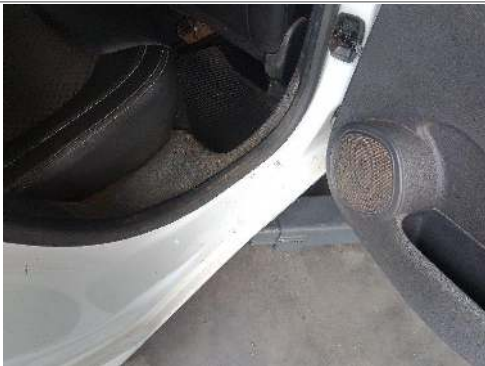
| Damage | Repair Way |
|---|---|
| Sill Panel Right Paintwork • Scratched | Repair |

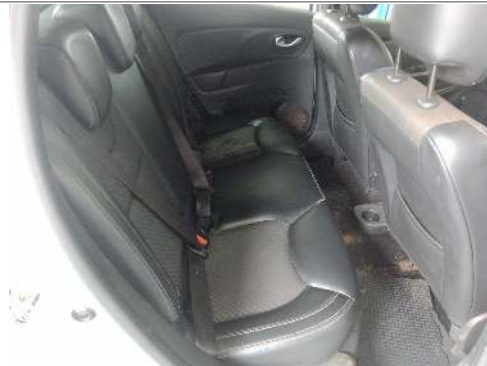
| Damage | Repair Way |
|---|---|
| Seat Rear Damaged | Repair |

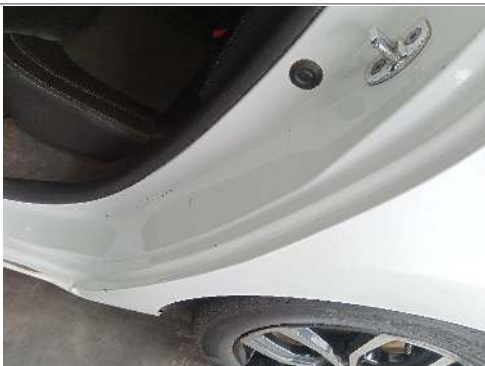
| Damage | Repair Way |
|---|---|
| C • Pillar Left Paintwork • Scratched | Repair |

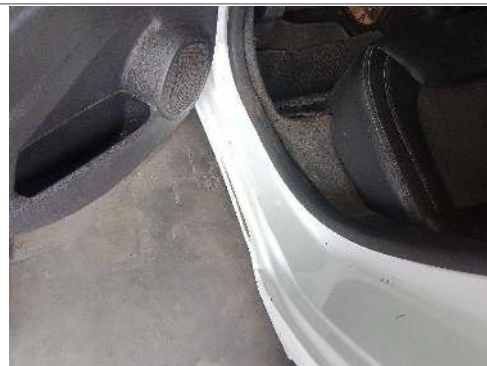
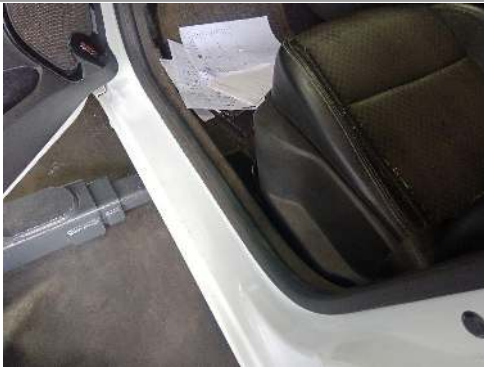
| Damage | Repair Way |
|---|---|
| Sill Panel Left Paintwork • Scratched | Repair |

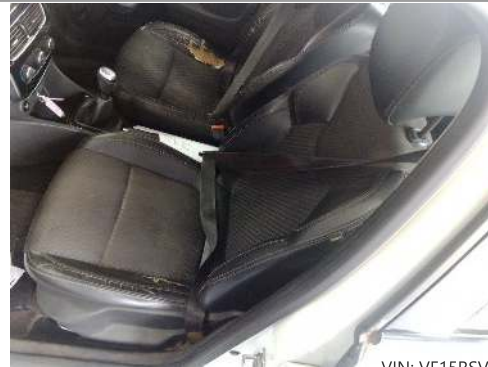
| Damage | Repair Way |
|---|---|
| Seat Front Left Damaged | Repair |

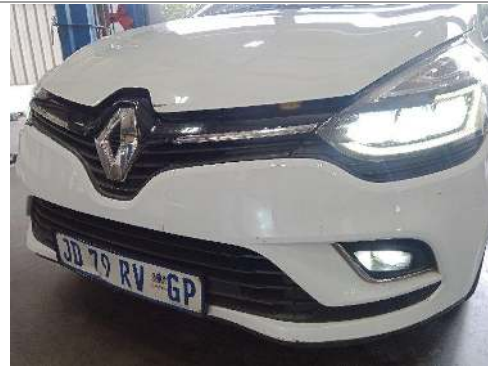
| Damage | Repair Way |
|---|---|
| Front Bumper Damaged | Repair |

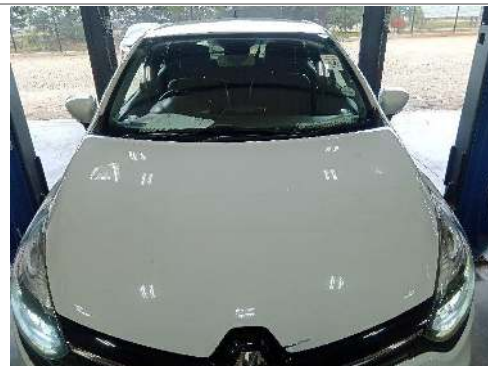
| Damage | Repair Way |
|---|---|
| Bonnet Dented | Repair |

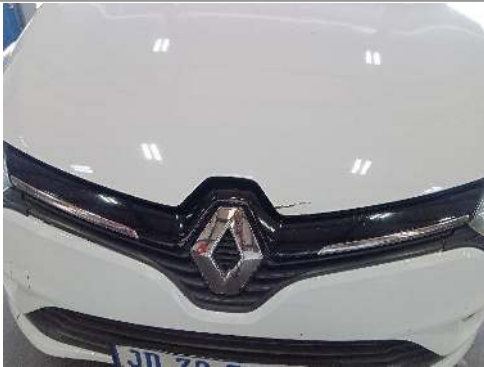
| Damage | Repair Way |
|---|---|
| Grill Paintwork • Scratched | Repair |

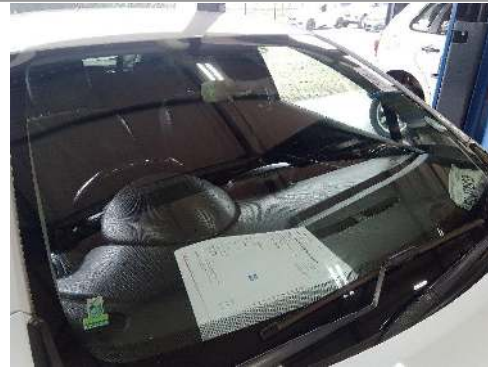
| Damage | Repair Way |
|---|---|
| Windscreen Cracked | Replace |

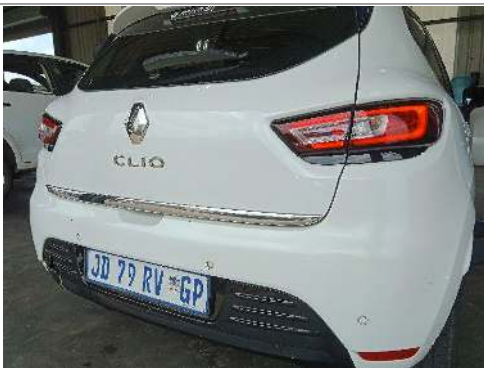
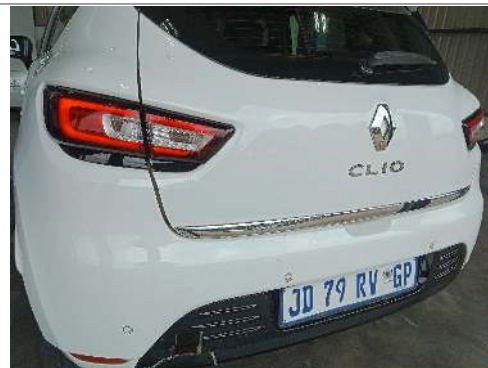
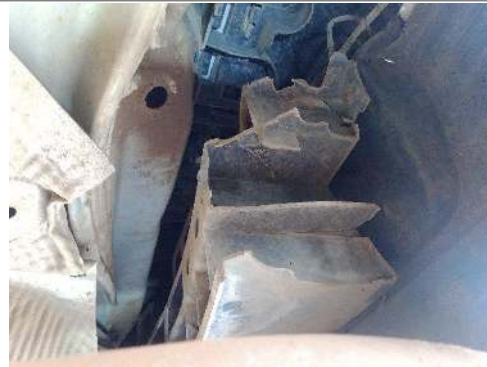
| Damage | Repair Way |
|---|---|
| Rear bumper Damaged | Repair |

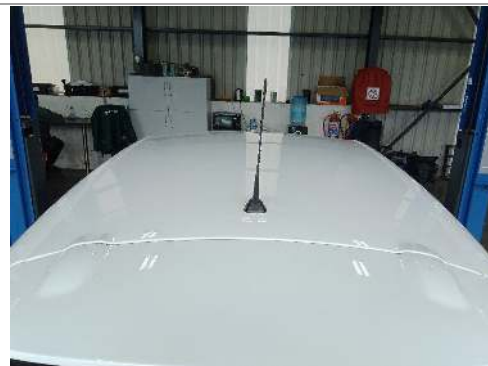
| Damage | Repair Way |
|---|---|
| Roof Dented | Repair |

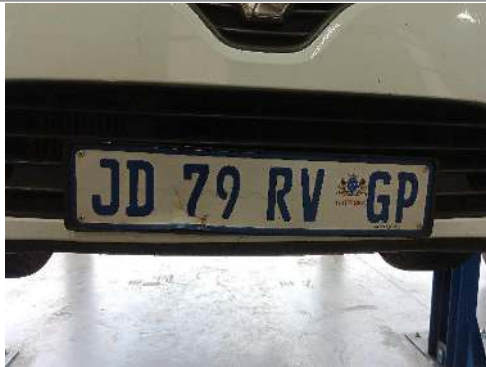
| Damage | Repair Way |
|---|---|
| Number Plate Front Dented | Replace |

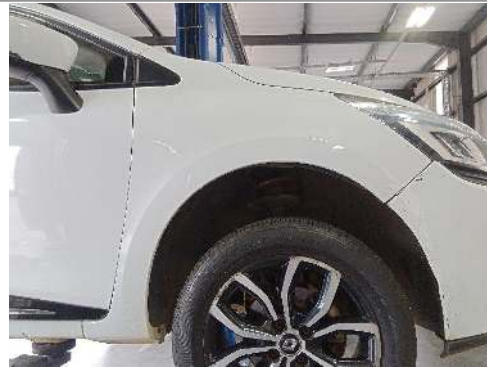
| Damage | Repair Way |
|---|---|
| Front Fender Right Paintwork • Scratched | Repair |

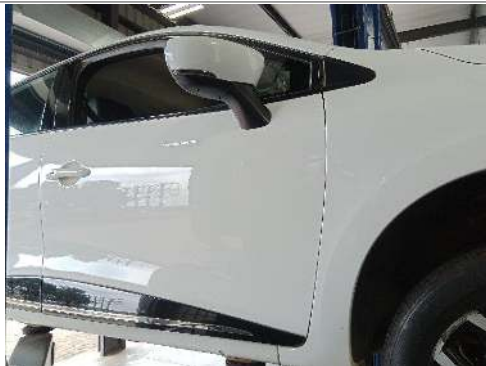
| Damage | Repair Way |
|---|---|
| Door Front Right Paintwork • Scratched | Repair |

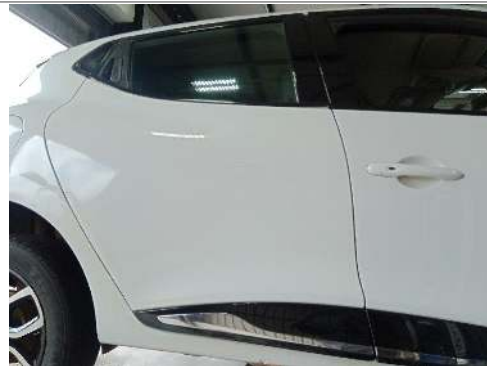
| Damage | Repair Way |
|---|---|
| Door Rear Right Residual Traces of Repair | Repair |

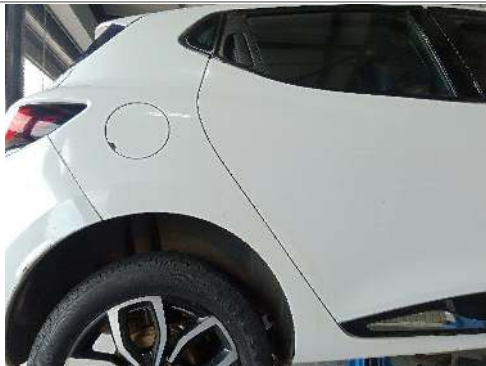
| Damage | Repair Way |
|---|---|
| Rear Fender Right Residual Traces of Repair | Repair |

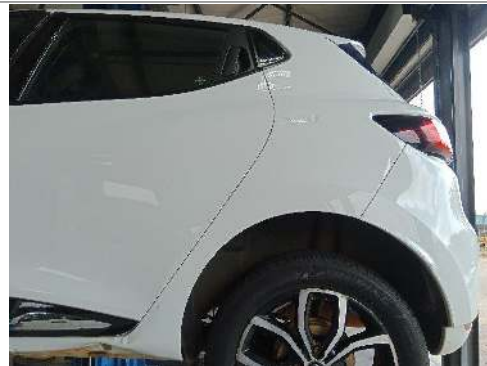
| Damage | Repair Way |
|---|---|
| Rear Fender Left Paintwork • Scratched | Repair |

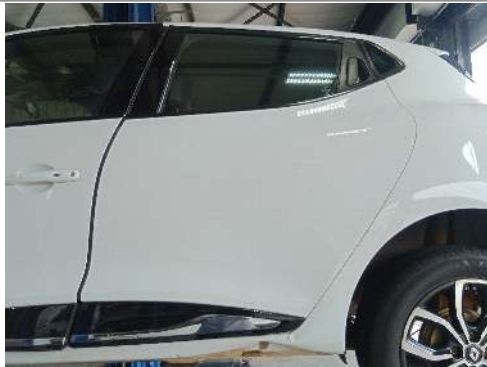
| Damage | Repair Way |
|---|---|
| Door Rear Left Paintwork • Scratched | Repair |

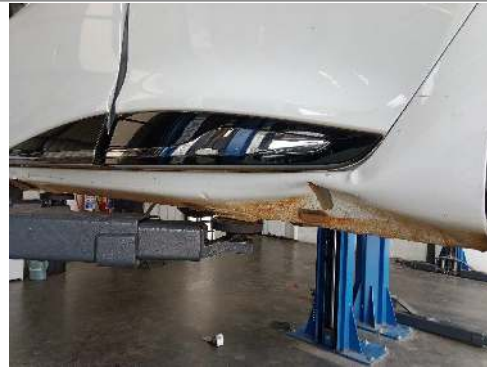
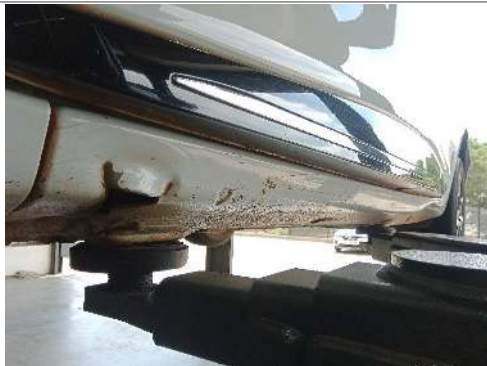
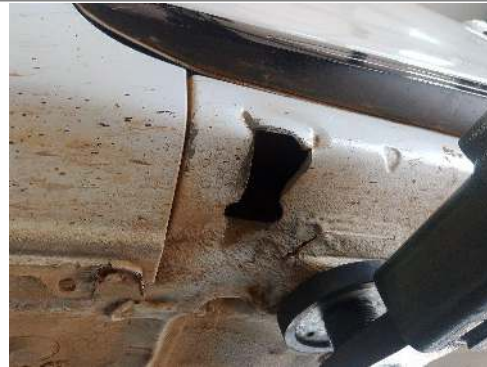
| Damage | Repair Way |
|---|---|
| Rocker Panel Left Damaged | Repair |

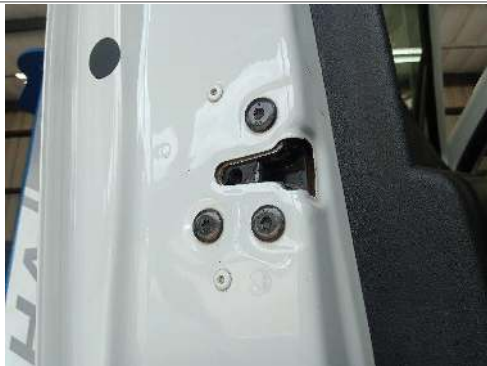
| Damage | Repair Way |
|---|---|
| Door Lock Front Left Malfunction | Replace |

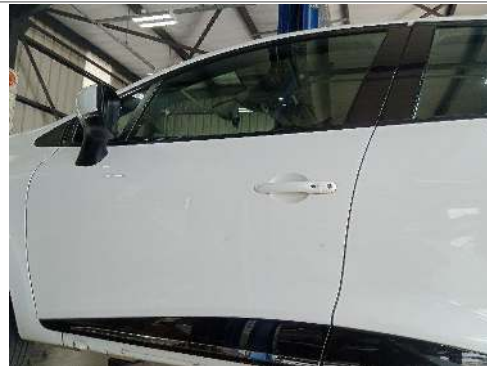
| Damage | Repair Way |
|---|---|
| Door Front Left Paintwork • Scratched | Repair |

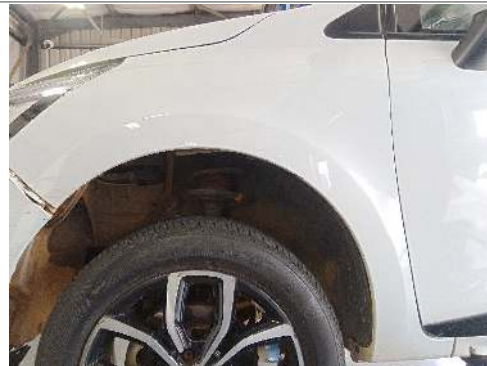
| Damage | Repair Way |
|---|---|
| Front Fender Left Paintwork • Scratched | Repair |

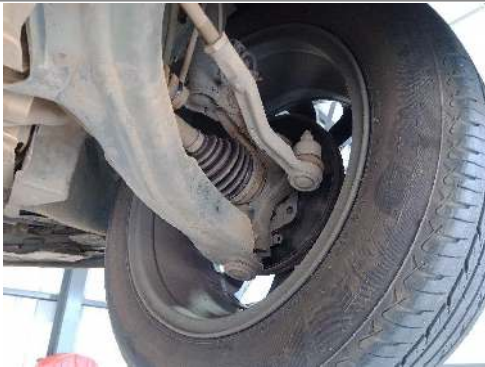
| Damage | Repair Way |
|---|---|
| Rim Front Right Dented | Repair |

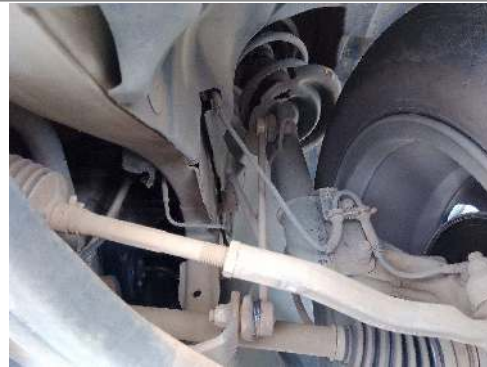
| Damage | Repair Way |
|---|---|
| Stabilizer Mounting Front Right Defective | Replace |

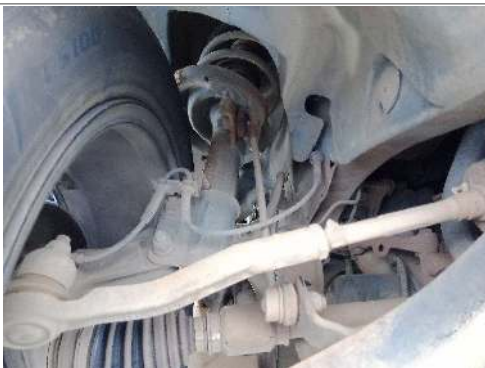
| Damage | Repair Way |
|---|---|
| Stabilizer Mounting Front Left Defective | Replace |

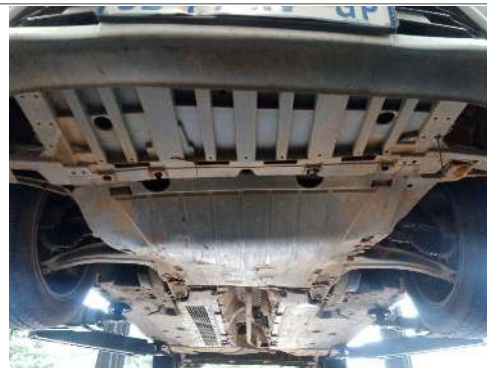
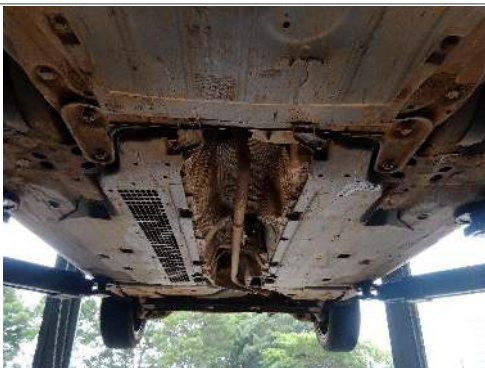
| Damage | Repair Way |
|---|---|
| Belly plates Damaged | Replace |

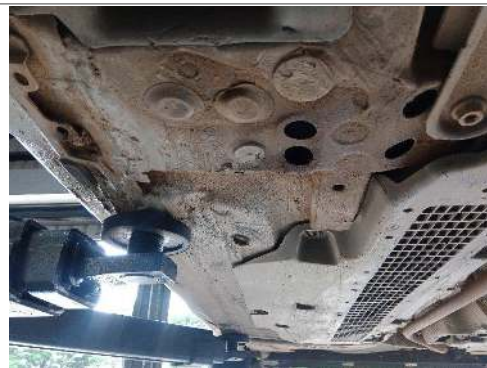
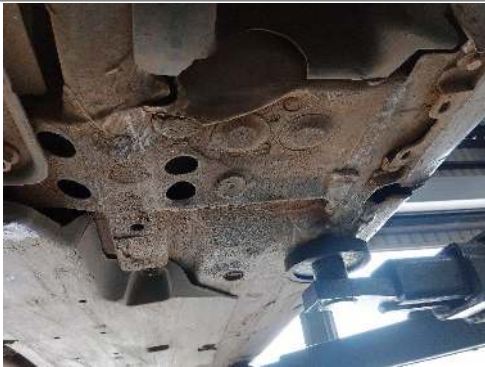
| Damage | Repair Way |
|---|---|
| Chassis Damaged | Repair |

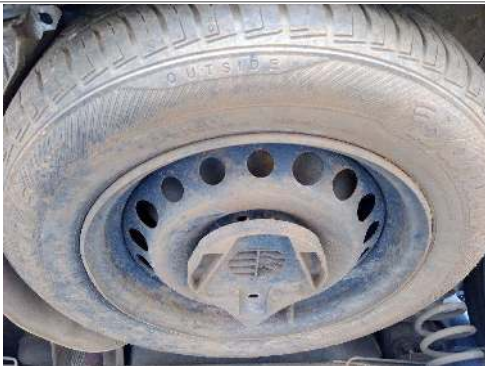
| Damage | Repair Way |
|---|---|
| Rim Spare Wheel Dented | Repair |

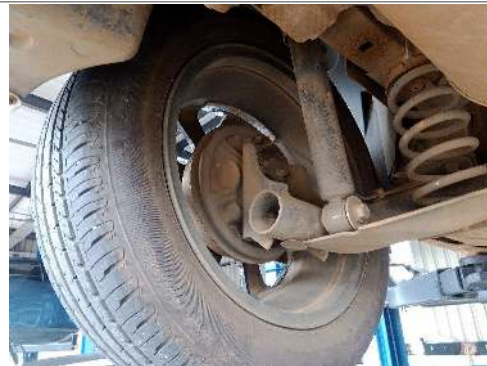
| Damage | Repair Way |
|---|---|
| Rim Rear Left Dented | Repair |

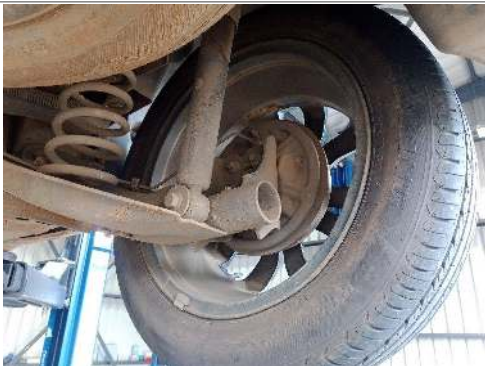
| Damage | Repair Way |
|---|---|
| Rim Rear Right Dented | Repair |

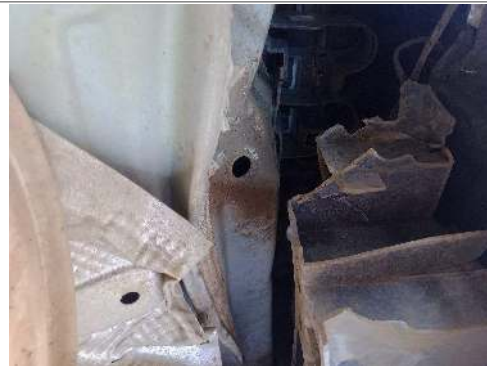
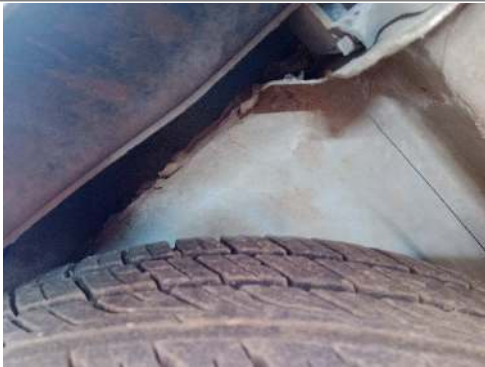
| Damage | Repair Way |
|---|---|
| Inner Boot Floor Pan and Spare Wheel Well Damaged | Repair |

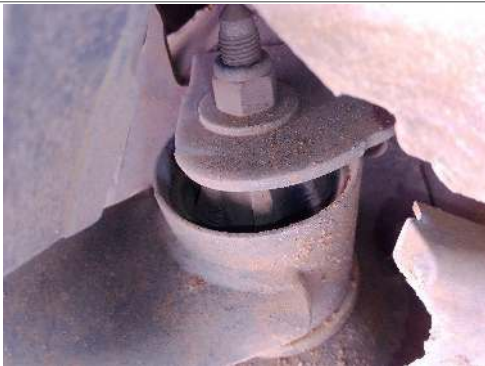
| Damage | Repair Way |
|---|---|
| Mounting Rubber(s) Rear Axle Right Cracked | Replace |

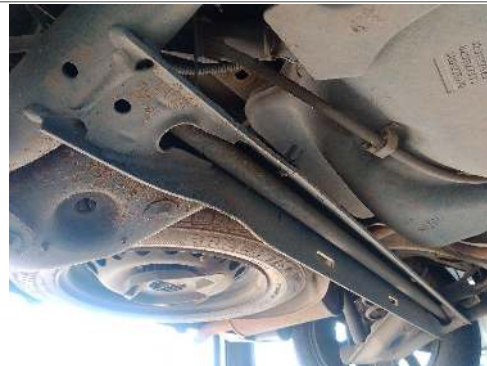
| Damage | Repair Way |
|---|---|
| Rear Axle Damaged | Repair |

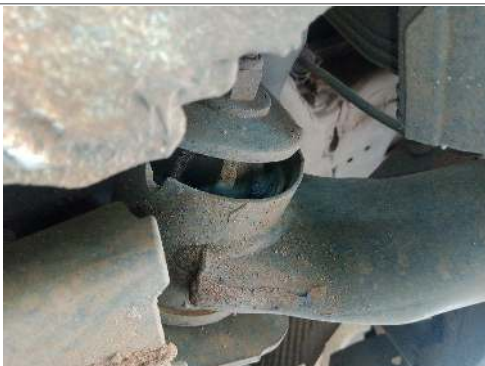
| Damage | Repair Way |
|---|---|
| Mounting Rubber(s) Rear Axle Left Cracked | Replace |

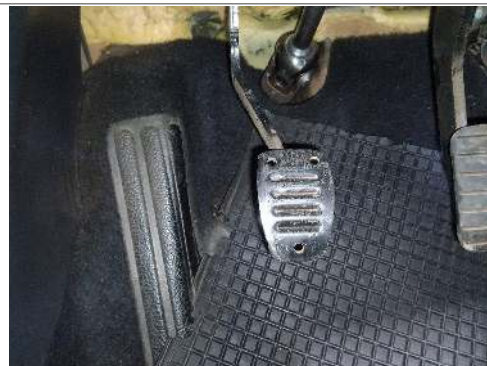
| Damage | Repair Way |
|---|---|
| Clutch Pedal Rubber Missing | Replace |
