CONDITION REPORT

Report No:
2016911273
DATE
12/06/2025

| Manufacturer | RENAULT | Registration Number | JN82MYGP |
| Model | SANDERO | Register Number | |

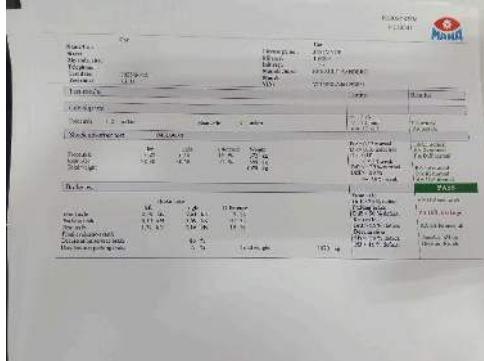
Brake test.

| Damage | Repair Way |
|--|---|
| Parking Brake Performance Left / Right Difference out of legal range | Repair |

| | Left | Right | Axe Weight [KG] | Deceleration [m/s ²] |
|---|---|---|---|---|
| Emergency / Parking | 0.1 | 1.69 | - | |

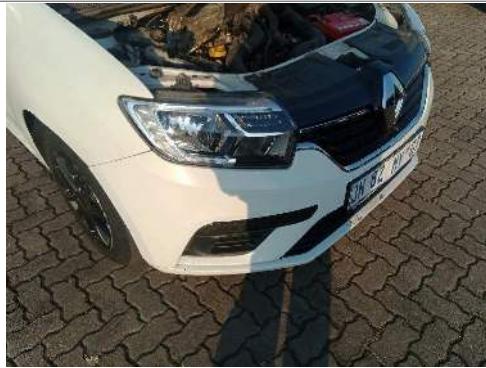
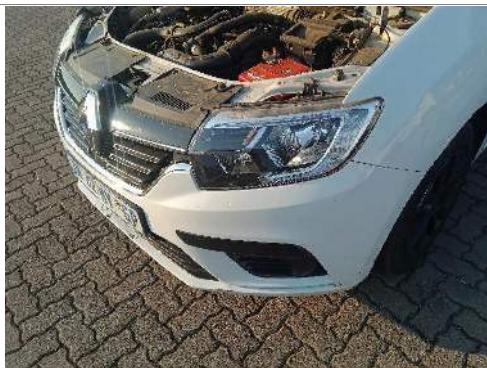
| Damage | Repair Way |
|--|---|
| Front Bumper Damaged | Repair |

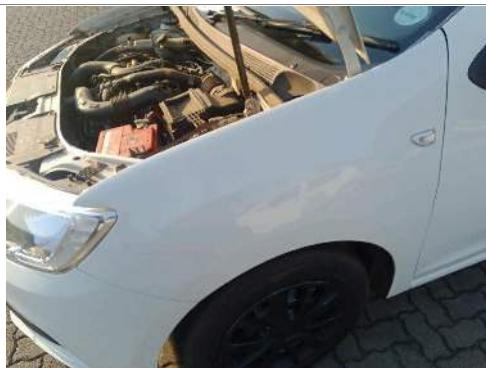
| Damage | Repair Way |
|--|---|
| Front Fender Left Damaged | Repair |

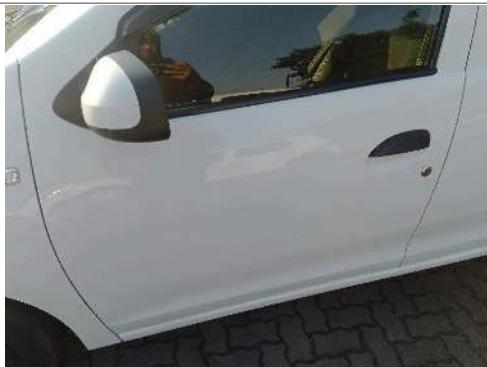
| Damage | Repair Way |
|--|---|
| Door Front Left Damaged | Repair |

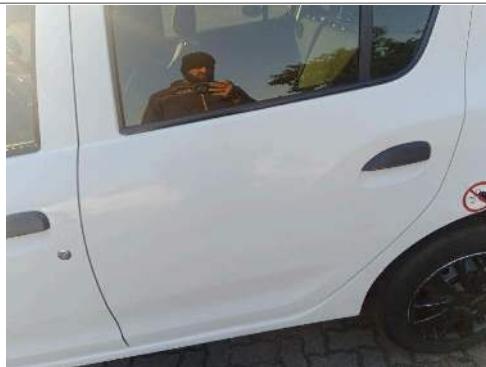
| Damage | Repair Way |
|--|---|
| Door Rear Left Damaged | Repair |

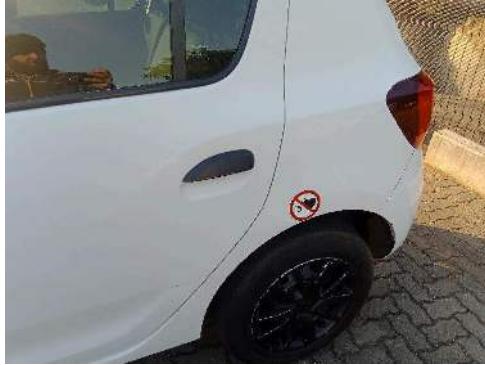
| Damage | Repair Way |
|--|---|
| Rear Fender Left Damaged | Repair |

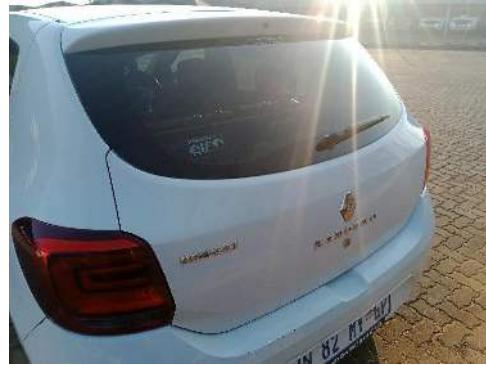
| Damage | Repair Way |
|--|---|
| Boot Lid / Hatch door Damaged | Repair |

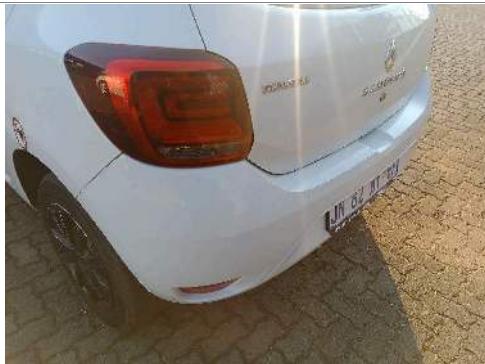
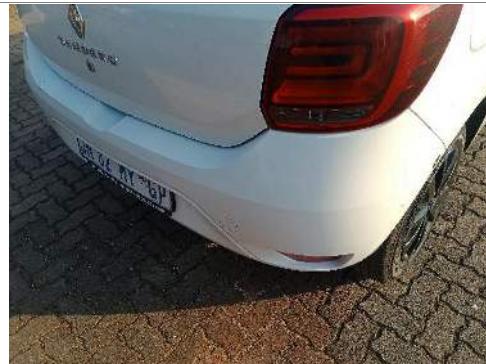
| Damage | Repair Way |
|--|---|
| Rear bumper Damaged | Repair |

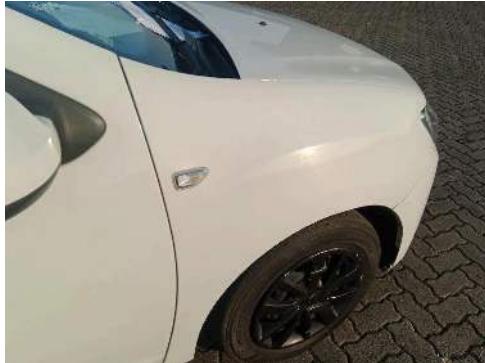
| Damage | Repair Way |
|--|---|
| Front Fender Right Damaged | Repair |

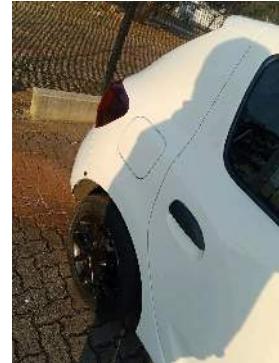
| Damage | Repair Way |
|--|---|
| Rear Fender Right Damaged | Repair |

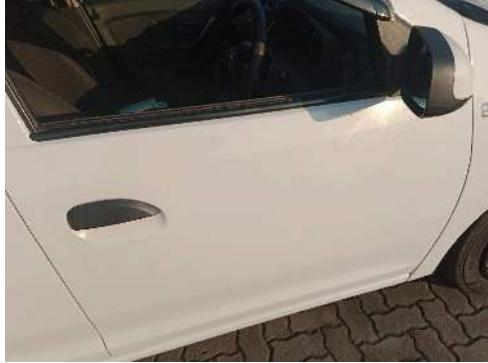
| Damage | Repair Way |
|--|---|
| Door Front Right Damaged | Repair |

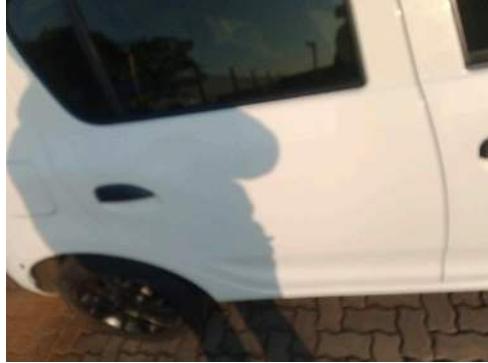
| Damage | Repair Way |
|--|---|
| Door Rear Right Damaged | Repair |

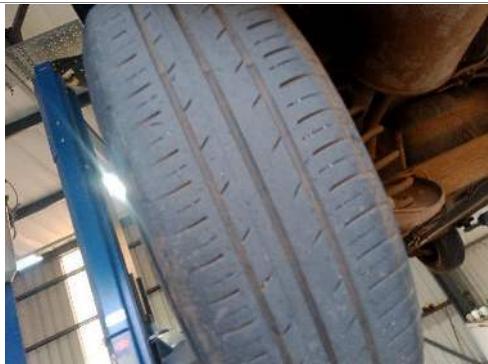
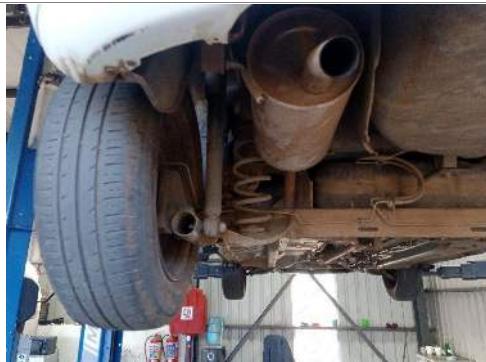
| Damage | Repair Way |
|--|---|
| Tyre Rear Left Worn | Repair |

| | Size | Load/Speed Index | Manufacture | Model | Type* | Production Date | Tread Depth (mm) |
|---|---|---|---|---|---|---|---|
| Rear Left | 185/65R15 | 88H | Kumho | Radial | V | 5121 | 0 mm |

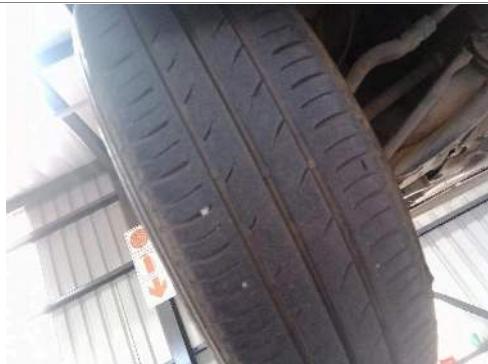
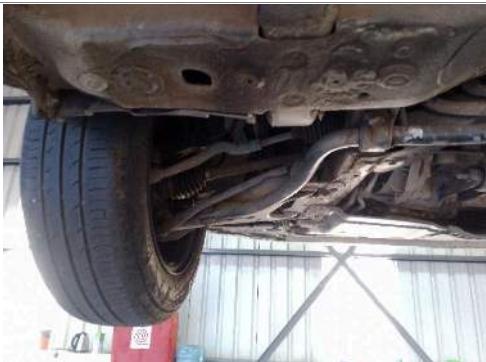
| Damage | Repair Way |
|--|---|
| Tyre Front Left Worn | Repair |

| | Size | Load/Speed Index | Manufacture | Model | Type* | Production Date | Tread Depth (mm) |
|---|---|---|---|---|---|---|---|
| Front Left | 185/65R15 | 88H | Kumho | Radial | V | 3121 | 0 mm |

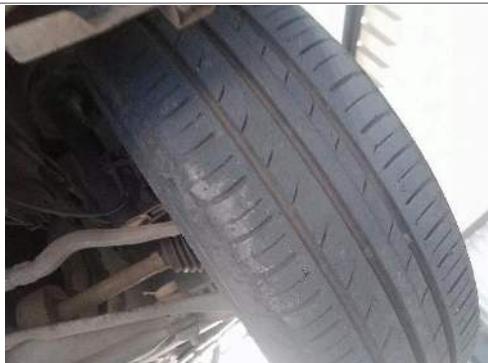
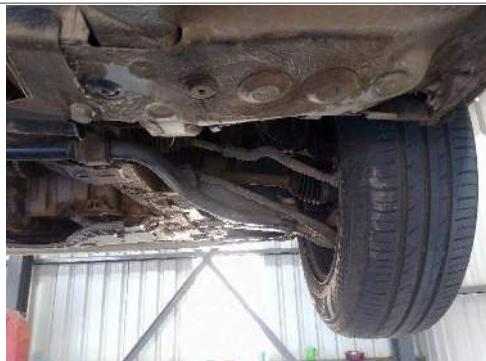
| Damage | Repair Way |
|--|---|
| Tyre Front Right Worn | Repair |

| | Size | Load/Speed Index | Manufacture | Model | Type* | Production Date | Tread Depth (mm) |
|---|---|---|---|---|---|---|---|
| Front Right | 185/65R15 | 88H | Kumho | Radial | V | 2021 | 0 mm |

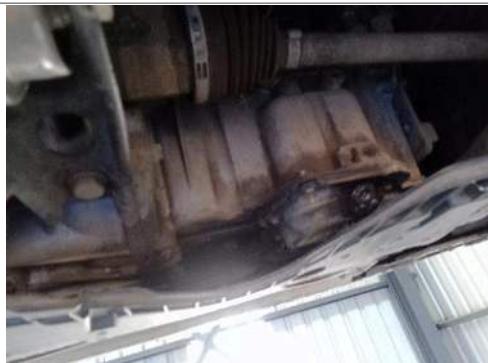
| Damage | Repair Way |
|--|---|
| Engine Oil Leak | Repair |

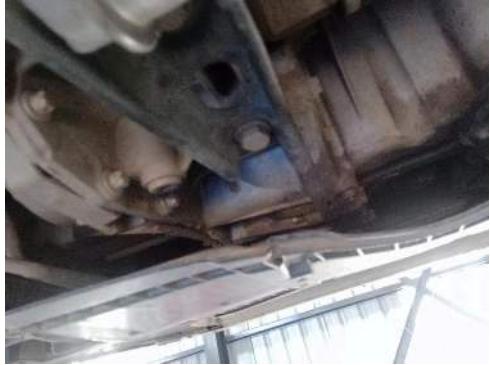
| Damage | Repair Way |
|--|---|
| Gearbox Oil Leak | Repair |
