MFC Auction House  
M57 Pretoria Rd, Glenmarais, KEMPTON PARK  
Gauteng

| Manufacturer | PEUGEOT | Registration Number | DUPLOOYGP |

## CONDITION REPORT

Report No: 2016318268

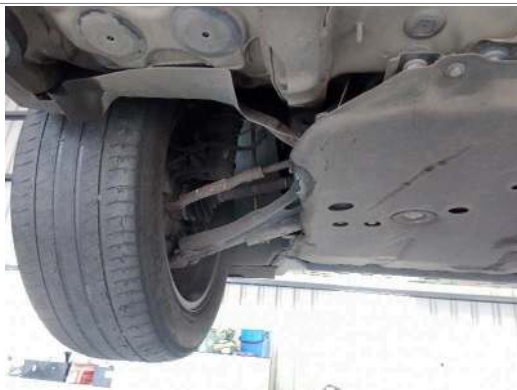
LF TYRE TREAD

| | Size | Load/Speed Index | Manufacture | Model | Type* | Production Date | Tread Depth (mm) |
|---|---|---|---|---|---|---|---|
| Front Left | 225/55 R18 | 98V | Michelin | Primacy | V | 3719 | 1 mm |

| Damage | Repair Way |
|---|---|
| Tyre Front Left Defective | Replace |

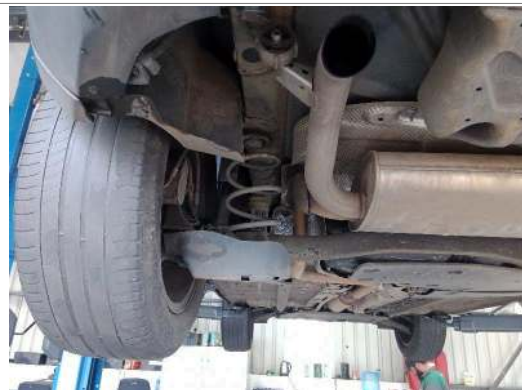
LR TYRE TREAD

| | Size | Load/Speed Index | Manufacture | Model | Type* | Production Date | Tread Depth (mm) |
|---|---|---|---|---|---|---|---|
| Rear Left | 225/55 R18 | 98V | Michelin | Primacy | V | 3719 | 0 mm |

| Damage | Repair Way |
|---|---|
| Tyre Rear Left Damaged | Replace |

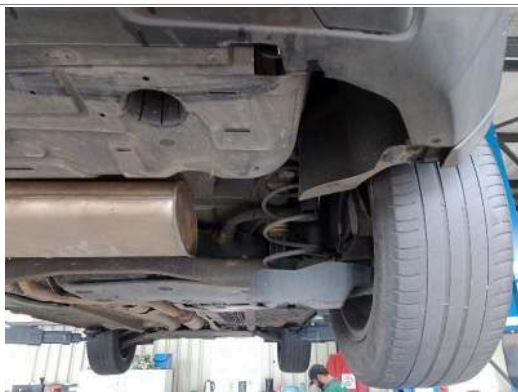
RR TYRE TREAD

| | Size | Load/Speed Index | Manufacture | Model | Type* | Production Date | Tread Depth (mm) |
|---|---|---|---|---|---|---|---|
| Rear Right | 225/55 R18 | 98V | Michelin | Primacy | V | 3719 | 1 mm |

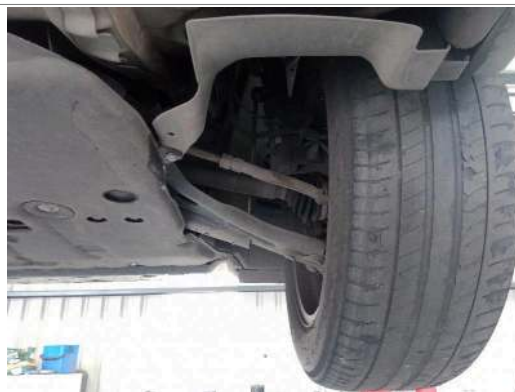
RF TYRE TREAD

| | Size | Load/Speed Index | Manufacture | Model | Type* | Production Date | Tread Depth (mm) |
|---|---|---|---|---|---|---|---|
| Front Right | 225/55 R18 | 98V | Michelin | Primacy | V | 3719 | 0 mm |

| Damage | Repair Way |
|---|---|
| Tyre Front Right Damaged | Replace |

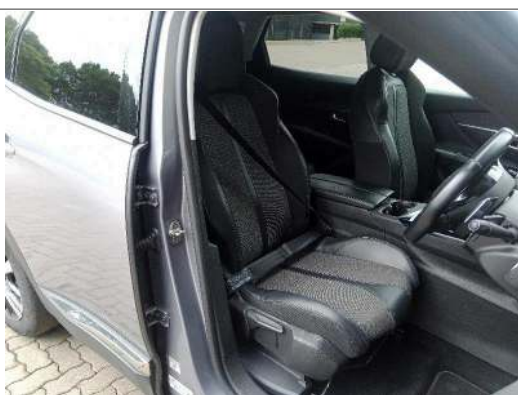
| Damage | Repair Way |
|---|---|
| Seat Front Right Damaged | Repair |

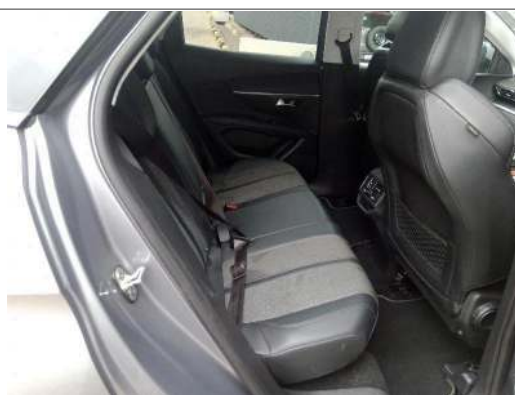
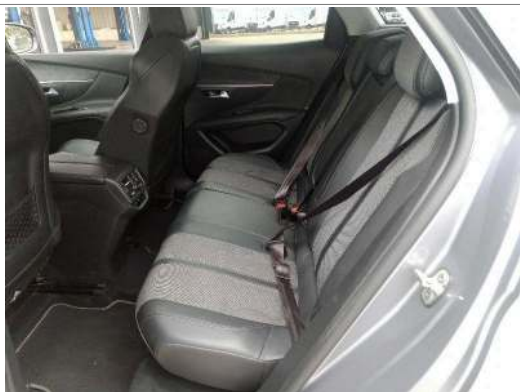
| Damage | Repair Way |
|---|---|
| Seat Rear Dirty | Repair |

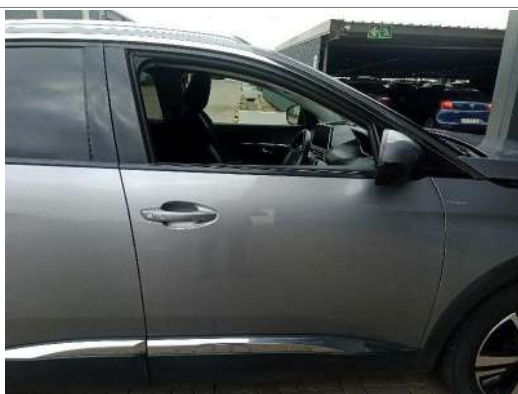
| Damage | Repair Way |
|---|---|
| Door Front Right Dented | Repair |

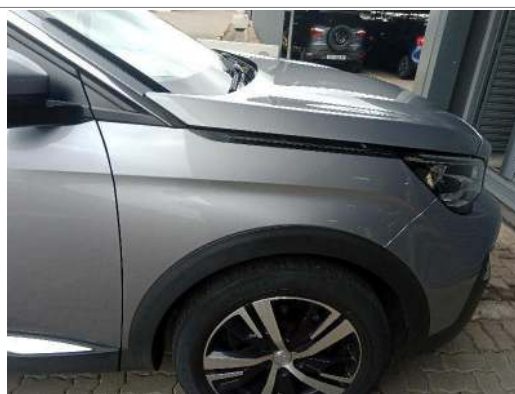
| Damage | Repair Way |
|---|---|
| Front Fender Right Paintwork • Scratched | Repair |

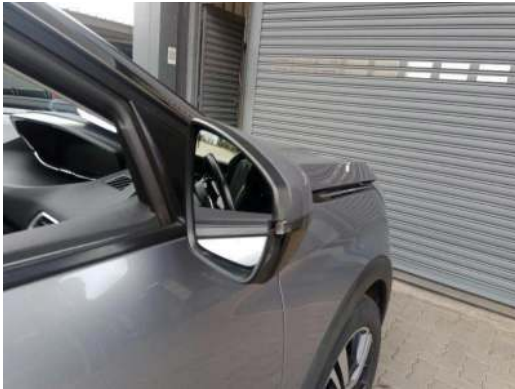
| Damage | Repair Way |
|---|---|
| Side Mirror Right Damaged | Repair |

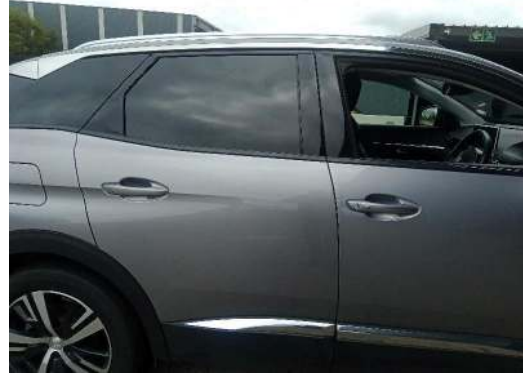
| Damage | Repair Way |
|---|---|
| Door Rear Right Paintwork • Scratched | Repair |

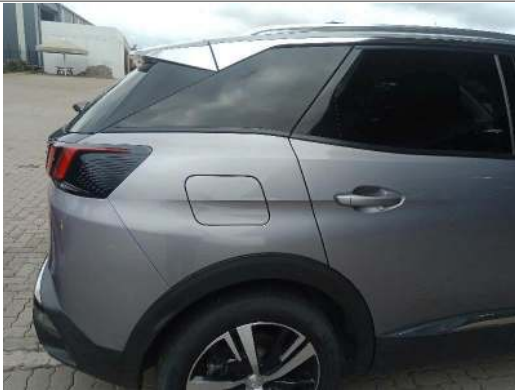
| Damage | Repair Way |
|---|---|
| Rear Fender Right Paintwork • Scratched | Repair |

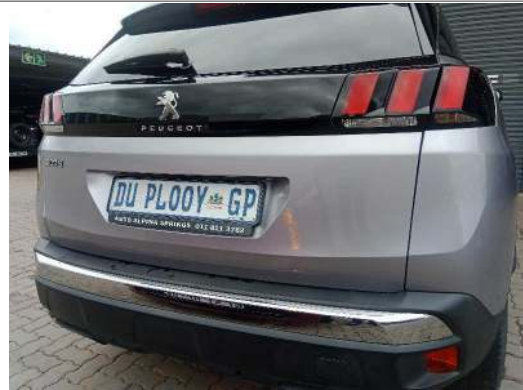
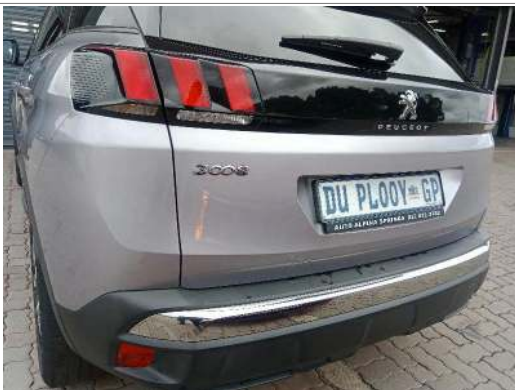
| Damage | Repair Way |
|---|---|
| Rear bumper Paintwork • Scratched | Repair |

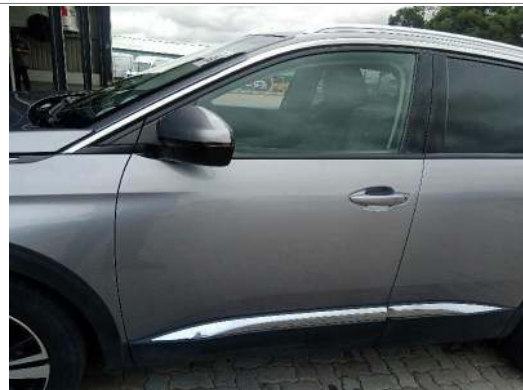
| Damage | Repair Way |
|---|---|
| Door Front Left Paintwork • Scratched | Repair |

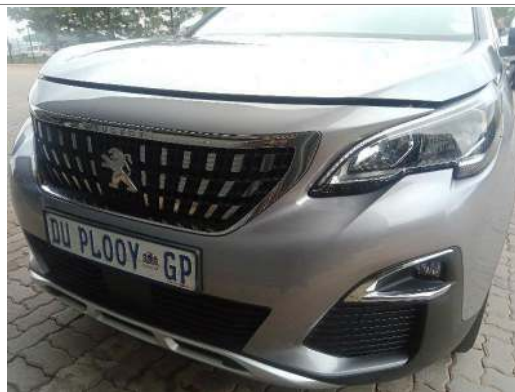
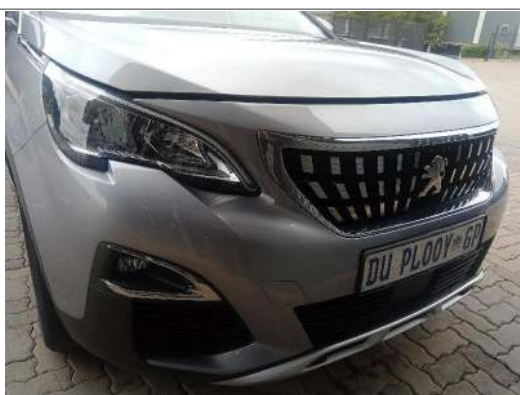
| Damage | Repair Way |
|---|---|
| Front Bumper Paintwork • Scratched | Repair |

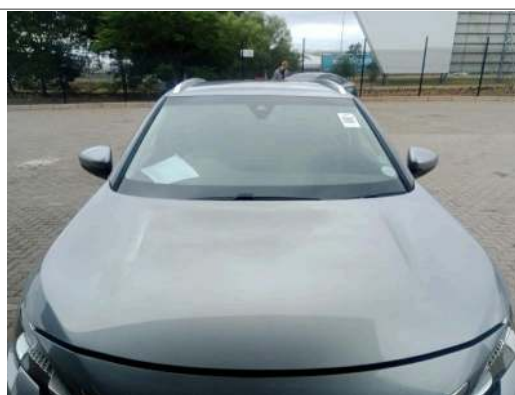
| Damage | Repair Way |
|---|---|
| Bonnet Paintwork • Chipmarks | Repair |

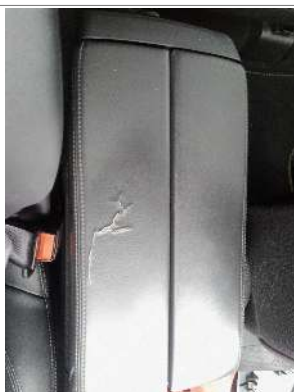
| Damage | Repair Way |
|---|---|
| Center Console / Cubbyhole + Lid Defective | Repair |

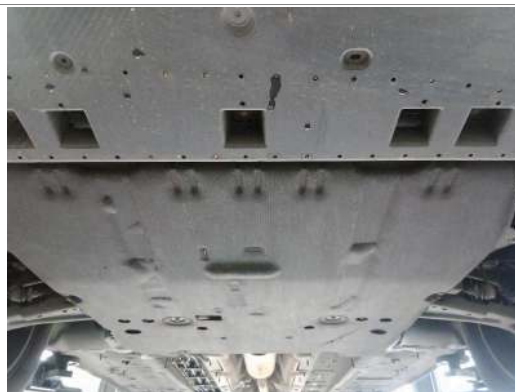
| Damage | Repair Way |
|---|---|
| Belly plates Defective | Repair |

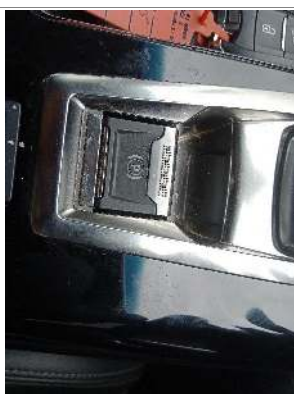
| Damage | Repair Way |
|---|---|
| Parking Brake Performance Malfunction | Repair |

| | Left | Right | | |
|---|---|---|---|---|
| Emergency / Parking | 1.79 | 2.04 | - | |
