MFC Auction House  
M57 Pretoria Rd, Glenmarais, KEMPTON PARK  
Gauteng

## Assignment

## Vehicle Data

## VEHICLE INSPECTION

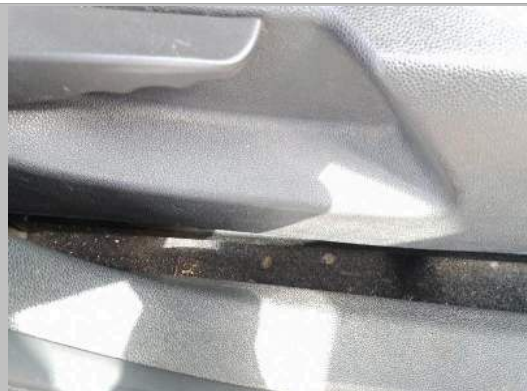
Damage	Repair Way
Engine Oil Leak	Repair
Air Conditioner Insufficient	Replace
Door Handle Front Right Damaged	Replace
Parcel Tray Damaged	Repair
Carpet Front Damaged	Repair
Side Mirror Right Paintwork • Scratched	Repair
Bonnet Paintwork • Chipmarks	Repair
Front Fender Left Residual Traces of Repair	Repair
Front Fender Right Paintwork • Scratched	Repair
Rear Fender Left Paintwork • Scratched	Repair
Rear Fender Right Paintwork • Scratched	Repair
Door Front Left Paintwork • Scratched	Repair
Door Front Right Paintwork • Scratched	Repair
Door Rear Left Paintwork • Scratched	Repair
Door Rear Right Paintwork • Scratched	Repair
Boot Lid / Hatch door Paintwork • Scratched	Repair
Rear bumper Paintwork • Scratched	Repair
Inner Boot Floor Pan and Spare Wheel Well Dented	Repair
Windscreen Chipped	Repair

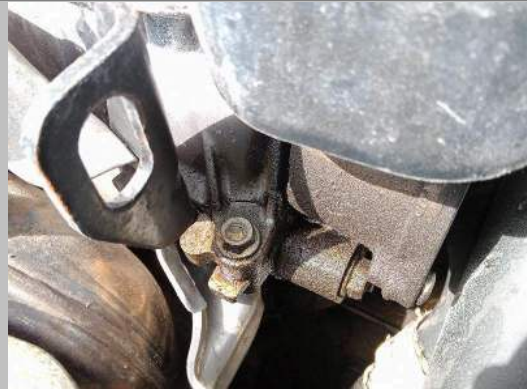
Damage	Repair Way
Tyre Rear Left Worn	Replace
Tyre Rear Right Damaged	Replace
Sub Frame Dented	Repair
Engine to silencer pipe Damaged	Repair
Gearbox Oil Leak	Repair
Jack Missing	Replace
Wheel Spanner Missing	Replace
Triangle Missing	Replace
Engine	Cylinder head cover cracked.
Body and Exterior	Dents and scratches on some body panels
Interior	Vehicle interior dirty and some panels scratched
Tyres and rims	Front and rear hubcaps scratched.
Body and Exterior	Stone chips and spray work on some body panels
Body and Exterior	Residual traces of repair on some body panels
Tyres and rims	Front and rear tyre sizes different
Tyres and rims	Spare wheel missing

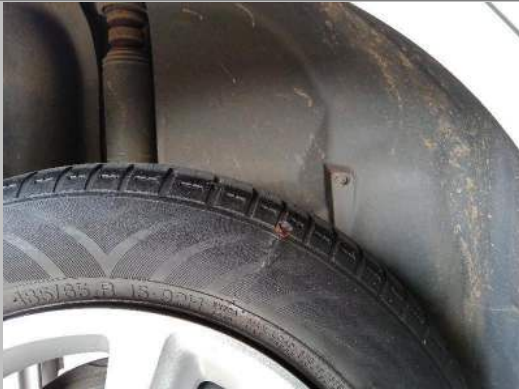
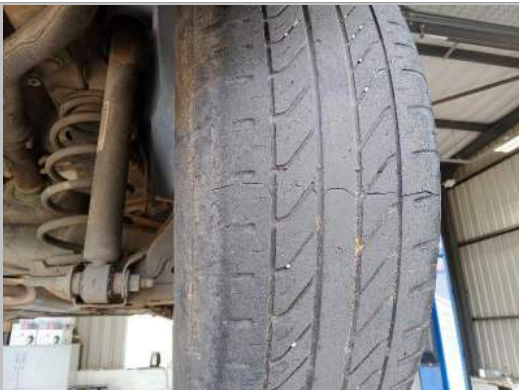
Tyre Rear Right

Size	Load/Speed Index	Manufacture	Model	Type*	Production Date	Tread Depth (mm)
Front Left	185/65 R15	92H	Sumitomo	HTR H5	V	1921	2 mm
Front Right	185/65 R15	92H	Sumitomo	HTR T5	V	1921	3 mm
Rear Left	185/65 R15	88H	Continental	ContiEco	V	1017	0 mm
Rear Right	185/65 R15	92H	Dunlop	Sp-Sport	V	3717	0 mm
