## CONDITION REPORT

Report No: 2016868454

Vehicle Type	PASSENGER VEHICLE	Registered Owner	
Manufacturer	OPEL	Registration Number	HR45TFGP
Model	ADAM 1.0T 3-DR [2018-2019]	Register Number	
VIN	W0V0MAP08J6053038	Date Of First Licensing	
Engine Number		Last COR	
Doors	3	License Expiry Date	30/04/2026
Color	RED	Power / Displacement	
Year Model	2018	Paint Finish	C - COMMON
Km Reading	100,059 KM	Fuel	PETROL
Cab / Body Type	HATCHBACK	Transmission	MANUAL

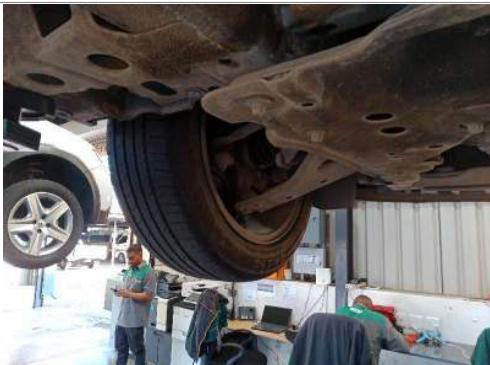
LF TYRE TREAD

Size	Load/Speed Index	Manufacture	Model	Type*	Production Date	Tread Depth (mm)
Front Left	195/55R16	87V	Davanti	Dx390	V	2323	3 mm
Front Right	195/55R16	87V	Davanti	Dx390	V	2423	2 mm
Rear Left	195/55R16	87H	Continental	Contact	V	1418	4 mm
Rear Right	195/55R16	87H	Continental	Contact	V	1418	4 mm
Spare	T115/70R16	92M	Continental	Temporary	V	0918	3 mm

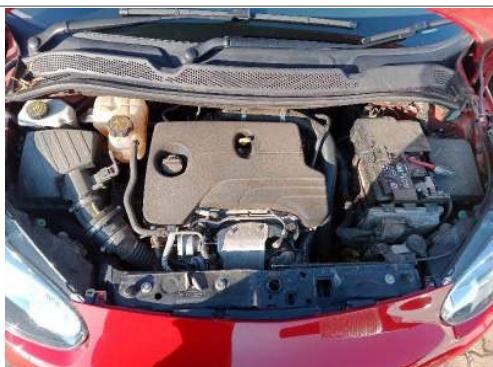
ENGINE 1

Engine number – not possible to verify engine number (not visible without dismantling)

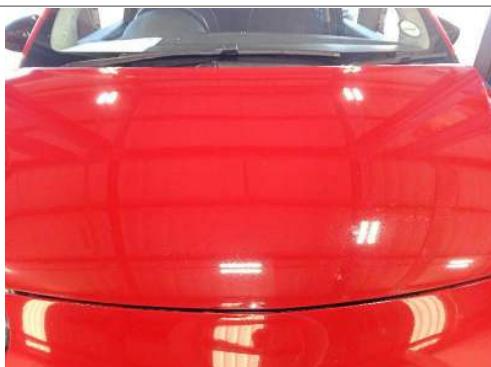
Damage	Repair Way
Front Bumper Paintwork • Scratched	Repair
Bonnet Paintwork • Chipmarks	Repair
Front Fender Left Paintwork • Chipmarks	Repair
Front Fender Right Paintwork • Chipmarks	Repair
Rear Fender Left Paintwork • Scratched	Repair
Rear Fender Right Paintwork • Scratched	Repair
Door Front Left Paintwork • Scratched	Repair
Door Front Right Dented	Repair
