## CONDITION REPORT

Report No: 2016402973

DATE  
03/06/2024

MFC Auction House  
M57 Pretoria Rd, Glenmarais, KEMPTON PARK  
Gauteng

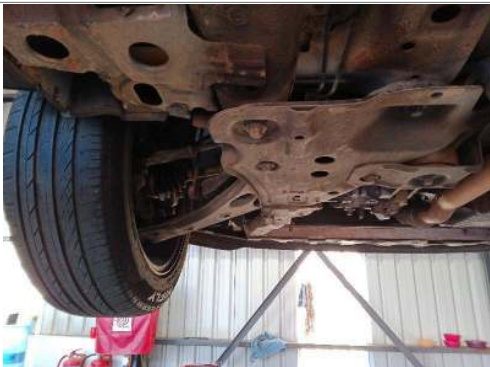
LF TYRE TREAD

| | Size | Load/Speed Index | Manufacture | Model | Type* | Production Date | Tread Depth (mm) |
|---|---|---|---|---|---|---|---|
| Front Left | 195/55R16 | 91V | Hifly | Radial | V | 1122 | 2 mm |

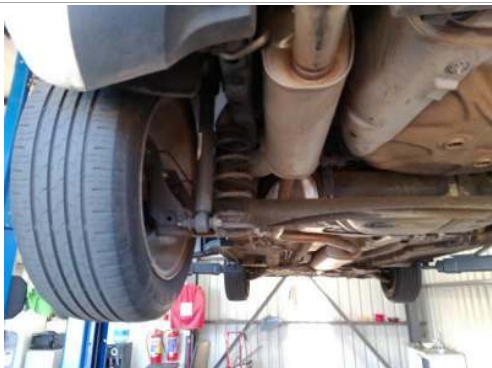
LR TYRE TREAD

| | Size | Load/Speed Index | Manufacture | Model | Type* | Production Date | Tread Depth (mm) |
|---|---|---|---|---|---|---|---|
| Rear Left | 195/55R16 | 87H | Continental | Eco | V | 2719 | 2 mm |

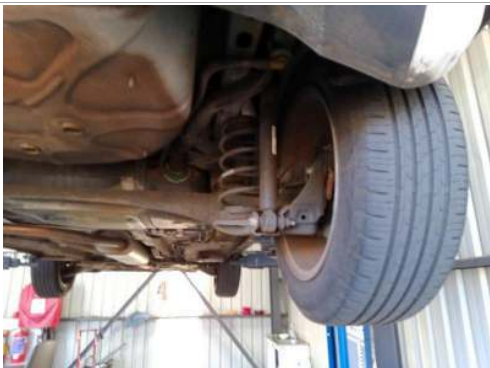
RR TYRE TREAD

| | Size | Load/Speed Index | Manufacture | Model | Type* | Production Date | Tread Depth (mm) |
|---|---|---|---|---|---|---|---|
| Rear Right | 195/55R16 | 87H | Continental | Eco | V | 2619 | 2 mm |

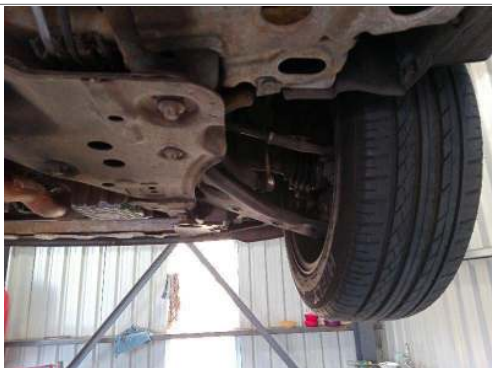
RF TYRE TREAD

| | Size | Load/Speed Index | Manufacture | Model | Type* | Production Date | Tread Depth (mm) |
|---|---|---|---|---|---|---|---|
| Front Right | 195/55R16 | 91V | Hifly | Radial | V | 1122 | 2 mm |

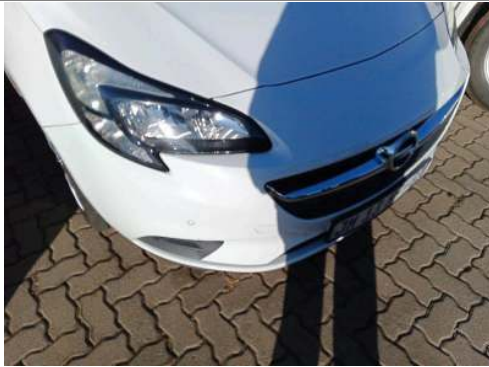
| Damage | Repair Way |
|---|---|
| Front Bumper Damaged | Repair |

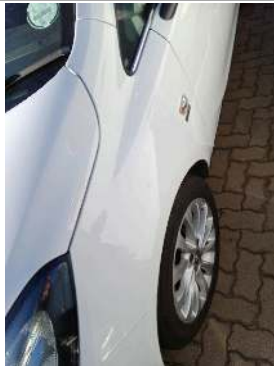
| Damage | Repair Way |
|---|---|
| Front Fender Left Damaged | Repair |

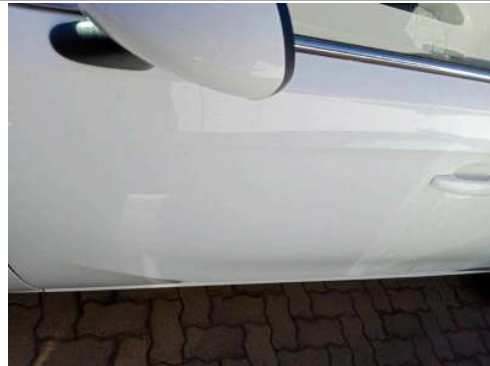
| Damage | Repair Way |
|---|---|
| Door Front Left Damaged | Repair |

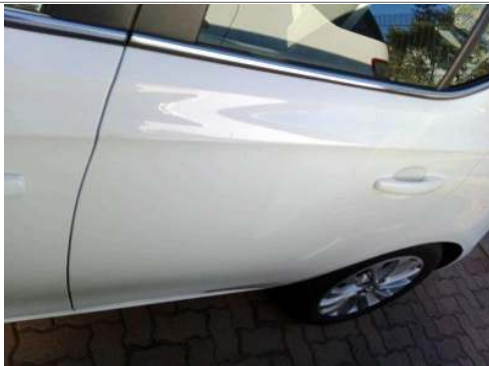
| Damage | Repair Way |
|---|---|
| Door Rear Left Damaged | Repair |

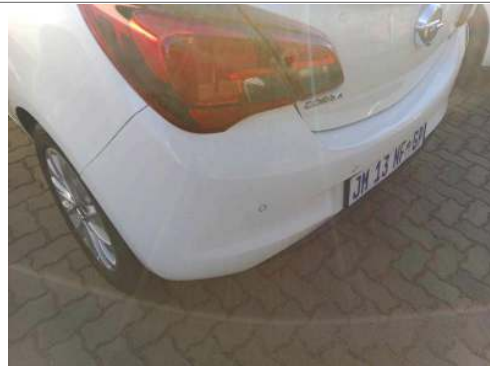
| Damage | Repair Way |
|---|---|
| Rear bumper Damaged | Repair |

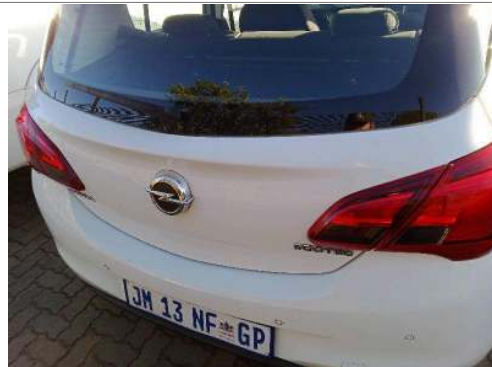
| Damage | Repair Way |
|---|---|
| Boot Lid / Hatch door Damaged | Repair |

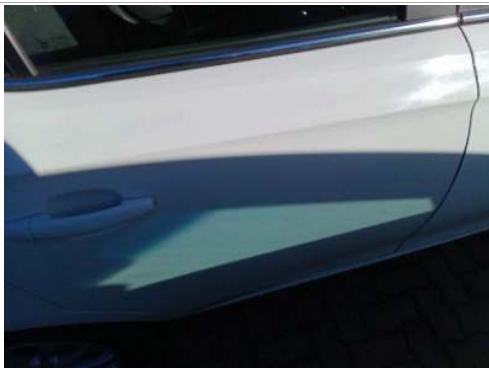
| Damage | Repair Way |
|---|---|
| Door Rear Right Damaged | Repair |

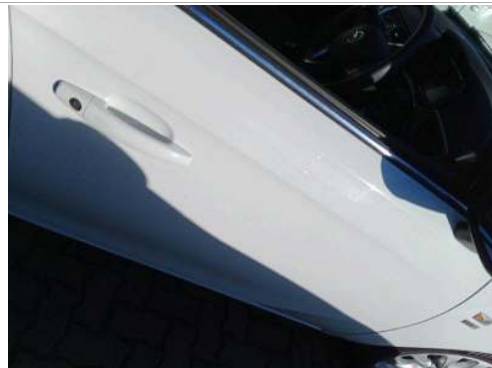
| Damage | Repair Way |
|---|---|
| Door Front Right Damaged | Repair |

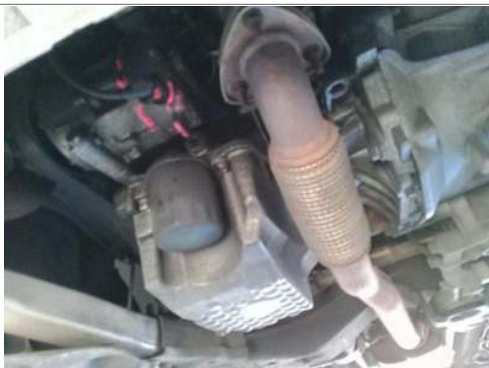
| Damage | Repair Way |
|---|---|
| Engine Oil Leak | Repair |
