## CONDITION REPORT

Report No: 2016204298

MFC Auction House  
M57 Pretoria Rd, Glenmarais, KEMPTON PARK  
Gauteng

| Manufacturer | AUDI | Registration Number | CG54GDGP |

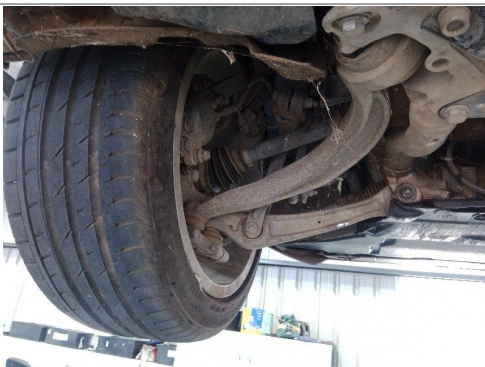
LF TYRE TREAD

| | Size | Load/Speed Index | Manufacture | Model | Type* | Production Date | Tread Depth (mm) |
|---|---|---|---|---|---|---|---|
| Front Left | 245/40 R18 | 93Y | Continental | ContiSport | V | 1719 | 3 mm |

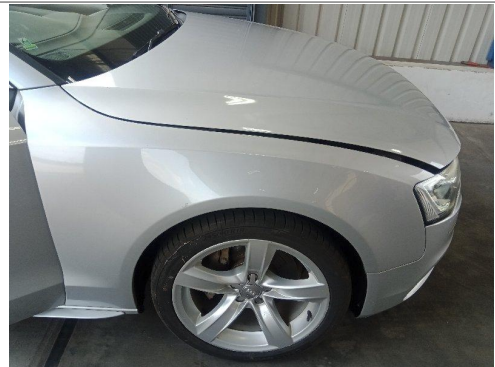
| Damage | Repair Way |
|---|---|
| Front Fender Right Paintwork • Scratched | Repair |

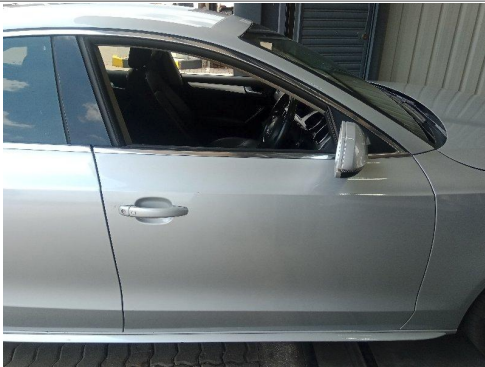
| Damage | Repair Way |
|---|---|
| Door Front Right Residual Traces of Repair | Repair |

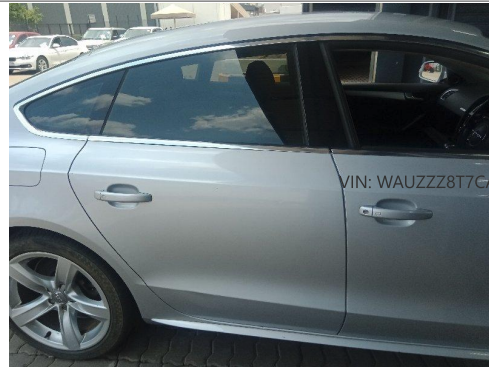
| Damage | Repair Way |
|---|---|
| Door Rear Right Residual Traces of Repair | Repair |

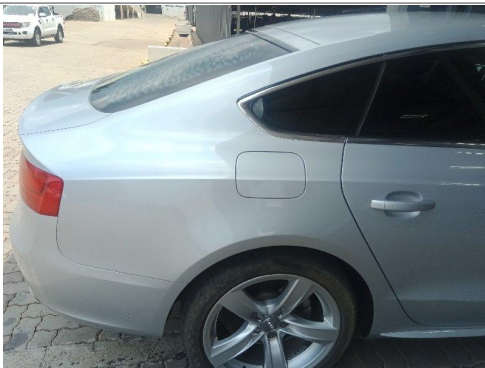
| Damage | Repair Way |
|---|---|
| Rear Fender Right Residual Traces of Repair | Repair |

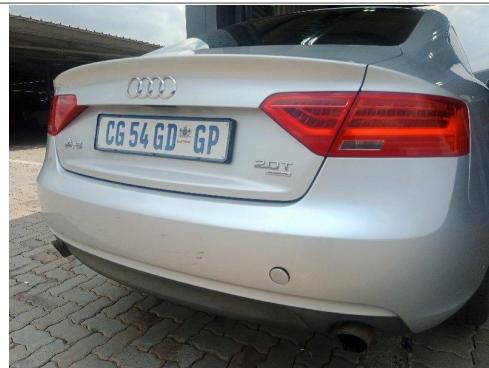
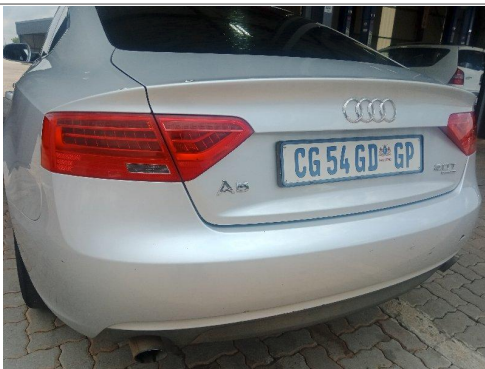
| Damage | Repair Way |
|---|---|
| Rear bumper Paintwork • Scratched | Repair |

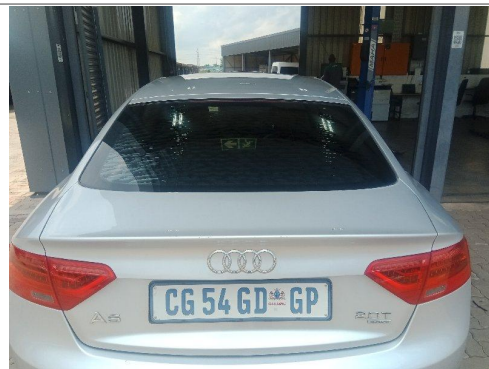
| Damage | Repair Way |
|---|---|
| Boot Lid / Hatch door Paintwork • Scratched | Repair |

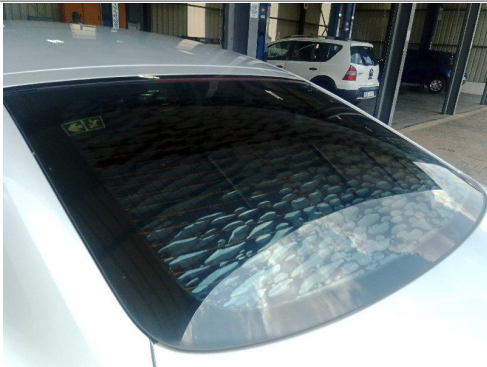
| Damage | Repair Way |
|---|---|
| Back Window Defective | Repair |

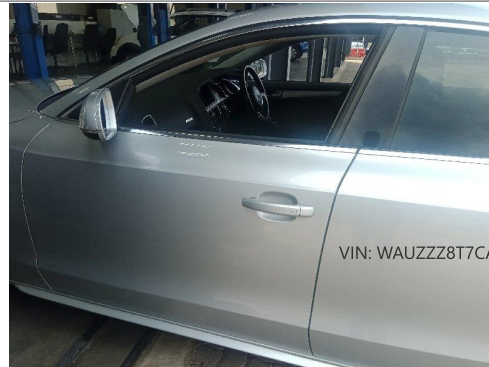
| Damage | Repair Way |
|---|---|
| Door Front Left Paintwork • Scratched | Repair |

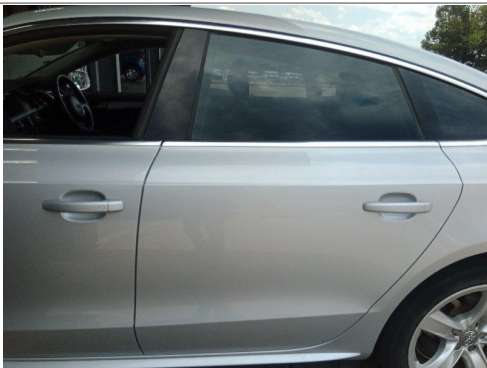
| Damage | Repair Way |
|---|---|
| Door Rear Left Paintwork • Scratched | Repair |

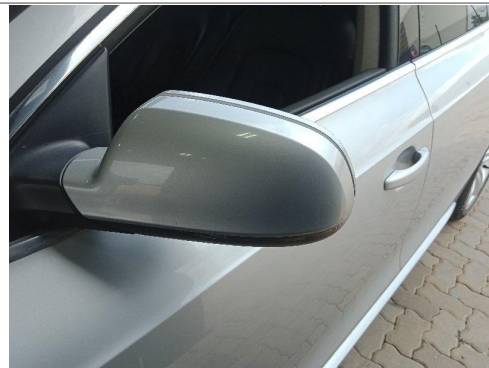
| Damage | Repair Way |
|---|---|
| Side Mirror Left Paintwork • Scratched | Repair |

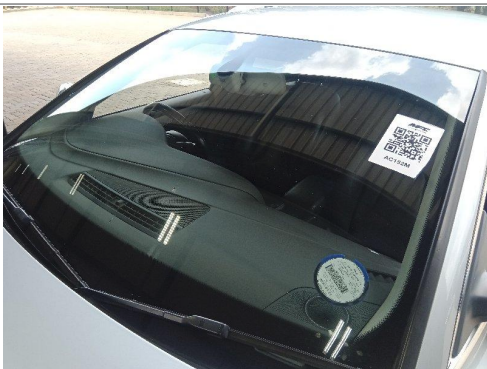
| Damage | Repair Way |
|---|---|
| Windscreen Damaged | Replace |

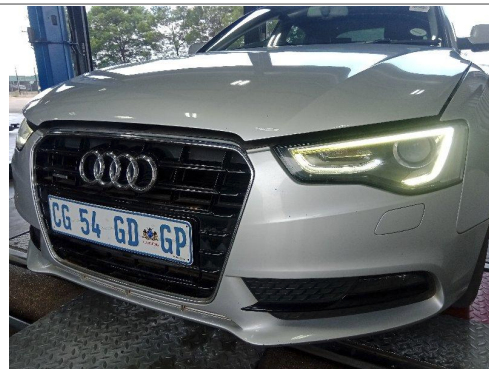
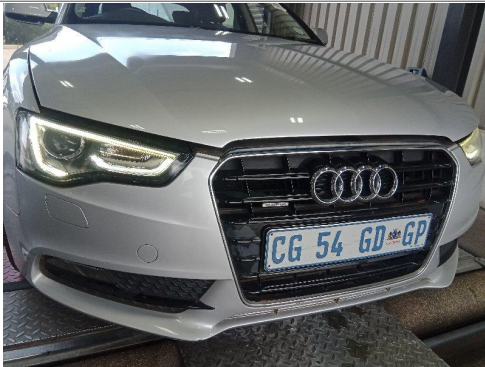
| Damage | Repair Way |
|---|---|
| Front Bumper Paintwork • Scratched | Repair |

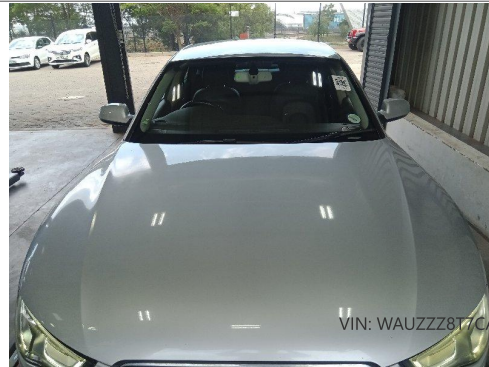
| Damage | Repair Way |
|---|---|
| Bonnet Residual Traces of Repair | Repair |

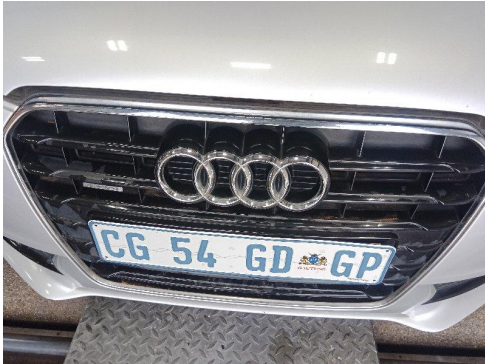
| Damage | Repair Way |
|---|---|
| Grill Paintwork • Flaking | Repair |

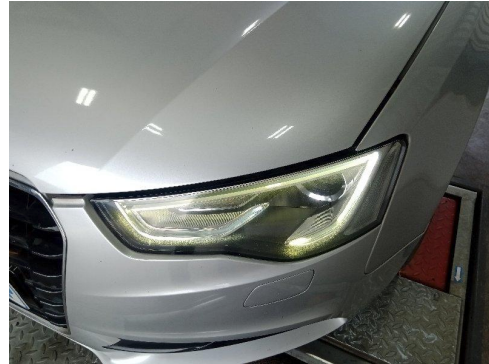
| Damage | Repair Way |
|---|---|
| Headlight Left Defective | Repair |

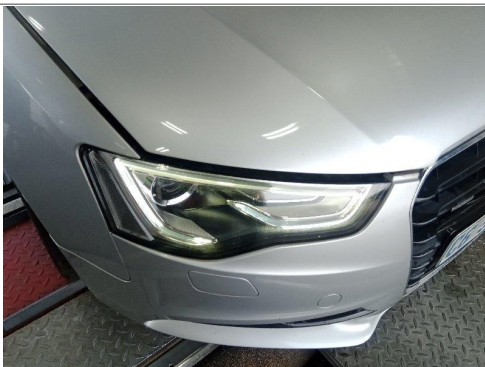
| Damage | Repair Way |
|---|---|
| Headlight Right Defective | Repair |

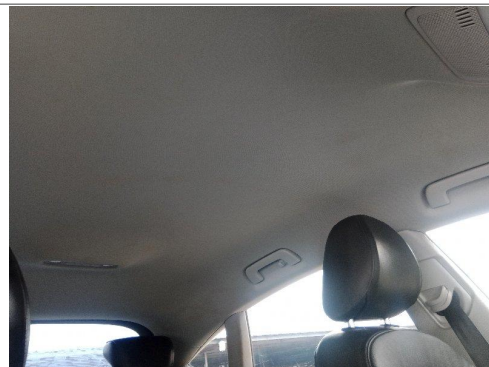
| Damage | Repair Way |
|---|---|
| Hood Lining Dirty | Repair |

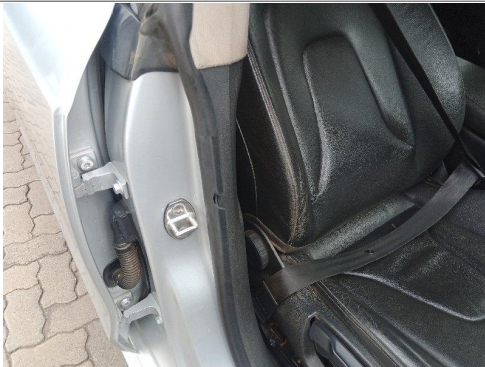
| Damage | Repair Way |
|---|---|
| Door Sealing Rubber Front Right Damaged | Replace |

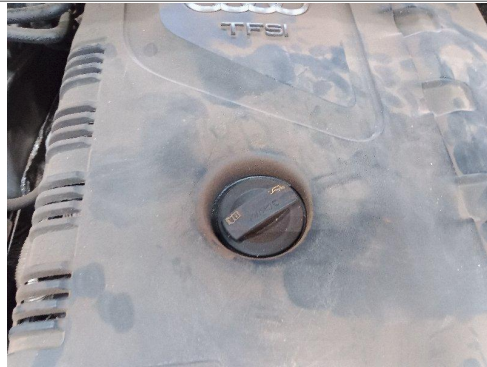
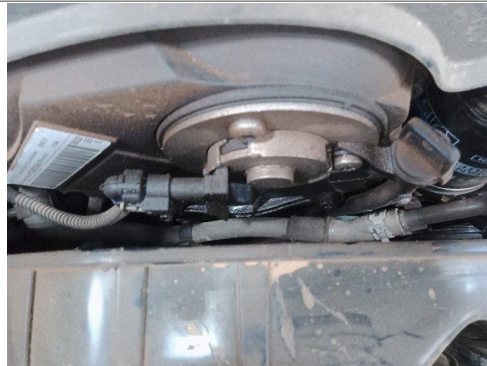
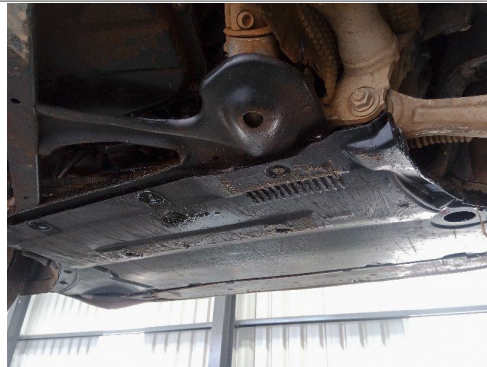
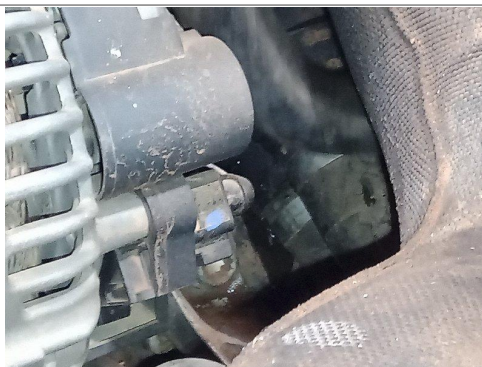
| Damage | Repair Way |
|---|---|
| Engine Oil Leak | Repair |

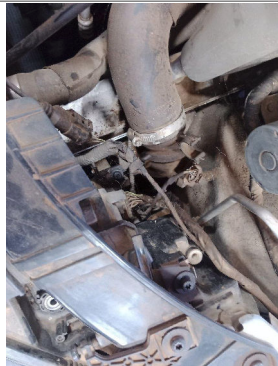
| Damage | Repair Way |
|---|---|
| Engine Wiring Defective | Repair |

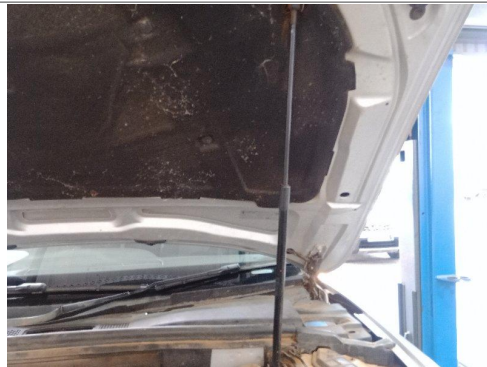
| Damage | Repair Way |
|---|---|
| Bonnet stay and shocks Damaged | Replace |

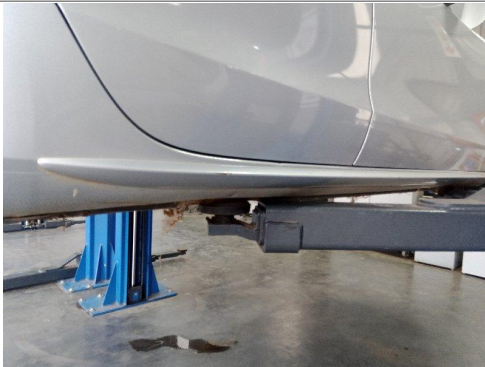
| Damage | Repair Way |
|---|---|
| Rocker Panel Right Dented | Repair |

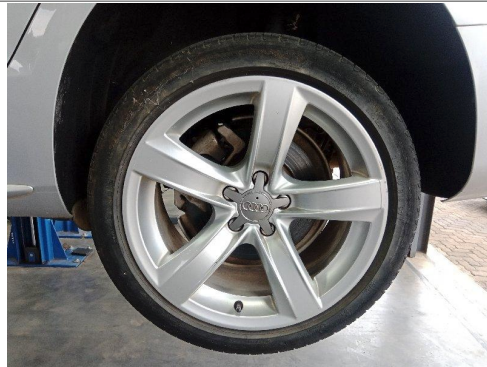
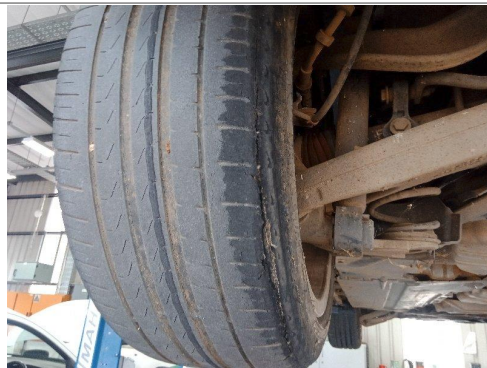
| Damage | Repair Way |
|---|---|
| Tyre Rear Left Damaged | Replace |

| | Size | Load/Speed Index | Manufacture | Model | Type* | Production Date | Tread Depth (mm) |
|---|---|---|---|---|---|---|---|
| Rear Left | 245/40 R18 | 97Y | Pirelli | Cinturato | V | 2717 | 0 mm |

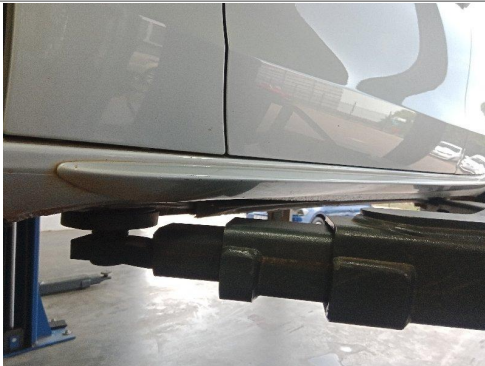
| Damage | Repair Way |
|---|---|
| Rocker Panel Left Dented | Repair |

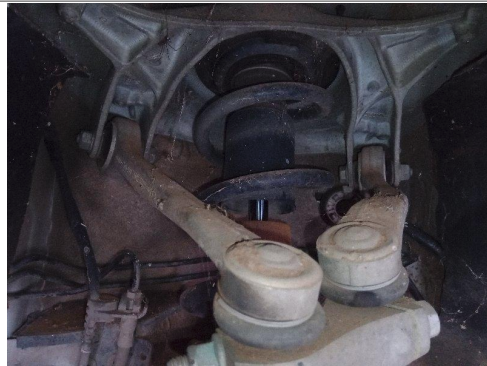
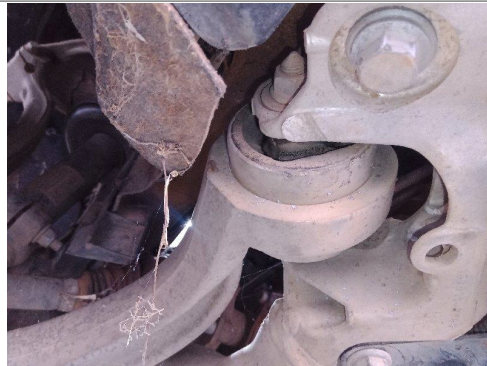
| Damage | Repair Way |
|---|---|
| Control Arm Bush(es) Front Axle Left Cracked | Replace |

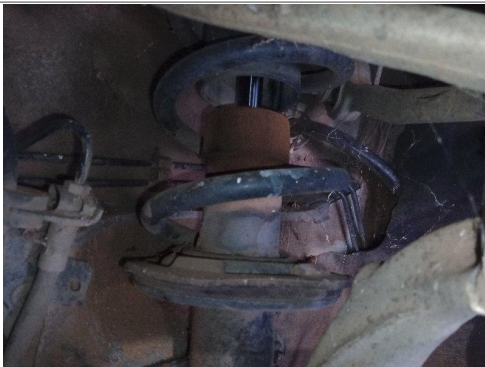
| Damage | Repair Way |
|---|---|
| Shock Absorber Front Left Sweat | Replace |

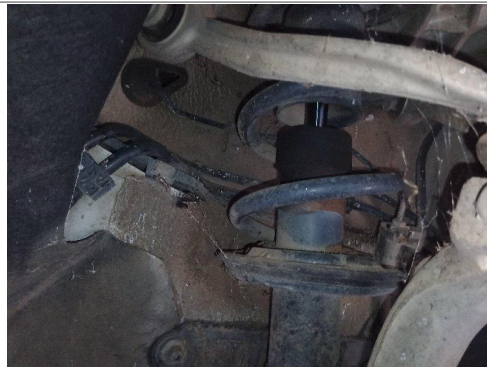
| Damage | Repair Way |
|---|---|
| Shock Absorber Front Right Sweat | Replace |

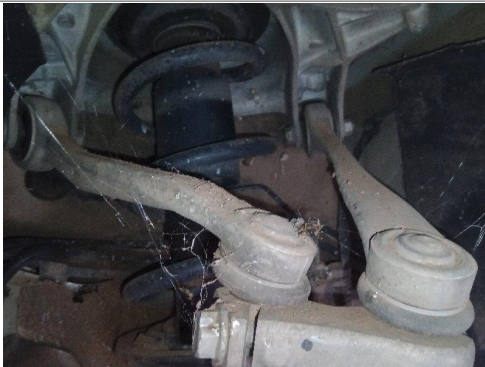
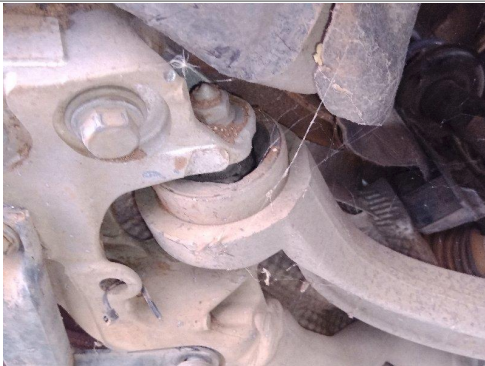
| Damage | Repair Way |
|---|---|
| Control Arm Bush(es) Front Axle Right Cracked | Replace |

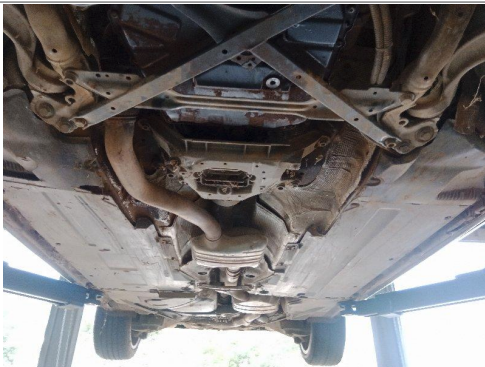
Cross Member Rear Right Dented  
 Belly plates Damaged  
 Gearbox Oil Leak  
 Differential Oil Sweat  
 CV Joint(s) Rear Left (inner/outer) Defective  
 CV Joint(s) Rear Right (inner/outer) Defective  
 Engine Performance Idling / Hunting  
 Jack Missing  
 Wheel Spanner Missing  
 Warning lights illuminated on dashboard

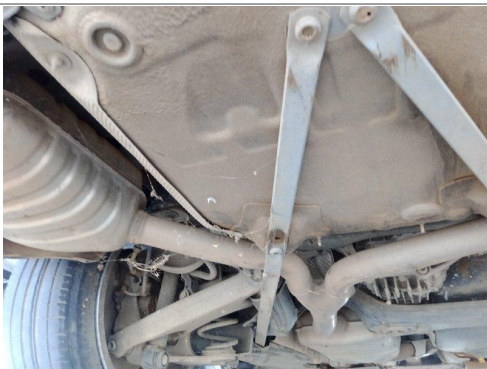
| Damage | Repair Way |
|---|---|
| Cross Member Rear Left Dented | Repair |
