## CONDITION REPORT

Report No: 2016360753

| Manufacturer | AUDI | Registration Number | HW73GRGP |
| Model | A3 TFSI | Register Number | |

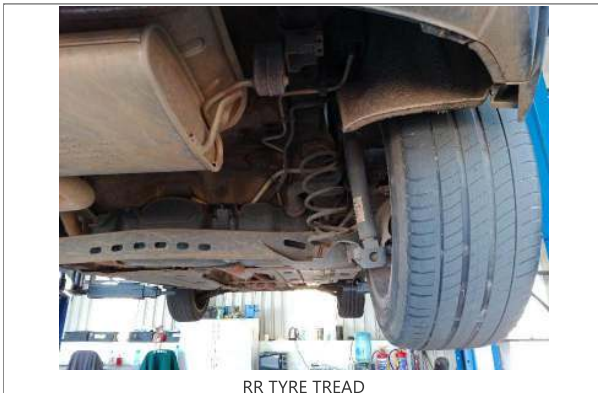
RR TYRE TREAD

| | Size | Load/Speed Index | Manufacture | Model | Type* | Production Date | Tread Depth (mm) |
|---|---|---|---|---|---|---|---|
| Rear Right | 225/45 R17 | 91Y | Michelin | Primacy 3 | V | 3618 | 0 mm |

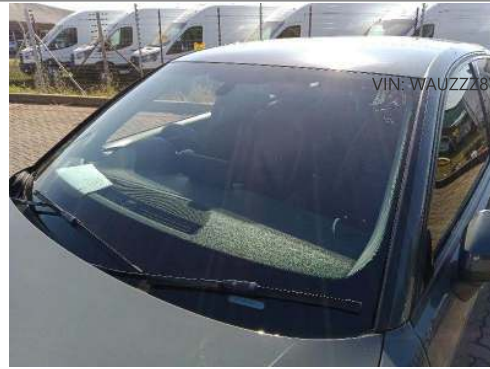
LICENSE DISC

| Damage | Repair Way |
|---|--|
| Body and Exterior | Vehicle license disk missing |

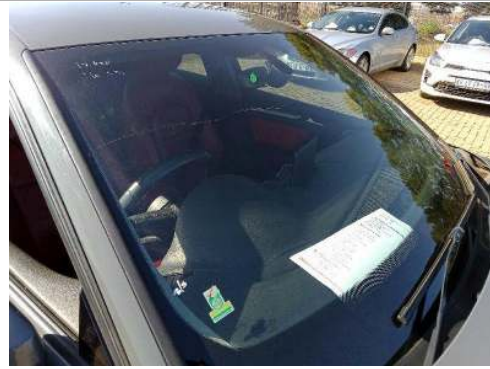
| Damage | Repair Way |
|--|---|
| Windscreen Cracked | Replace |

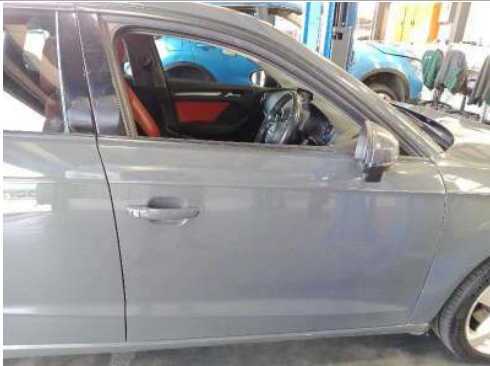
| Damage | Repair Way |
|--|---|
| Door Front Right Paintwork • Scratched | Repair |

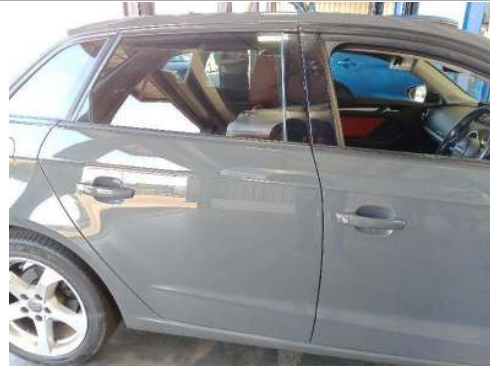
| Damage | Repair Way |
|--|---|
| Door Rear Right Paintwork • Scratched | Repair |

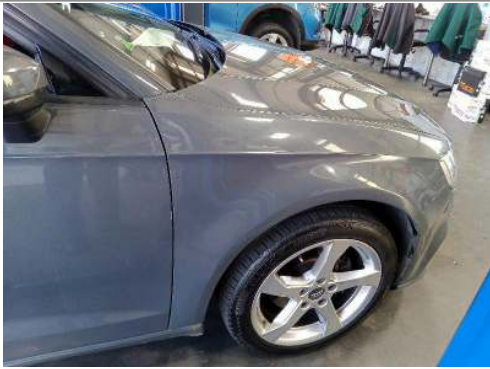
| Damage | Repair Way |
|--|---|
| Front Fender Right Residual Traces of Repair | Repair |

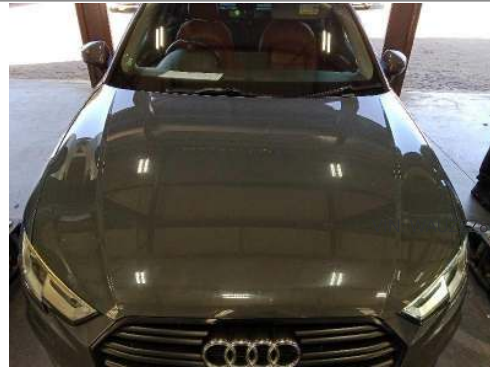
| Damage | Repair Way |
|--|---|
| Bonnet Residual Traces of Repair | Repair |

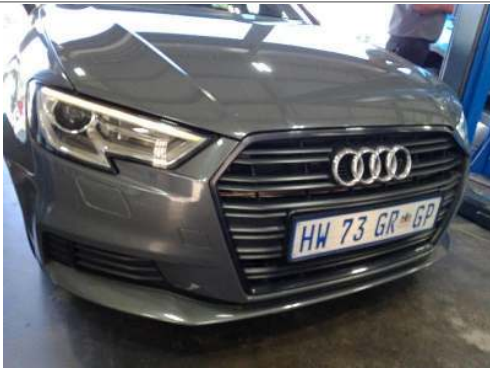
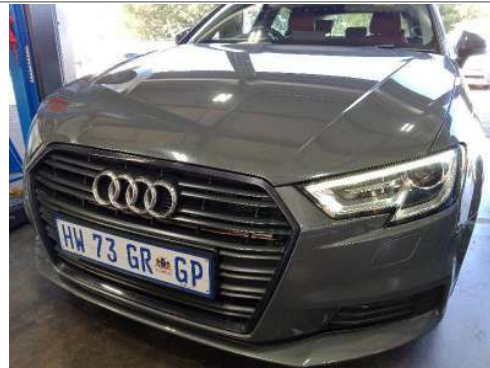
| Damage | Repair Way |
|--|---|
| Front Bumper Damaged | Repair |

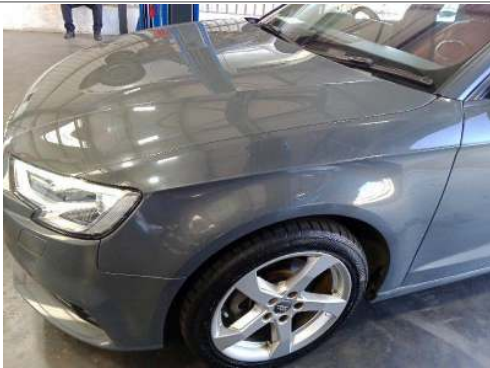
| Damage | Repair Way |
|--|---|
| Front Fender Left Paintwork • Scratched | Repair |

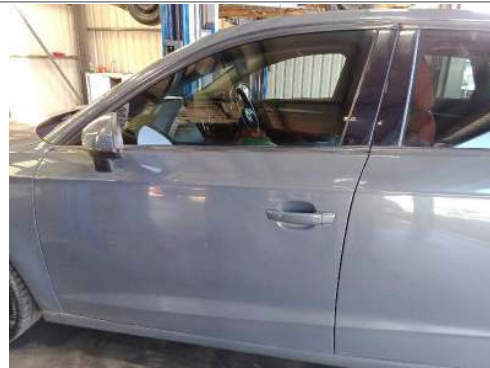
| Damage | Repair Way |
|--|---|
| Door Front Left Paintwork • Scratched | Repair |

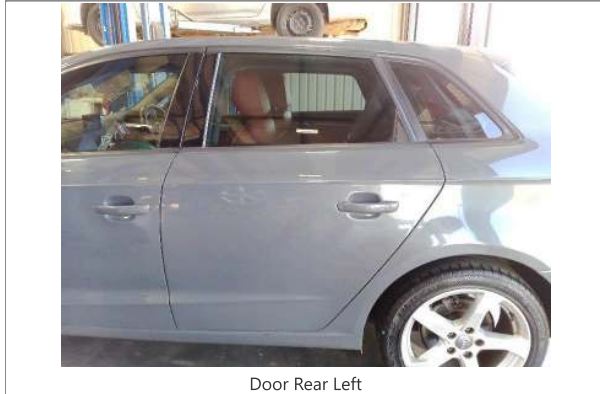
| Damage | Repair Way |
|--|---|
| Door Rear Left Residual Traces of Repair | Repair |

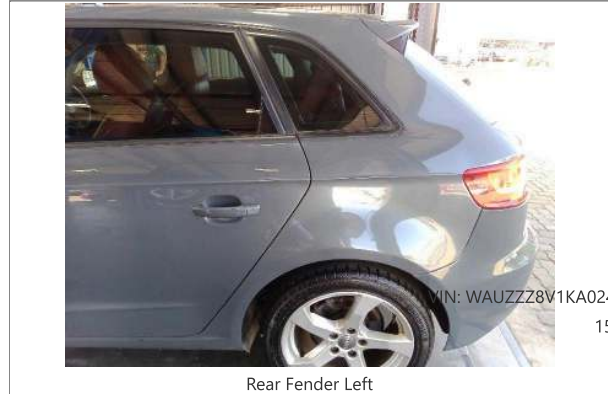
| Damage | Repair Way |
|--|---|
| Rear Fender Left Residual Traces of Repair | Repair |

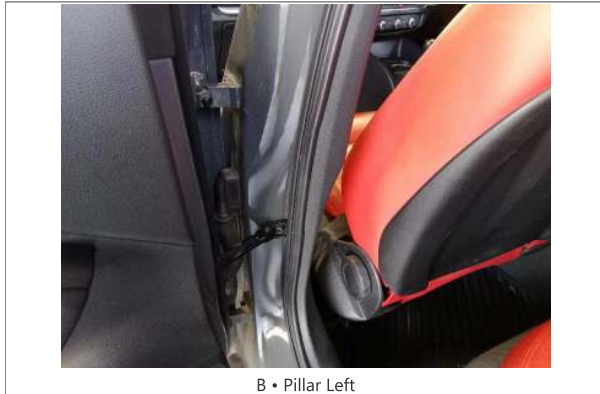
| Damage | Repair Way |
|--|---|
| B • Pillar Left Residual Traces of Repair | Repair |

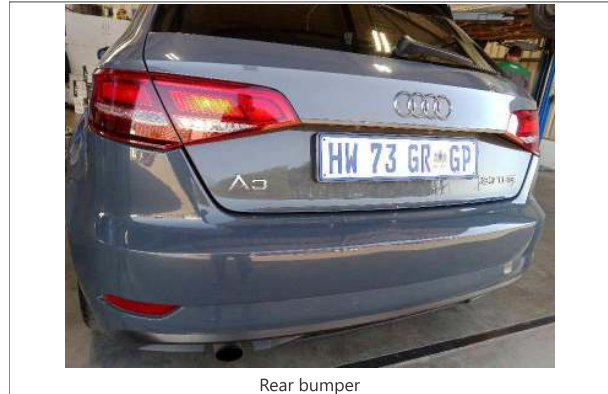
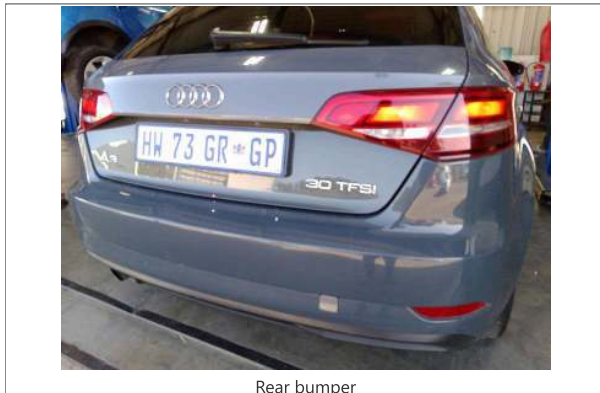
| Damage | Repair Way |
|--|---|
| Rear bumper Damaged | Repair |

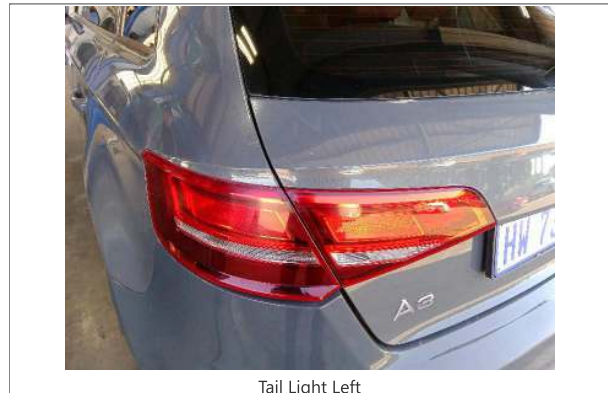
| Damage | Repair Way |
|--|---|
| Tail Light Left Scratched | Repair |

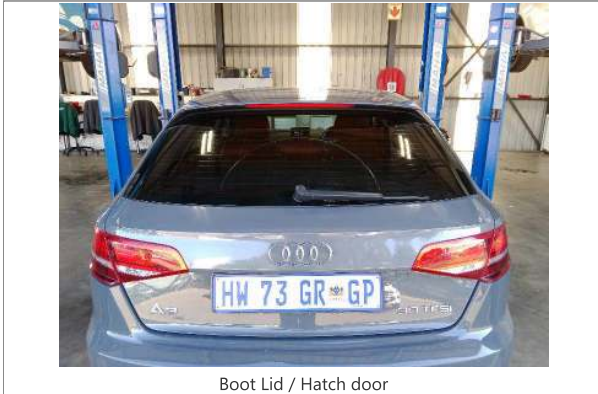
| Damage | Repair Way |
|--|---|
| Boot Lid / Hatch door Residual Traces of Repair | Repair |

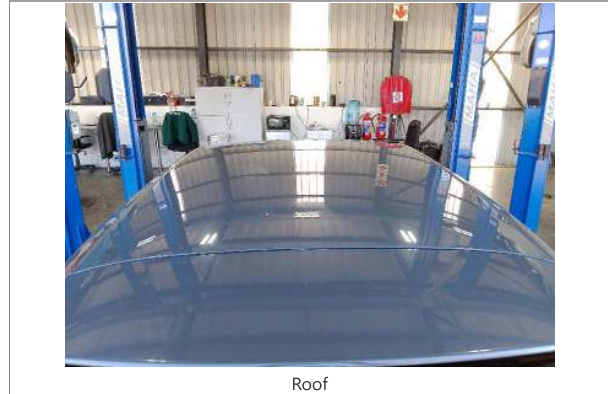
| Damage | Repair Way |
|--|---|
| Roof Paintwork • Scratched | Repair |

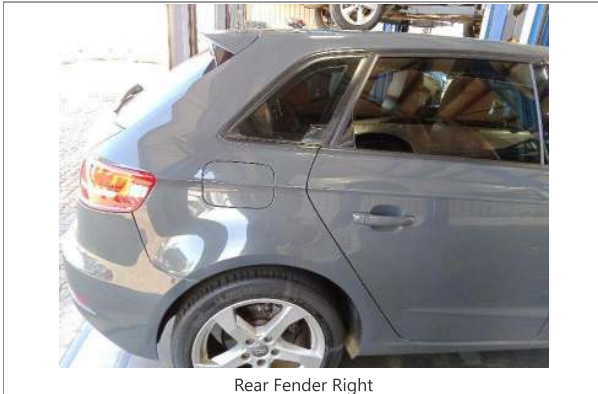
| Damage | Repair Way |
|--|---|
| Rear Fender Right Dented | Repair |

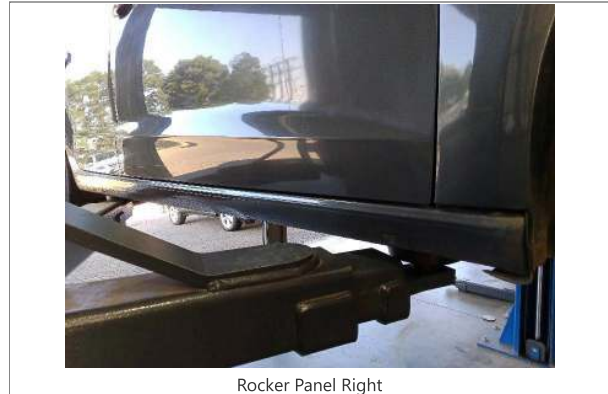
| Damage | Repair Way |
|--|---|
| Rocker Panel Right Dented | Repair |

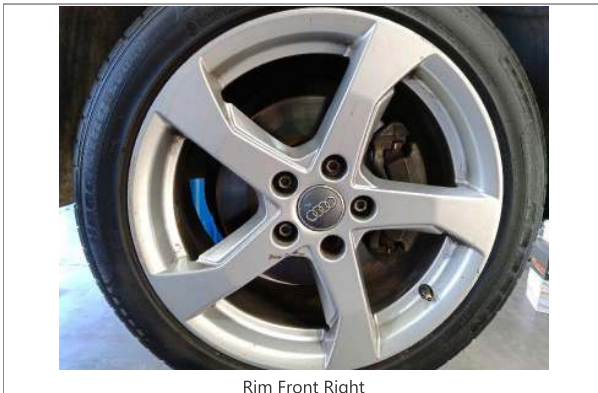
| Damage | Repair Way |
|--|---|
| Rim Front Right Scratched | Repair |

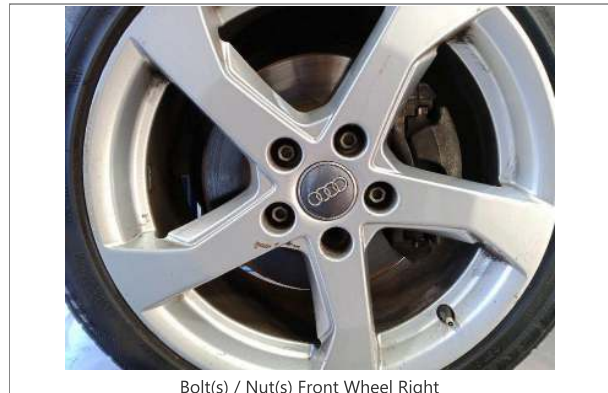
| Damage | Repair Way |
|---|--|
| Bolt(s) / Nut(s) Front Wheel Right Missing | Replace |

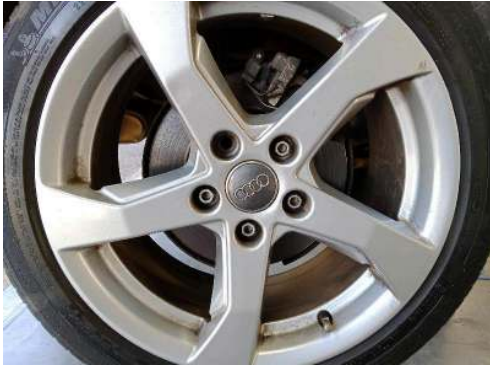
| Damage | Repair Way |
|---|--|
| Bolt(s) / Nut(s) Rear Wheel Right Missing | Replace |

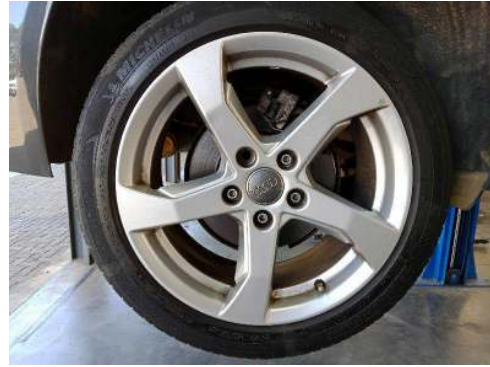
| Damage | Repair Way |
|--|---|
| Rim Rear Right Scratched | Repair |

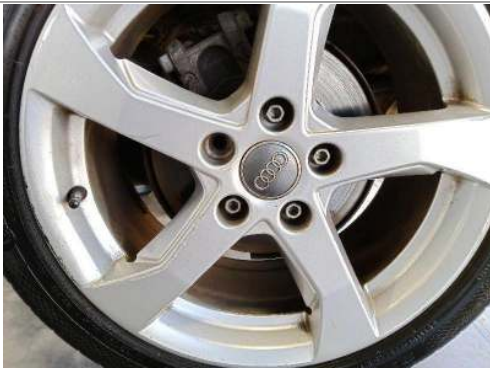
| Damage | Repair Way |
|---|--|
| Bolt(s) / Nut(s) Rear Wheel Left Missing | Replace |

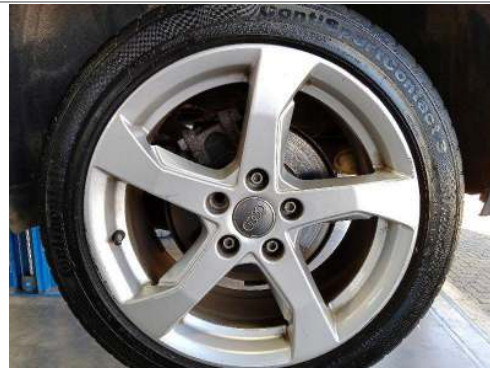
| Damage | Repair Way |
|--|---|
| Rim Rear Left Scratched | Repair |

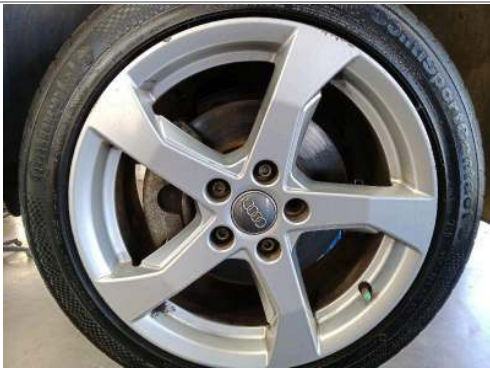
| Damage | Repair Way |
|--|---|
| Rim Front Left Scratched | Repair |

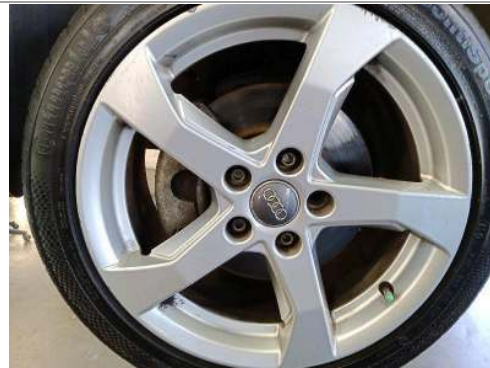
| Damage | Repair Way |
|--|---|
| Bolt(s) / Nut(s) Front Wheel Left Missing | Replace |

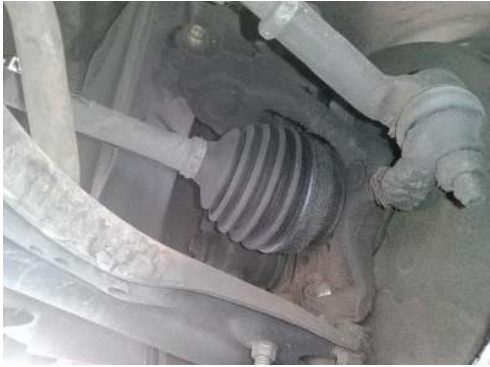
| Damage | Repair Way |
|---|--|
| CV Joint(s) Boot(s) Front Right (inner/outer) Damaged | Replace |

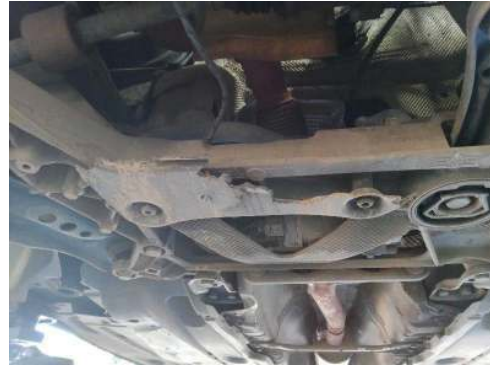
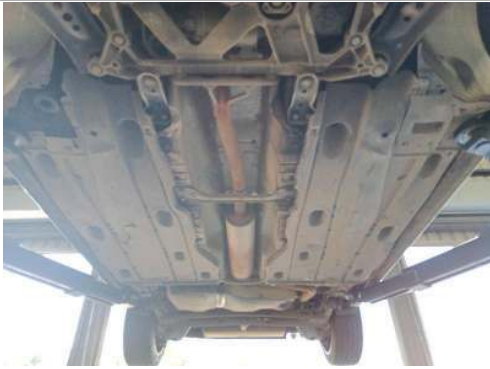
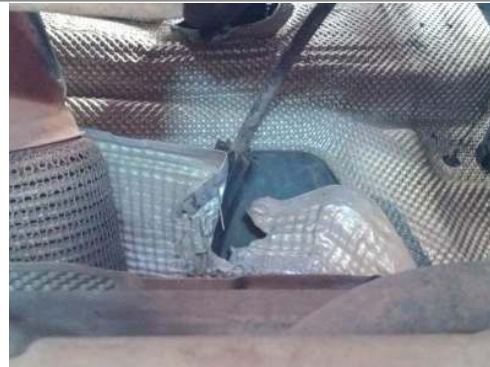
| Damage | Repair Way |
|---|--|
| Belly plates Damaged | Replace |

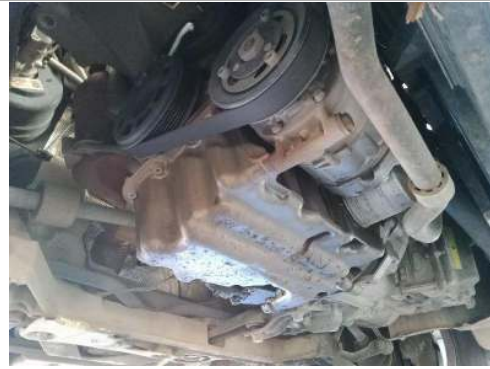
| Damage | Repair Way |
|--|---|
| Engine Oil Sweat | Repair |

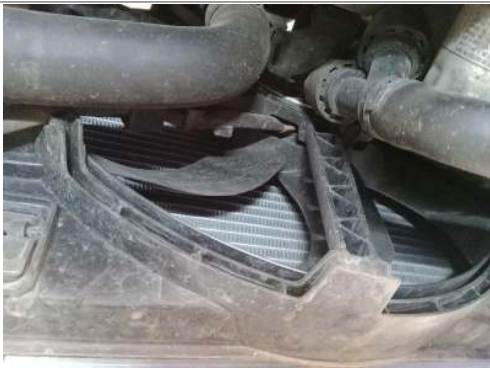
| Damage | Repair Way |
|--|---|
| Fan Defective | Replace |

| Damage | Repair Way |
|---|--|
| Engine | Fan Cowley misaligned |

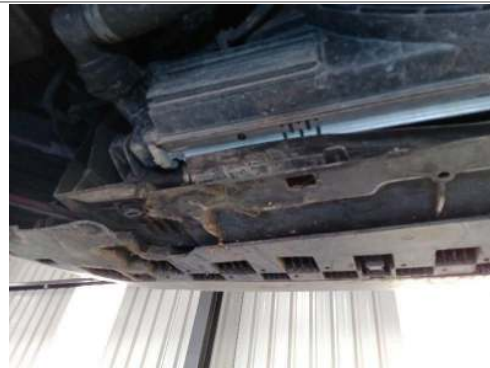
| Damage | Repair Way |
|---|--|
| Radiator Cradle Residual Traces of Repair | Replace |

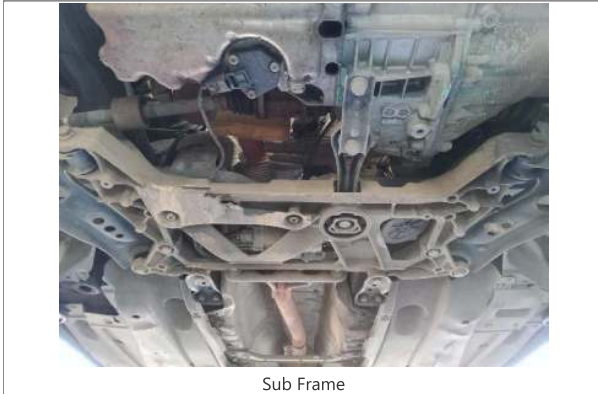
| Damage | Repair Way |
|---|--|
| Sub Frame Scratched | Repair |

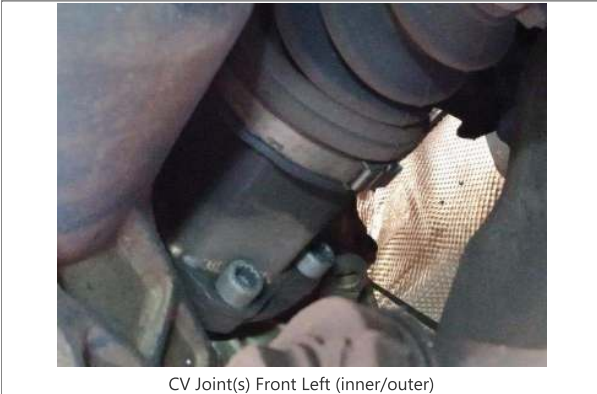
| Damage | Repair Way |
|---|--|
| CV Joint(s) Front Left (inner/outer) Welded | Replace |

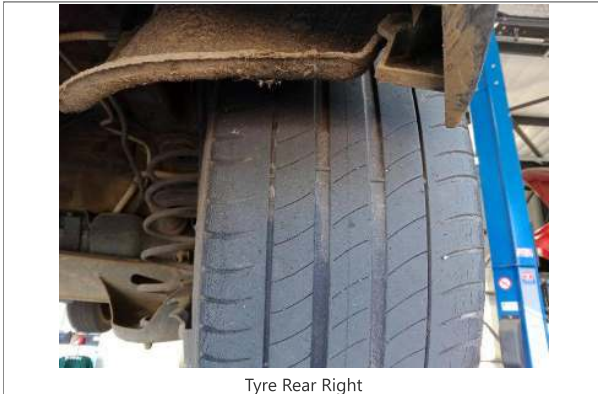
| Damage | Repair Way |
|--|---|
| Tyre Rear Right Worn | Replace |

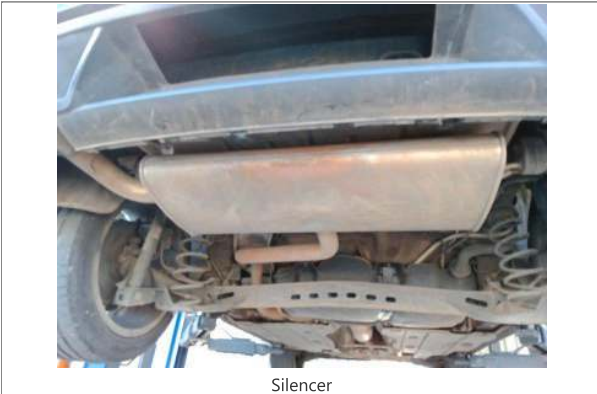
| Damage | Repair Way |
|---|--|
| Silencer Defective | Repair |

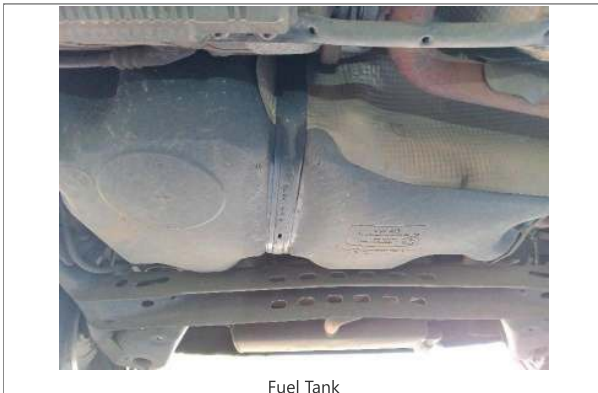
| Damage | Repair Way |
|---|--|
| Fuel Tank Sweat | Repair |

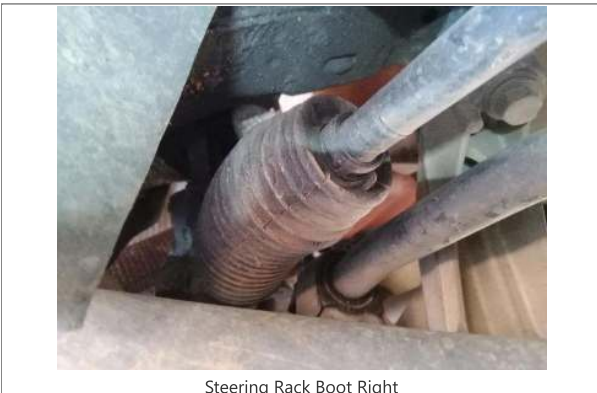
| Damage | Repair Way |
|--|---|
| Steering Rack Boot Right Defective | Replace |

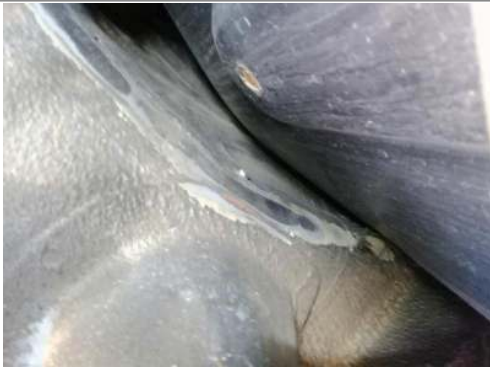
| Damage | Repair Way |
|--|---|
| Front Fender Right / Inner Tray Paintwork • Scratched | Repair |

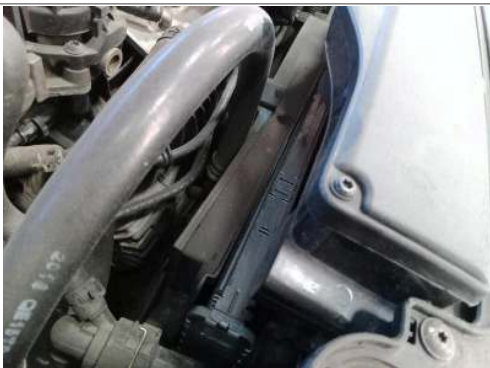
| Damage | Repair Way |
|--|---|
| Radiator Defective | Repair |

| Damage | Repair Way |
|---|--|
| Engine | Radiator and Aircon condenser misaligned |

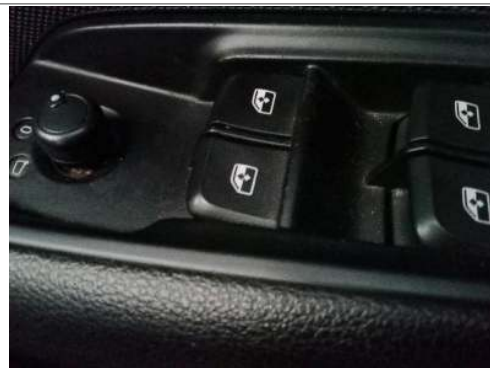
| Damage | Repair Way |
|--|---|
| Switch Electrical Window Winder front left Malfunction | Replace |
