MFC Auction House  
M57 Pretoria Rd, Glenmarais, KEMPTON PARK  
Gauteng

| Manufacturer | AUDI | Registration Number | FB8838L |

## CONDITION REPORT

Report No: 2016213189

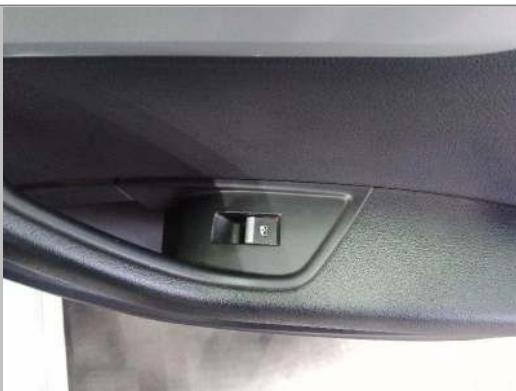
| | Damage | Repair Way |
|---|---|---|
| | Switch Electrical Window Winder rear right Damaged | Replace |

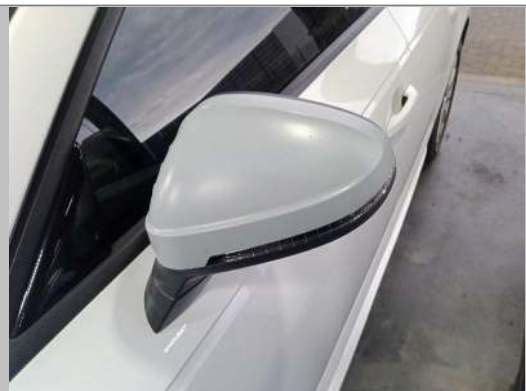
| | Damage | Repair Way |
|---|---|---|
| | Side Mirror Left Paintwork • Discoloured | Repair |

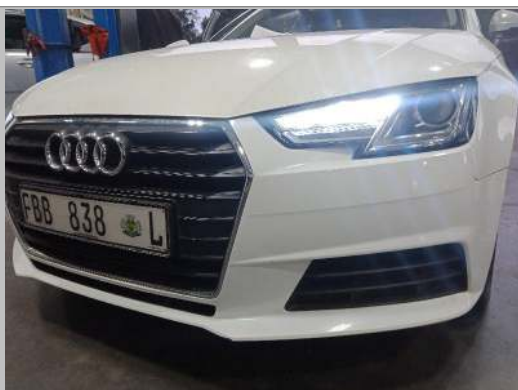
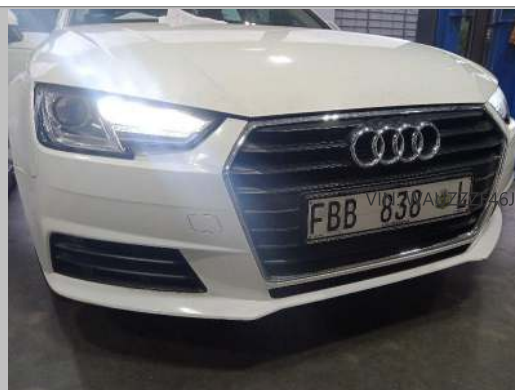
| | Damage | Repair Way |
|---|---|---|
| | Front Bumper Paintwork • Scratched | Repair |

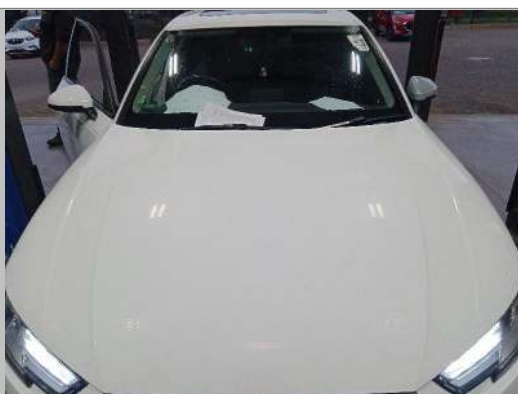
| | Damage | Repair Way |
|---|---|---|
| | Bonnet Paintwork • Discoloured | Repair |

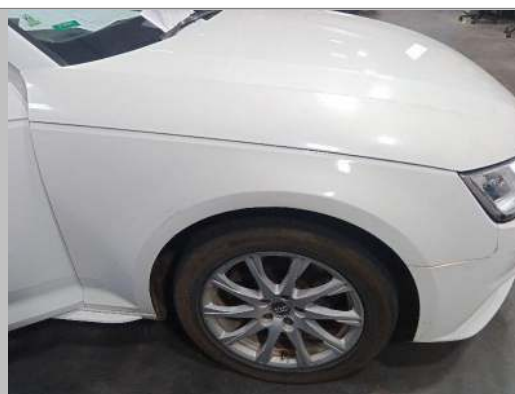
| | Damage | Repair Way |
|---|---|---|
| | Front Fender Right Dented | Repair |

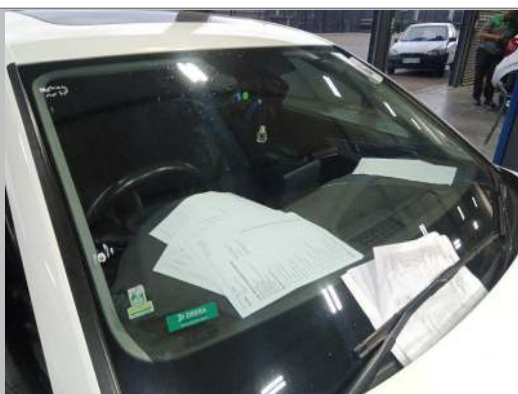
| | Damage | Repair Way |
|---|---|---|
| | Windscreen Chipped | Repair |

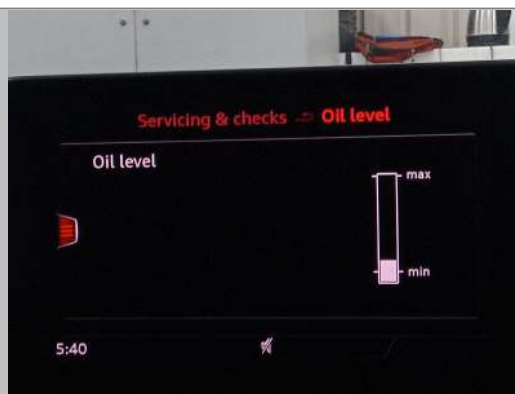
| | Damage | Repair Way |
|---|---|---|
| | Oil level Insufficient | Replace |

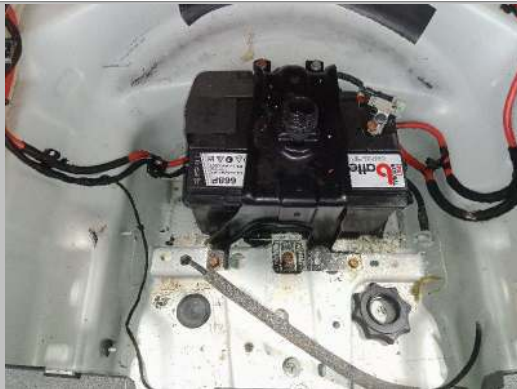
| | Damage | Repair Way |
|---|---|---|
| | Inner Boot Floor Pan and Spare Wheel Well Corrosion | Repair |

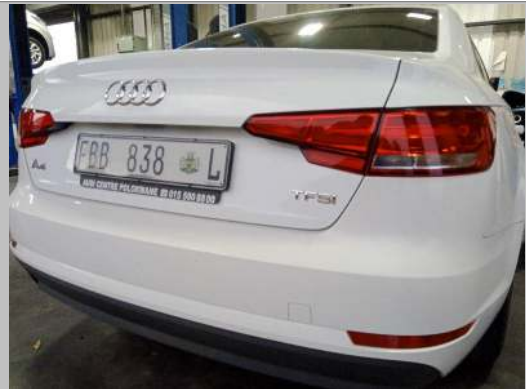
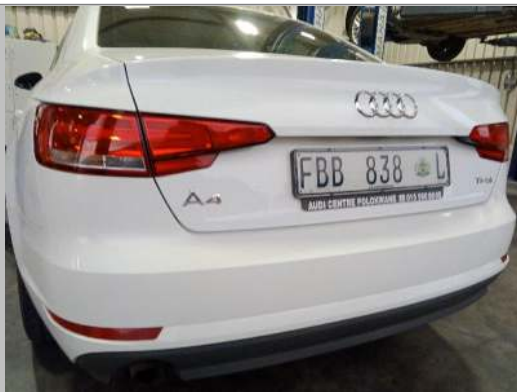
| | Damage | Repair Way |
|---|---|---|
| | Rear bumper Paintwork • Scratched | Repair |

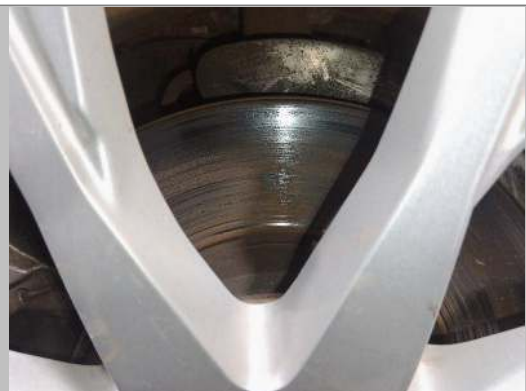
| | Damage | Repair Way |
|---|---|---|
| | Brake disc 1. Axle right Defective | Replace |

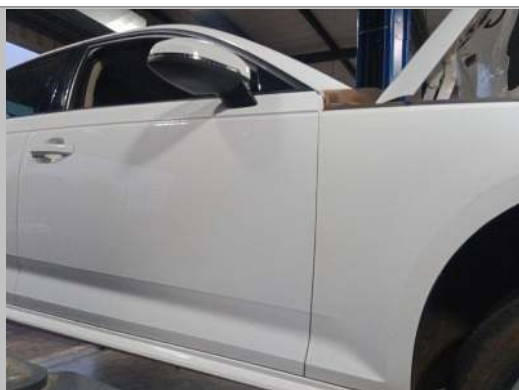
| | Damage | Repair Way |
|---|---|---|
| | Door Front Right Dented | Repair |

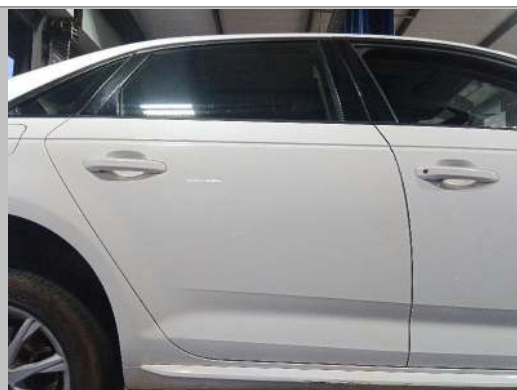
| | Damage | Repair Way |
|---|---|---|
| | Door Rear Right Paintwork • Scratched | Repair |

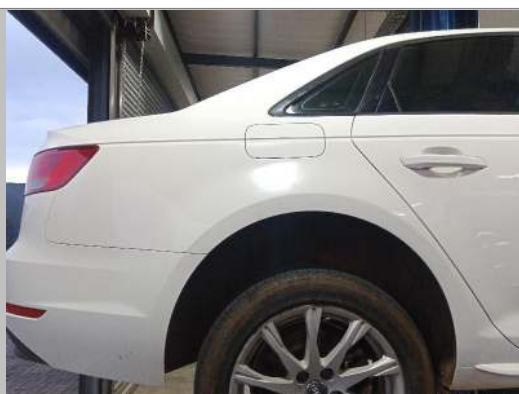
| | Damage | Repair Way |
|---|---|---|
| | Rear Fender Right Residual Traces of Repair | Repair |

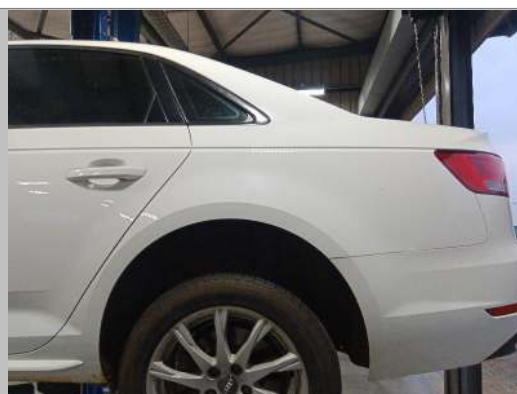
| | Damage | Repair Way |
|---|---|---|
| | Rear Fender Left Paintwork • Scratched | Repair |

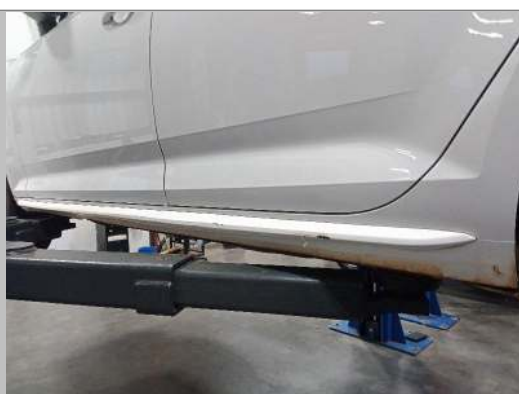
| | Damage | Repair Way |
|---|---|---|
| | Rocker Panel Left Paintwork • Scratched | Repair |

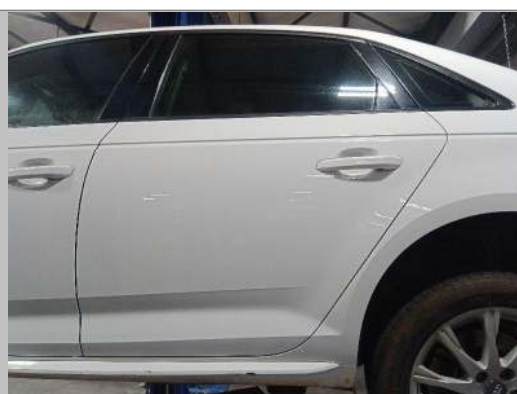
| | Damage | Repair Way |
|---|---|---|
| | Door Rear Left Paintwork • Scratched | Repair |

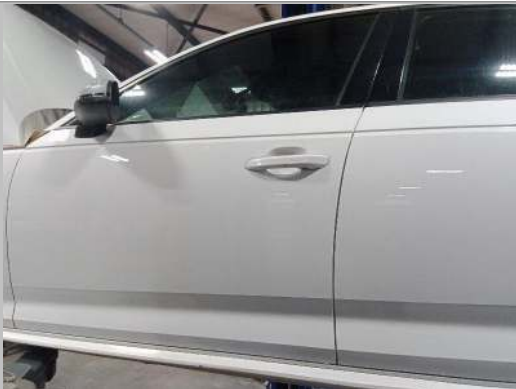
| | Damage | Repair Way |
|---|---|---|
| | Door Front Left Paintwork • Scratched | Repair |

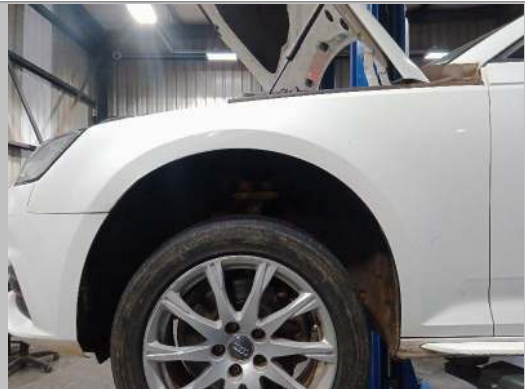
| | Damage | Repair Way |
|---|---|---|
| | Front Fender Left Paintwork • Scratched | Repair |

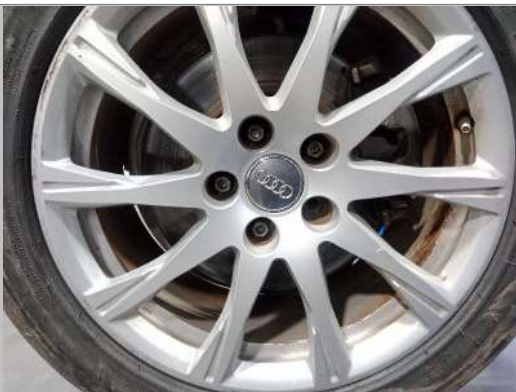
| Damage | Repair Way |
|---|---|
| Bolt(s) / Nut(s) Front Wheel Left Missing | Replace |

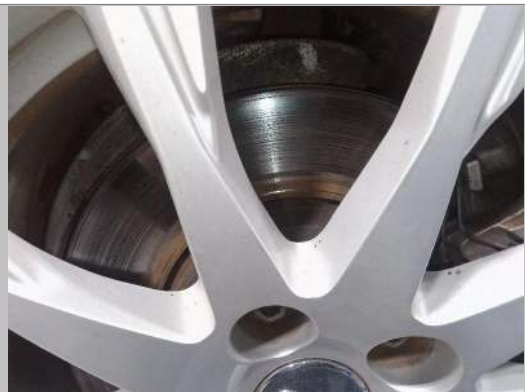
| | Damage | Repair Way |
|---|---|---|
| | Brake disc 1. Axle left Defective | Replace |

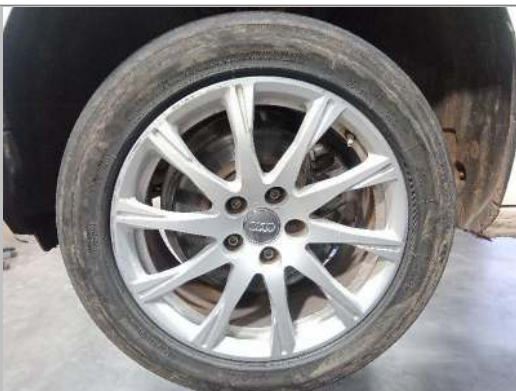
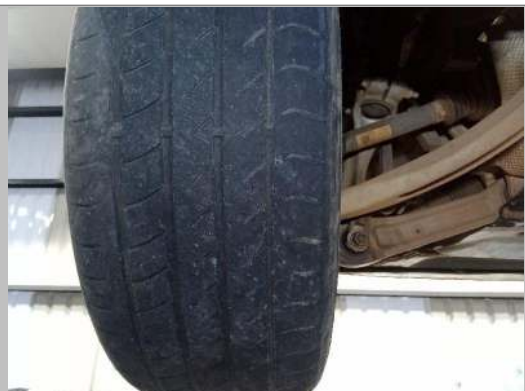
| | Damage | Repair Way |
|---|---|---|
| | Tyre Front Left Defective | Replace |

| | Size | Load/Speed Index | Manufacture | Model | Type* | Production Date | Tread Depth (mm) |
|---|---|---|---|---|---|---|---|
| Front Left | 225/50 R17 | 98V | Duran | M636 | V | 4119 | 0 mm |

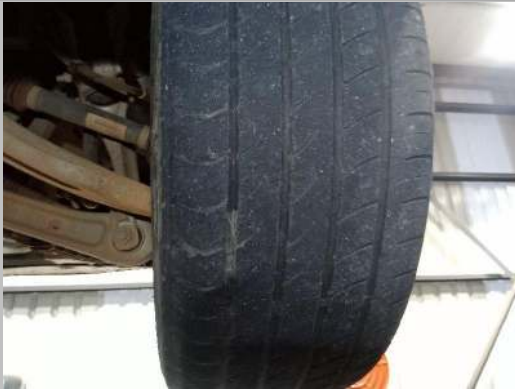
| Damage | Repair Way |
|---|---|
| Tyre Front Right Worn | Replace |

| | Size | Load/Speed Index | Manufacture | Model | Type* | Production Date | Tread Depth (mm) |
|---|---|---|---|---|---|---|---|
| Front Right | 225/50 R17 | 98V | Duran | M636 | V | 4119 | 0 mm |

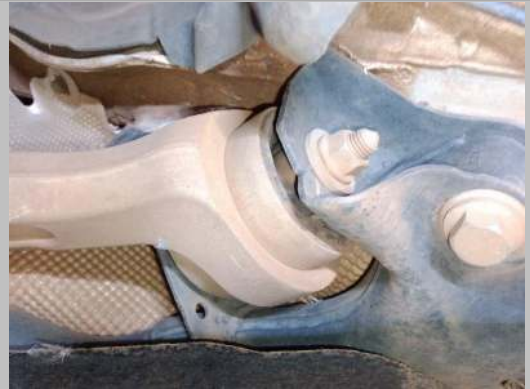
| | Damage | Repair Way |
|---|---|---|
| | Control Arm Bush(es) Front Axle Left Cracked | Replace |

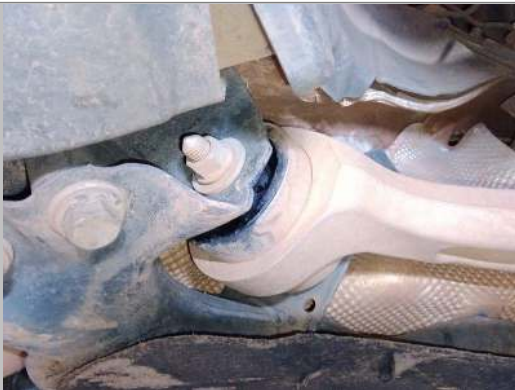
| | Damage | Repair Way |
|---|---|---|
| | Control Arm Bush(es) Front Axle Right Cracked | Replace |

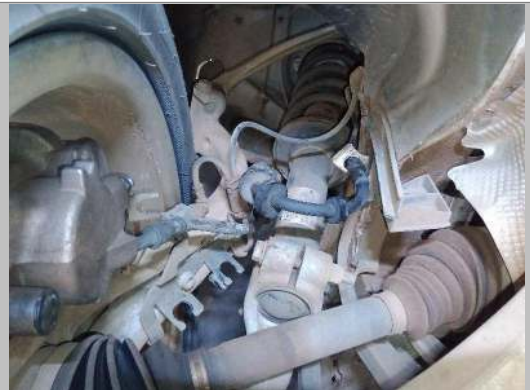
| | Damage | Repair Way |
|---|---|---|
| | Brake Piping Defective | Repair |

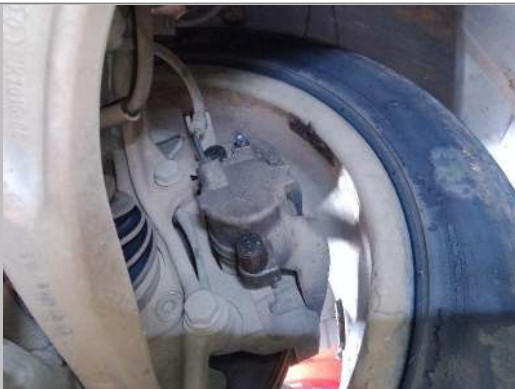
| | Damage | Repair Way |
|---|---|---|
| | Caliper 1. Axle right Leak | Repair |

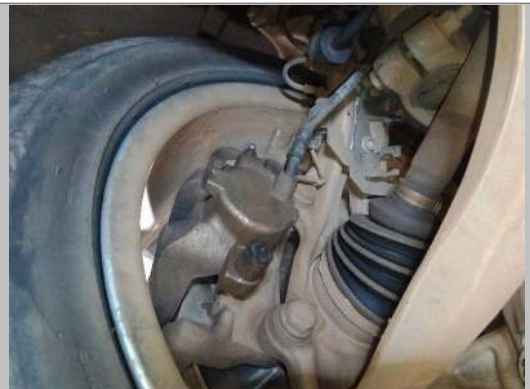
| | Damage | Repair Way |
|---|---|---|
| | Caliper 1. Axle left Leak | Repair |

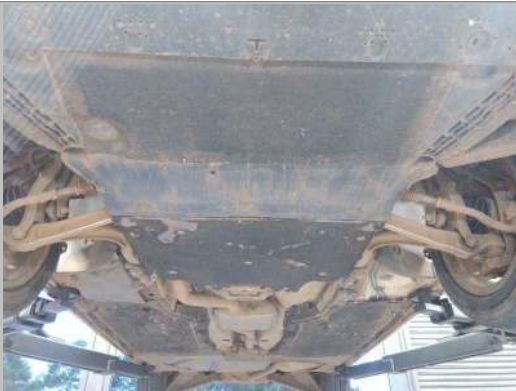
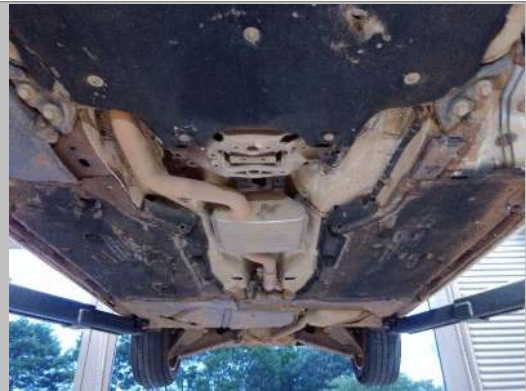
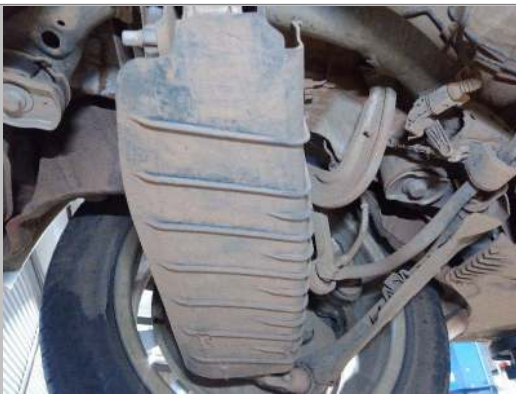
| Damage | Repair Way |
|---|---|
| Belly plates Damaged | Replace |

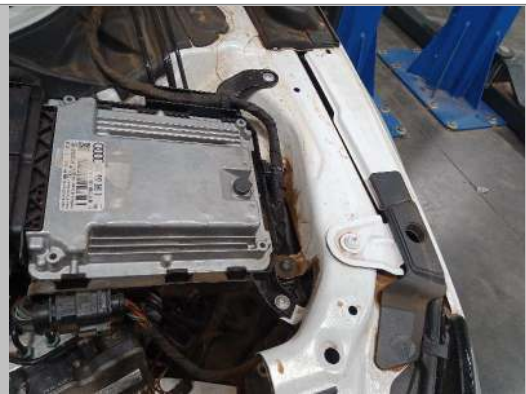
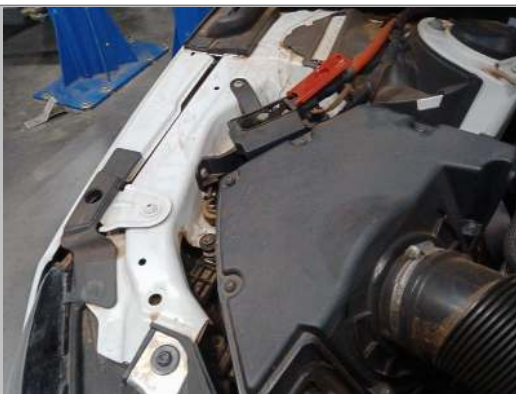
| | Damage | Repair Way |
|---|---|---|
| | Bonnet slam plate (Shock tower/ Inner tray) Residual | Repair |
| | Traces of Repair | |
