DEKRA MFC  
M57 Pretoria Rd - 1619  
KEMPTON PARK - GT  
08610 33572

| Manufacturer | BMW | Registration Number | DD54JNGP |

## CONDITION REPORT

Report No: 2016213160

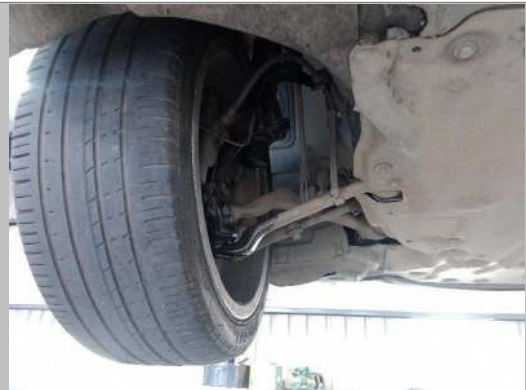
LF TYRE TREAD

| | Size | Load/Speed Index | Manufacture | Model | Type* | Production Date | Tread Depth (mm) |
|---|---|---|---|---|---|---|---|
| Front Left | 225/40Z R18 | 92Y | Pirelli | Pzero | V | 1513 | 1 mm |

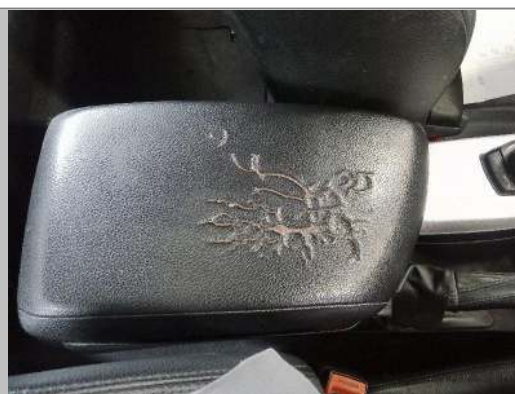
| | Damage | Repair Way |
|---|---|---|
| | Center Console / Cubbyhole + Lid Defective | Repair |

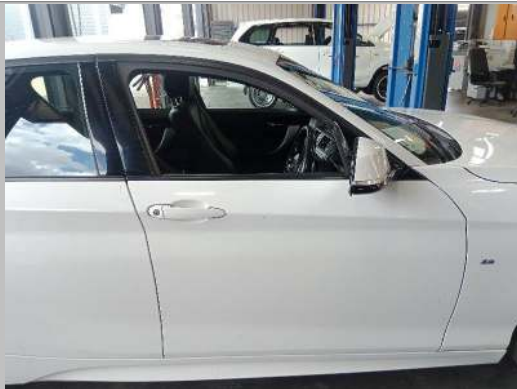
| | Damage | Repair Way |
|---|---|---|
| | Door Front Right Paintwork • Scratched | Repair |

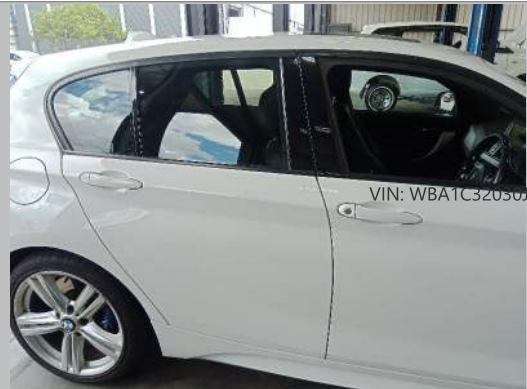
| | Damage | Repair Way |
|---|---|---|
| | Door Rear Right Dented | Repair |

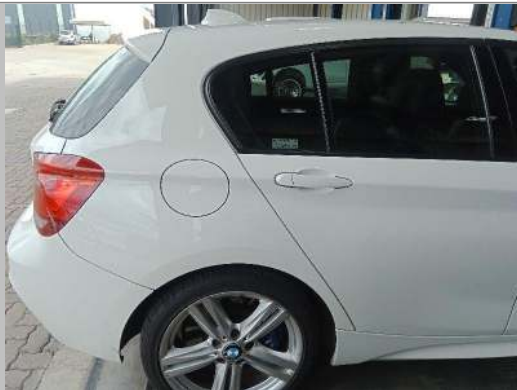
| | Damage | Repair Way |
|---|---|---|
| | Rear Fender Right Paintwork • Scratched | Repair |

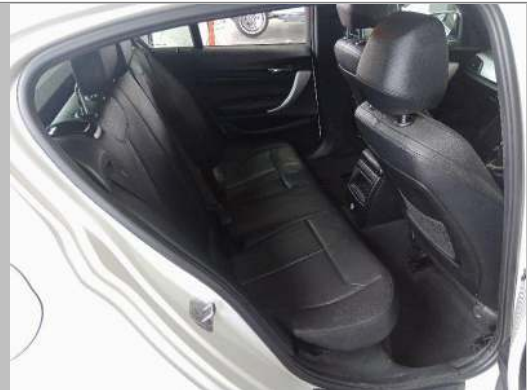
| | Damage | Repair Way |
|---|---|---|
| | Seat Rear Defective | Repair |

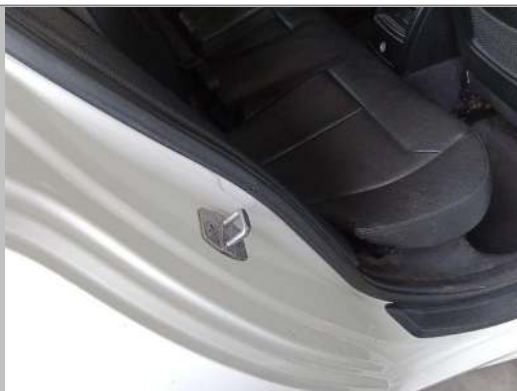
| | Damage | Repair Way |
|---|---|---|
| | Door Sealing Rubber Rear Right Torn / Cut | Repair |

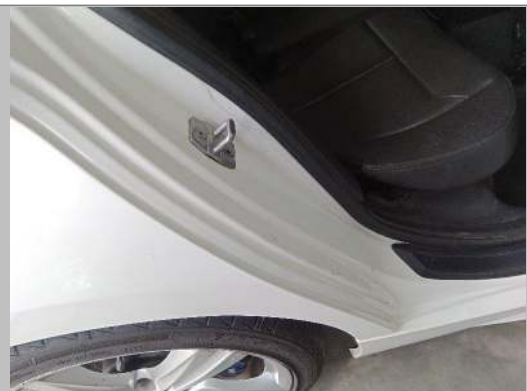
| | Damage | Repair Way |
|---|---|---|
| | C • Pillar Right Dented | Repair |

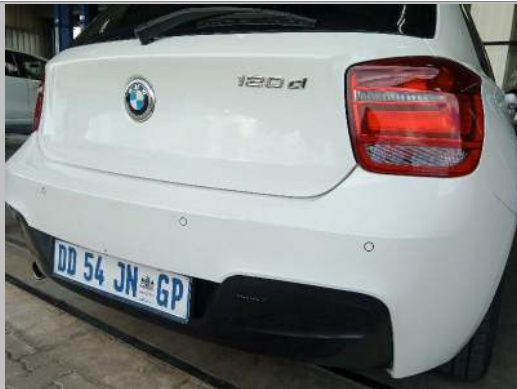
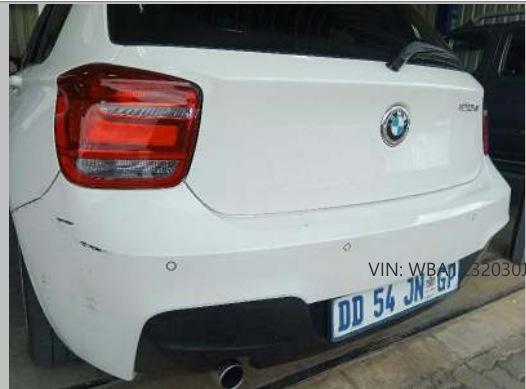
| | Damage | Repair Way |
|---|---|---|
| | Rear bumper Paintwork • Scratched | Repair |

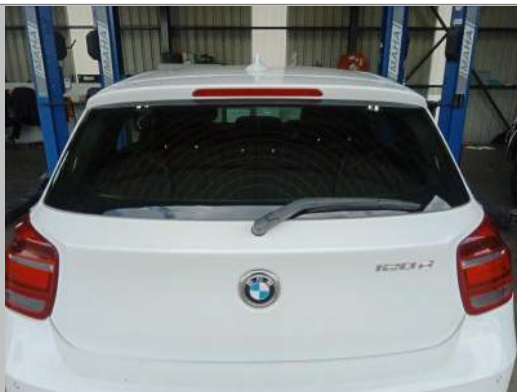
| | Damage | Repair Way |
|---|---|---|
| | Boot Lid / Hatch door Paintwork • Scratched | Repair |

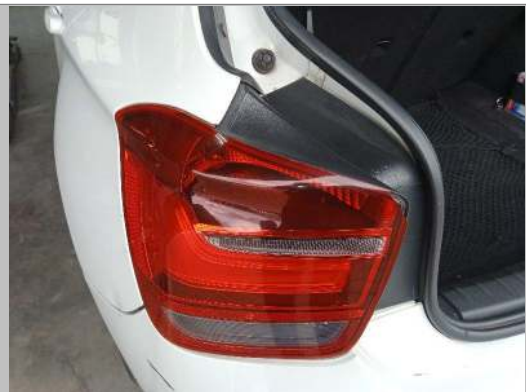
| | Damage | Repair Way |
|---|---|---|
| | Tail Light Left Damaged | Replace |

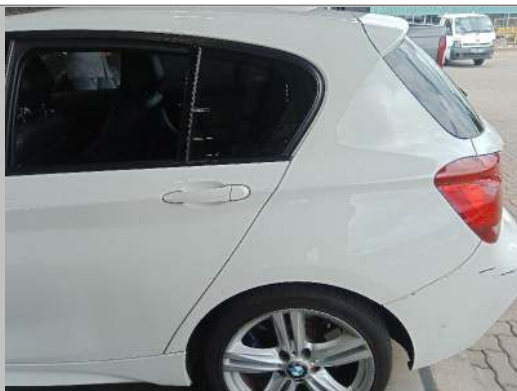
| | Damage | Repair Way |
|---|---|---|
| | Rear Fender Left Paintwork • Scratched | Repair |

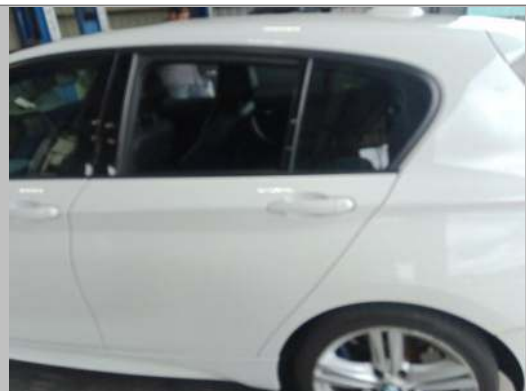
| | Damage | Repair Way |
|---|---|---|
| | Door Rear Left Paintwork • Scratched | Repair |

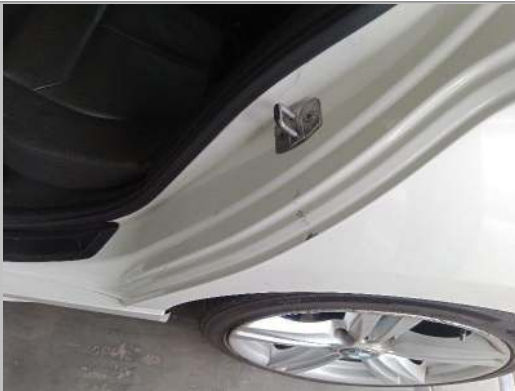
| | Damage | Repair Way |
|---|---|---|
| | C • Pillar Left Dented | Repair |

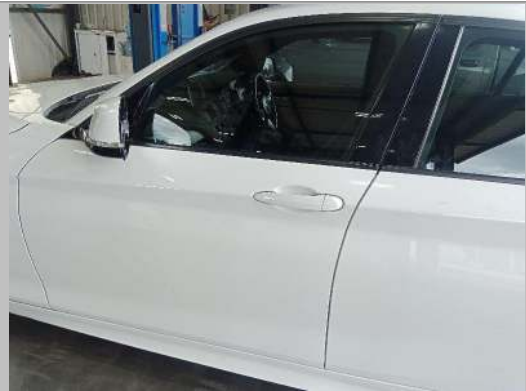
| | Damage | Repair Way |
|---|---|---|
| | Door Front Left Paintwork • Scratched | Repair |

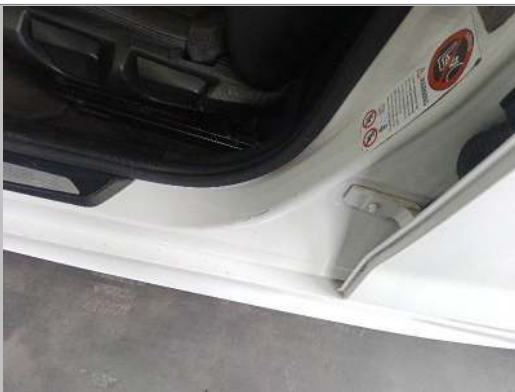
| | Damage | Repair Way |
|---|---|---|
| | B • Pillar Left Paintwork • Scratched | Repair |

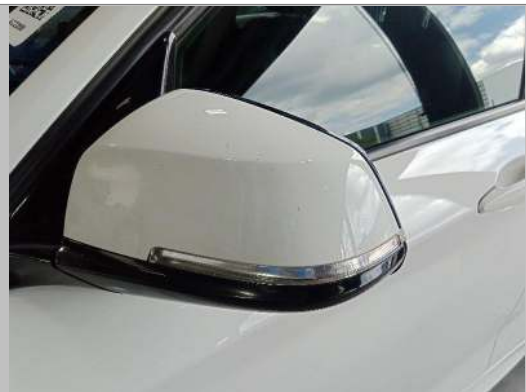
| | Damage | Repair Way |
|---|---|---|
| | Side Mirror Left Residual Traces of Repair | Repair |

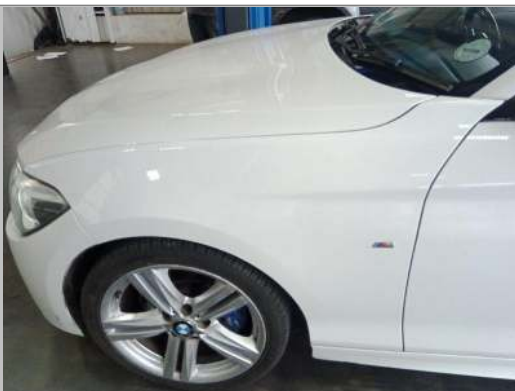
| | Damage | Repair Way |
|---|---|---|
| | Front Fender Left Paintwork • Scratched | Repair |

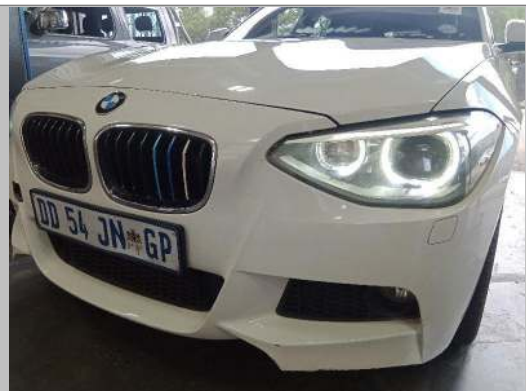
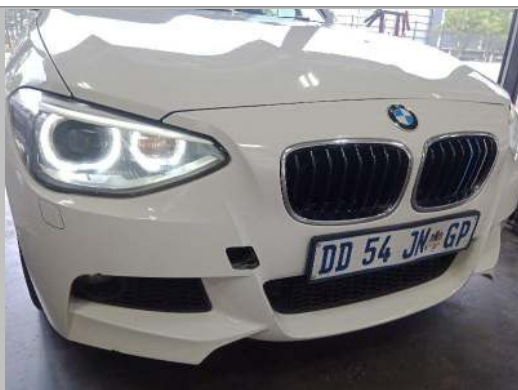
| | Damage | Repair Way |
|---|---|---|
| | Front Bumper Damaged | Repair |

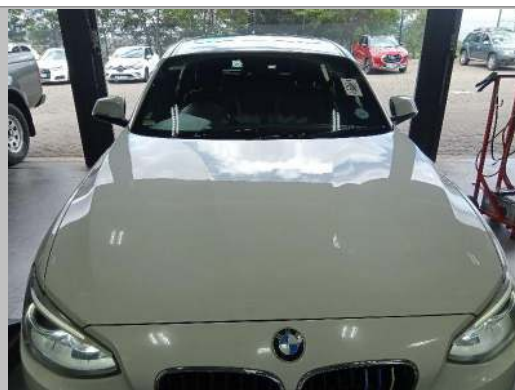
| | Damage | Repair Way |
|---|---|---|
| | Bonnet Paintwork • Scratched | Repair |

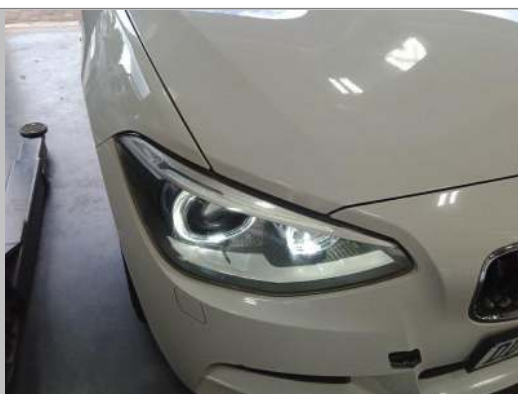
| | Damage | Repair Way |
|---|---|---|
| | Headlight Right Scratched | Repair |

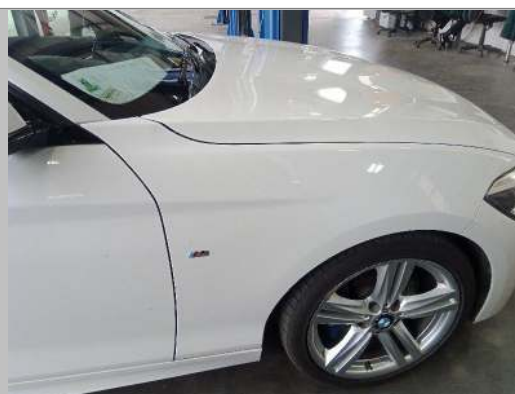
| | Damage | Repair Way |
|---|---|---|
| | Front Fender Right Paintwork • Scratched | Repair |

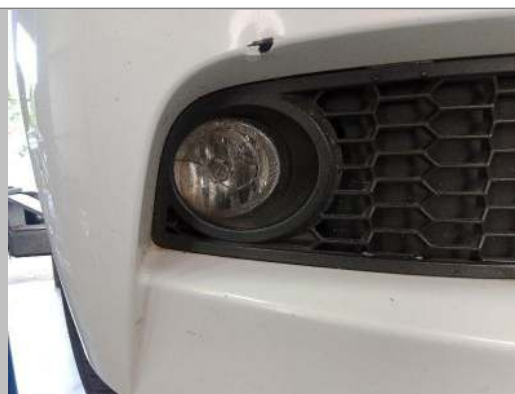
| | Damage | Repair Way |
|---|---|---|
| | Fog Light Front Right Damaged | Replace |

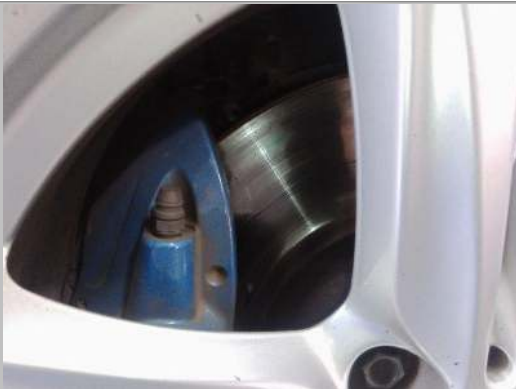
| | Damage | Repair Way |
|---|---|---|
| | Brake disc 1. Axle right Defective | Replace |

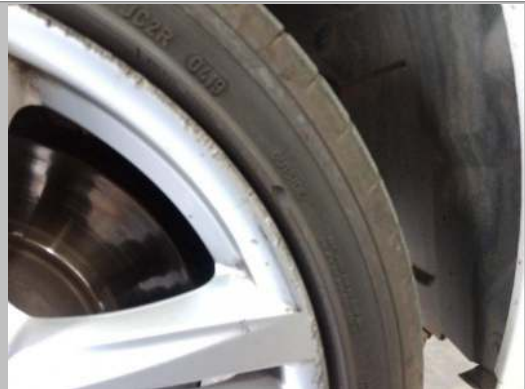
| Damage | Repair Way |
|---|---|
| Tyre Front Right Torn / Cut | Replace |

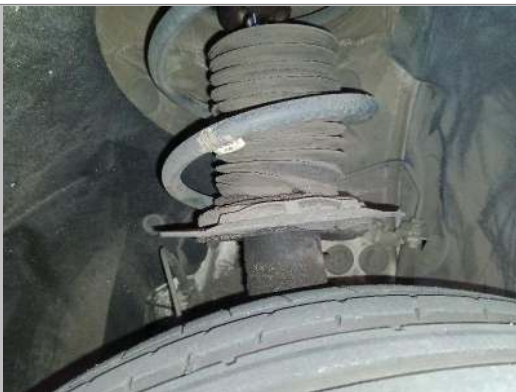
| | Damage | Repair Way |
|---|---|---|
| | Shock Absorber Front Right Sweat | Replace |

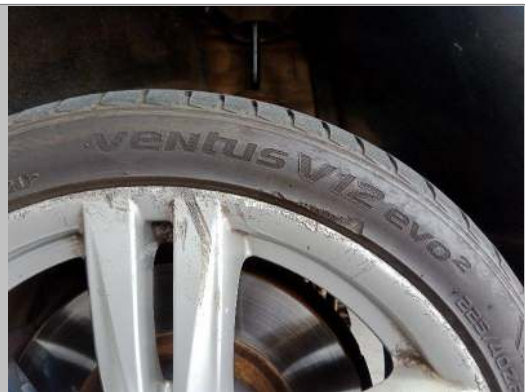
| Damage | Repair Way |
|---|---|
| Tyre Rear Left Torn / Cut | Replace |

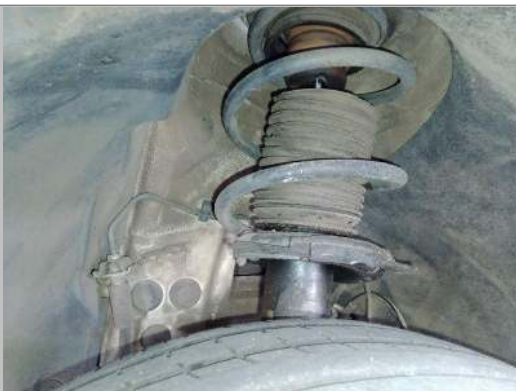
| | Damage | Repair Way |
|---|---|---|
| | Shock Absorber Front Left Leak | Replace |

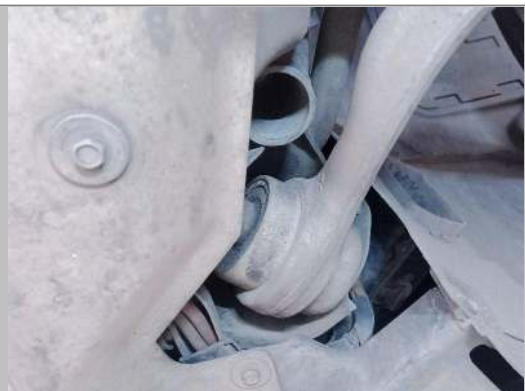
| Damage | Repair Way |
|---|---|
| Control Arm Bush(es) Front Axle Right Cracked | Replace |

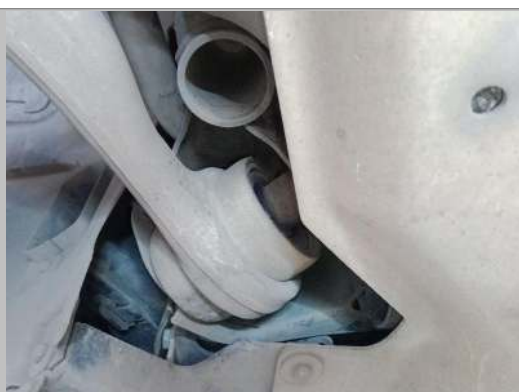
| Damage | Repair Way |
|---|---|
| Control Arm Bush(es) Front Axle Left Cracked | Replace |

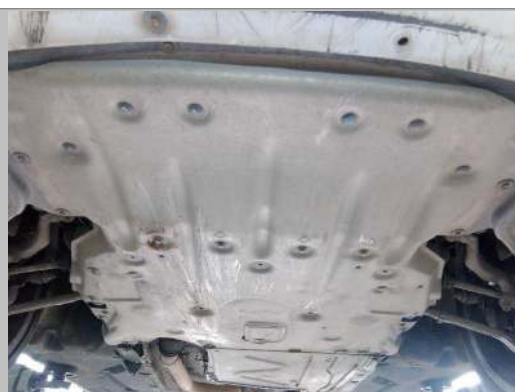
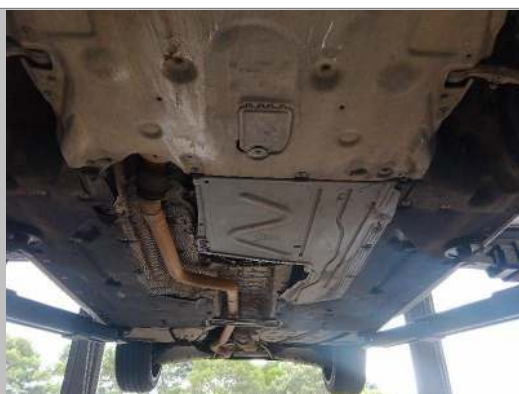
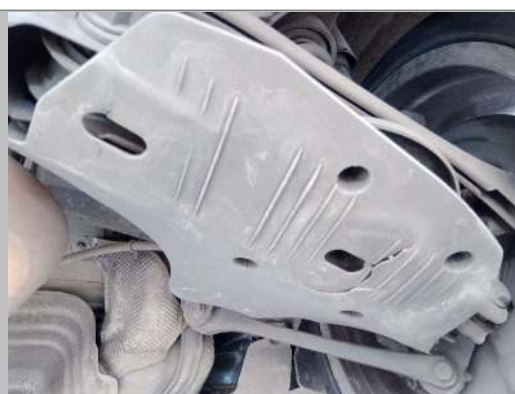
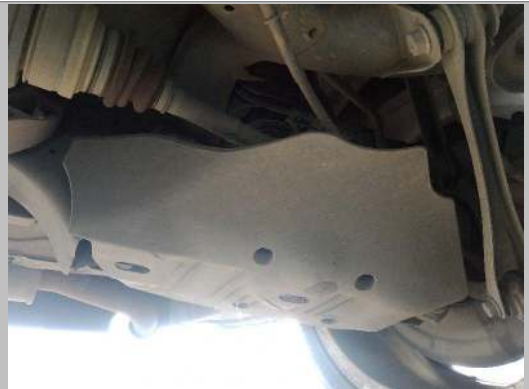
| Damage | Repair Way |
|---|---|
| Belly plates Defective | Repair |

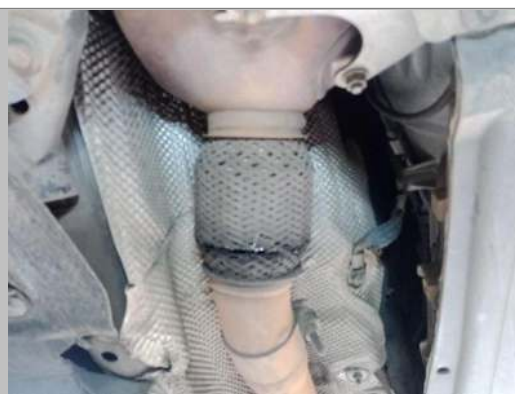
| Damage | Repair Way |
|---|---|
| Engine to silencer pipe Damaged | Repair |

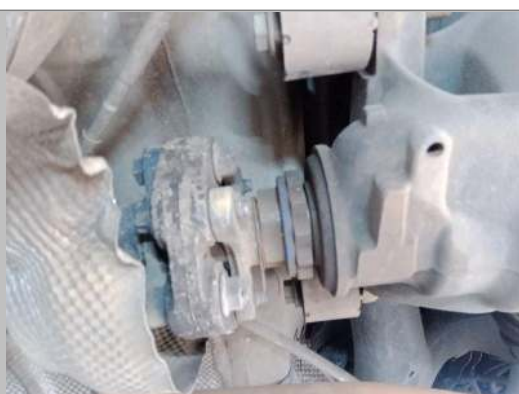
| Damage | Repair Way |
|---|---|
| Differential Defective | Repair |

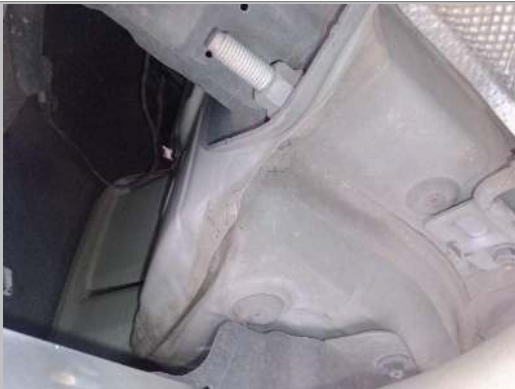
| | Damage | Repair Way |
|---|---|---|
| | Rear Fender Left / Inner Tray Damaged | Repair |

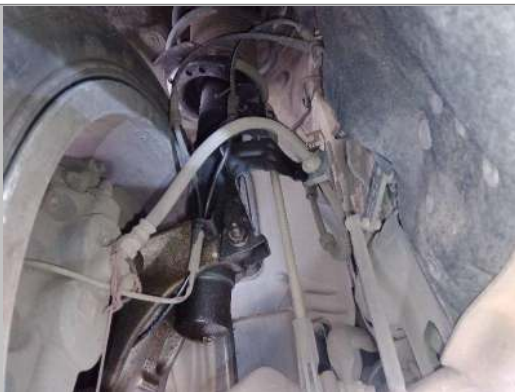
| Damage | Repair Way |
|---|---|
| Stabilizer Mounting Front Left Damaged | Replace |

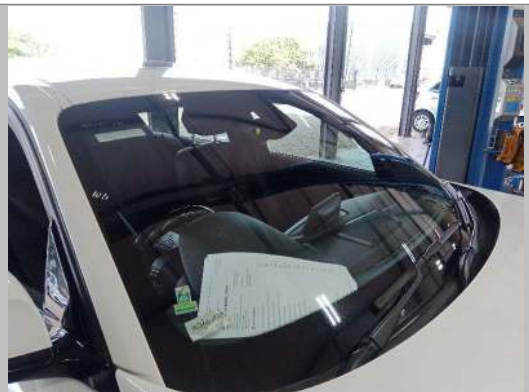
| | Damage | Repair Way |
|---|---|---|
| | Windscreen Chipped | Replace |

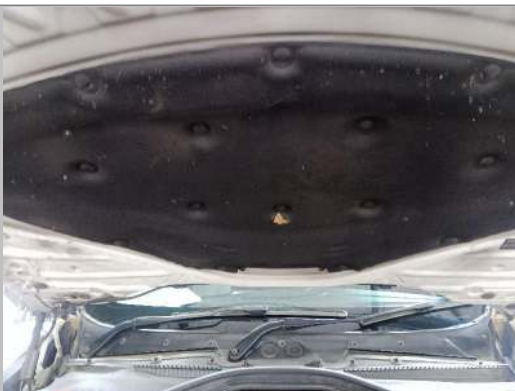
| | Damage | Repair Way |
|---|---|---|
| | Under bonnet insulation cover Damaged | Repair |
