## CONDITION REPORT

Report No:  
2016893862  
DATE  
28/05/2025

| Manufacturer | BMW | Registration Number | HH60VXGP |
| Model | 120I HATCH 5-DR STEPTRONIC [2016-2019] | Register Number | |

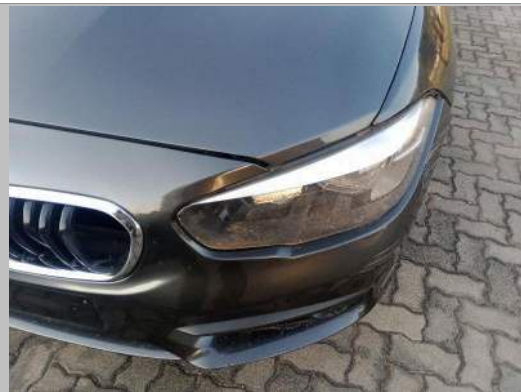
| Damage | Repair Way |
|---|---|
| Headlight Left Damaged | Replace |

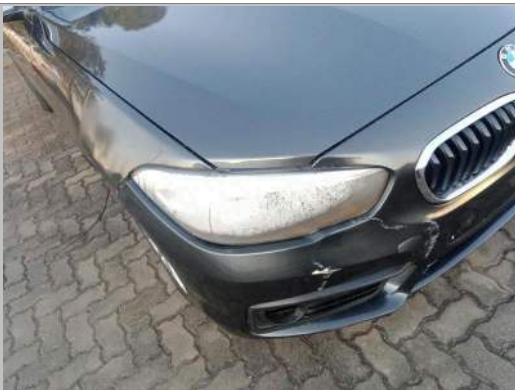
| Damage | Repair Way |
|---|---|
| Headlight Right Damaged | Replace |

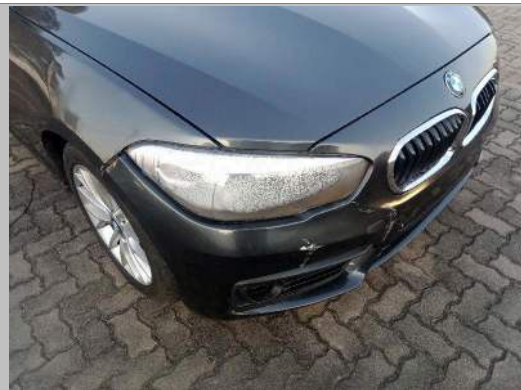
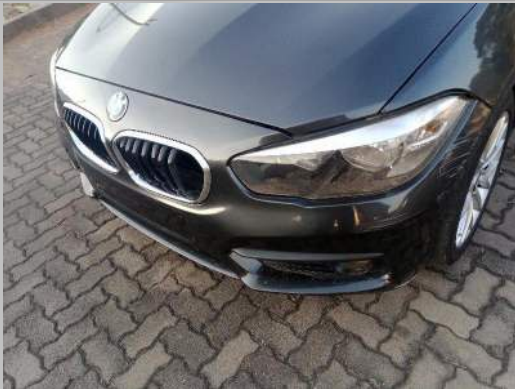
| Damage | Repair Way |
|---|---|
| Front Bumper Damaged | Replace |

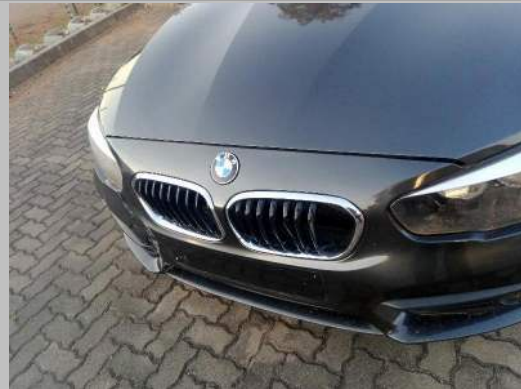
| Damage | Repair Way |
|---|---|
| Grill Damaged | Repair |

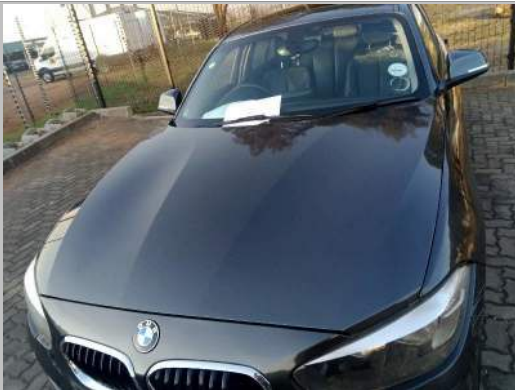
| Damage | Repair Way |
|---|---|
| Bonnet Damaged | Repair |

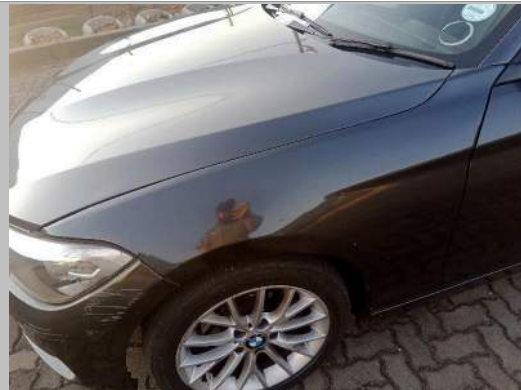
| Damage | Repair Way |
|---|---|
| Front Fender Left Damaged | Repair |

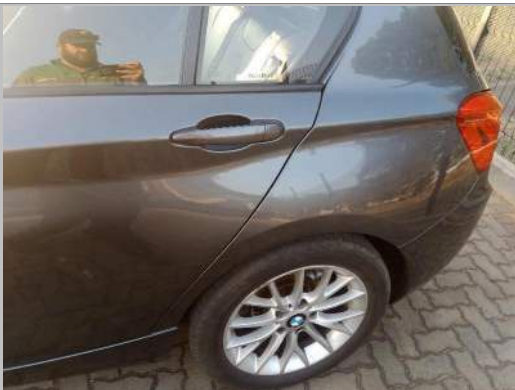
| Damage | Repair Way |
|---|---|
| Rear Fender Left Damaged | Repair |

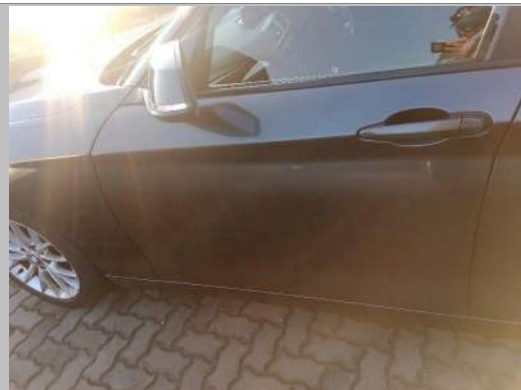
| Damage | Repair Way |
|---|---|
| Door Front Left Damaged | Repair |

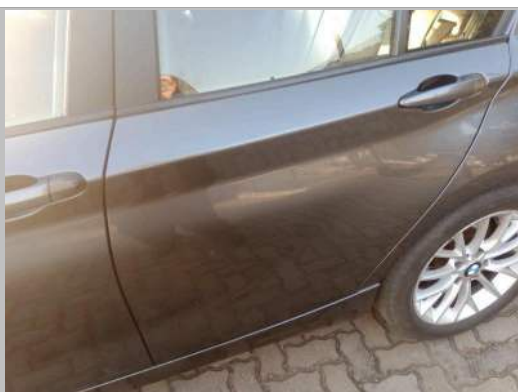
| Damage | Repair Way |
|---|---|
| Door Rear Left Damaged | Repair |

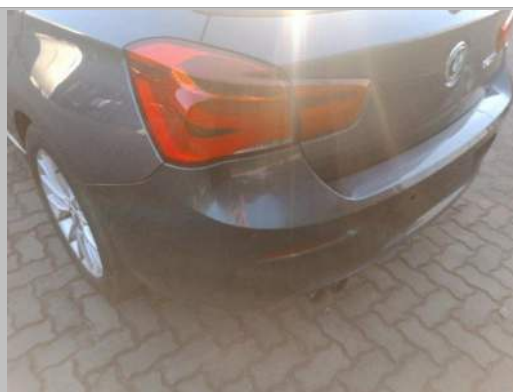
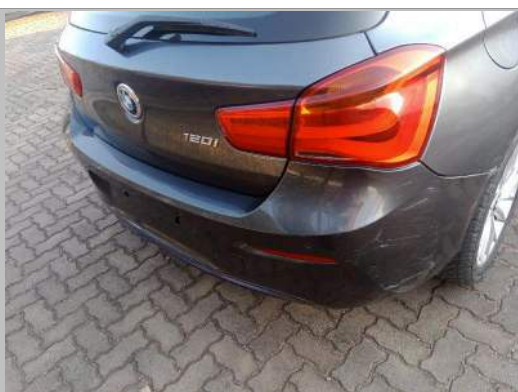
| Damage | Repair Way |
|---|---|
| Rear bumper Damaged | Repair |

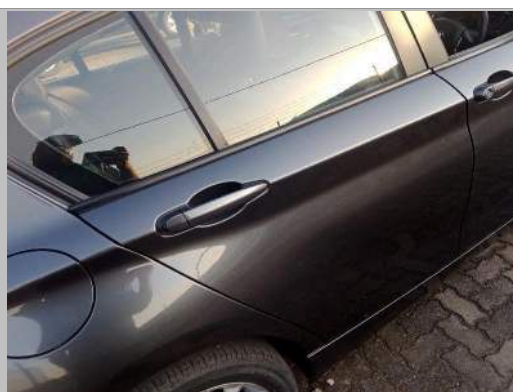
| Damage | Repair Way |
|---|---|
| Door Rear Right Damaged | Repair |

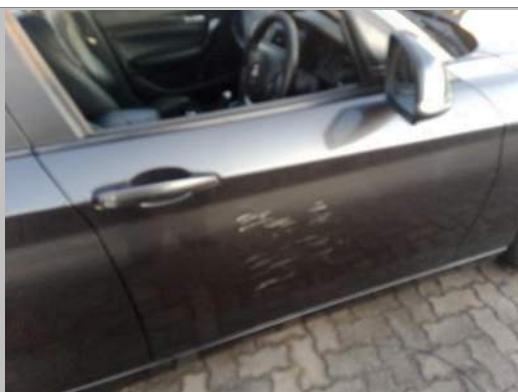
| Damage | Repair Way |
|---|---|
| Door Front Right Damaged | Repair |

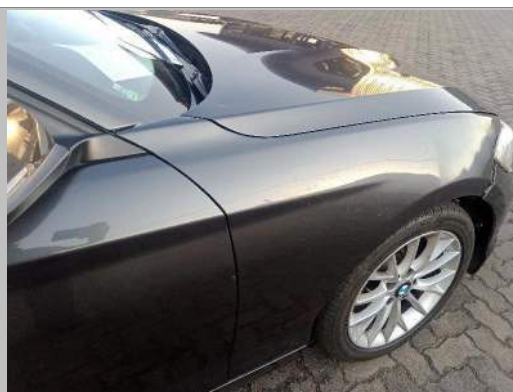
| Damage | Repair Way |
|---|---|
| Front Fender Right Damaged | Repair |

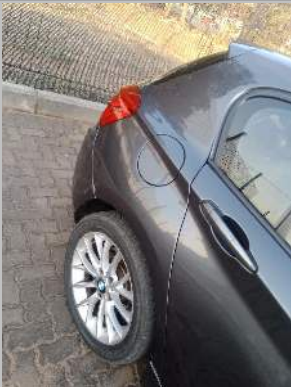
| Damage | Repair Way |
|---|---|
| Rear Fender Right Damaged | Repair |

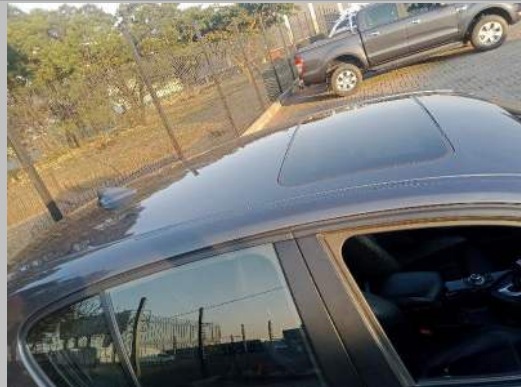
| Damage | Repair Way |
|---|---|
| Roof Damaged | Repair |

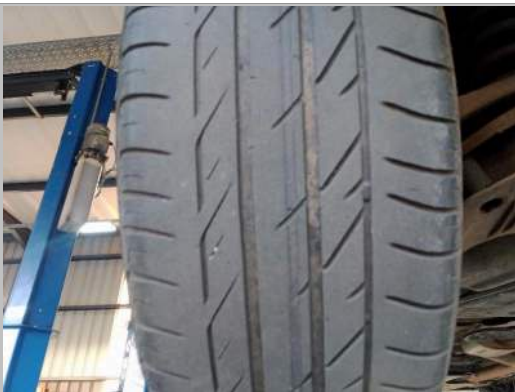
| Damage | Repair Way |
|---|---|
| Tyre Rear Left Worn | Replace |

| | Size | Load/Speed Index | Manufacture | Model | Type* | Production Date | Tread Depth (mm) |
|---|---|---|---|---|---|---|---|
| Rear Left | 225/50R17 | 94W | Bridgestone | Radial | V | 1820 | 0 mm |

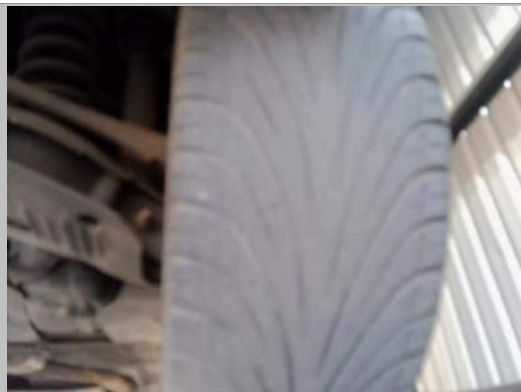
| Damage | Repair Way |
|---|---|
| Tyre Rear Right Worn | Replace |

| | Size | Load/Speed Index | Manufacture | Model | Type* | Production Date | Tread Depth (mm) |
|---|---|---|---|---|---|---|---|
| Rear Right | 225/45R17 | 94W | Nexen | Radial | V | 1013 | 0 mm |

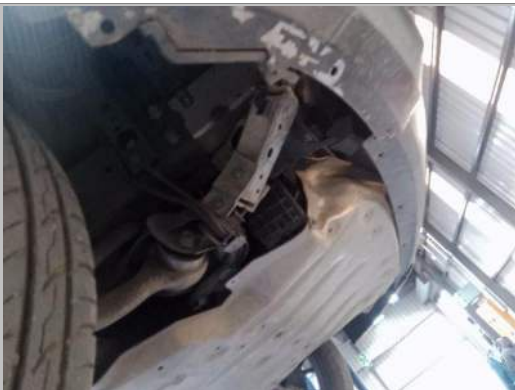
| Damage | Repair Way |
|---|---|
| Radiator Cradle Damaged | Replace |

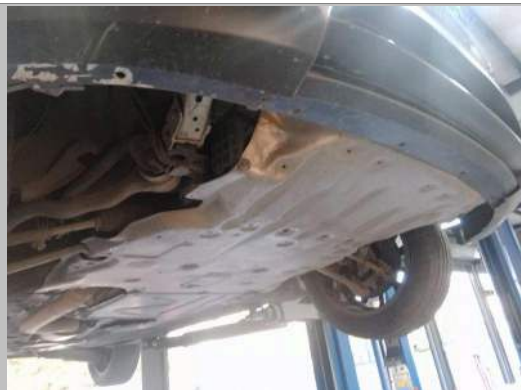
| Damage | Repair Way |
|---|---|
| Belly plates Damaged | Replace |

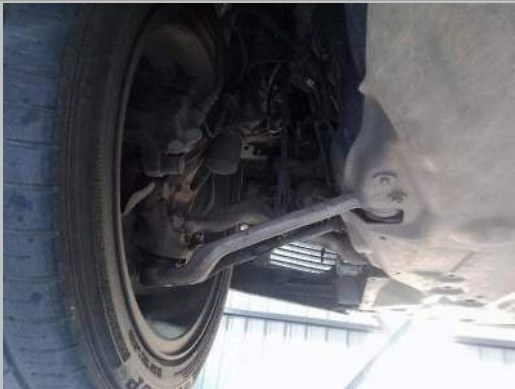
| Damage | Repair Way |
|---|---|
| Control Arm Bush(es) Front Axle Left Worn | Replace |

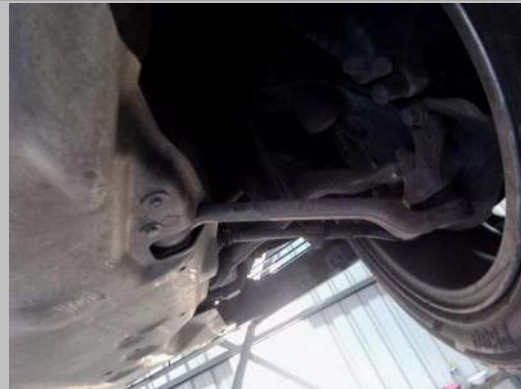
| Damage | Repair Way |
|---|---|
| Control Arm Bush(es) Front Axle Right Worn | Replace |
