## CONDITION REPORT

Report No:  
2016967753  
DATE  
04/08/2025

| Manufacturer | BMW | Registration Number | MC95KYGP |
| Model | 320I STEPTRONIC 5F32 [2019-2022] | Register Number | |

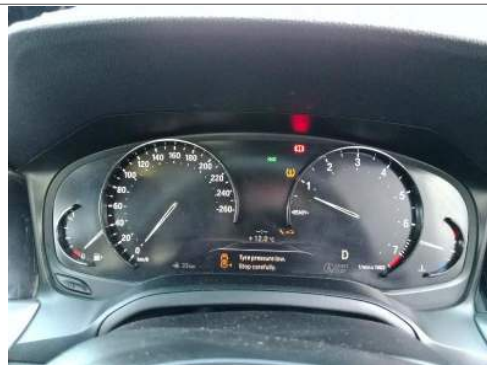
DASHBOARD (W/ ENGINE RUNNING)

| Warning lights illuminated on dashboard | Repair |

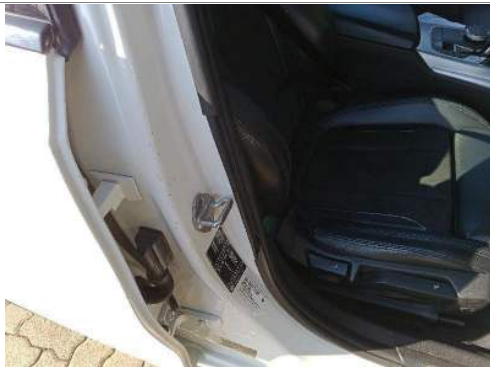
| Door Sealing Rubber Front Right Damaged | Replace |

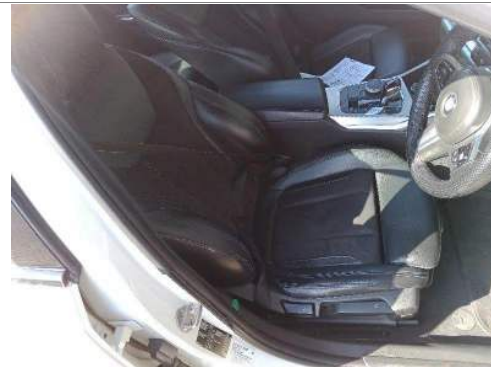
| Seat Front Right Torn / Cut | Repair |

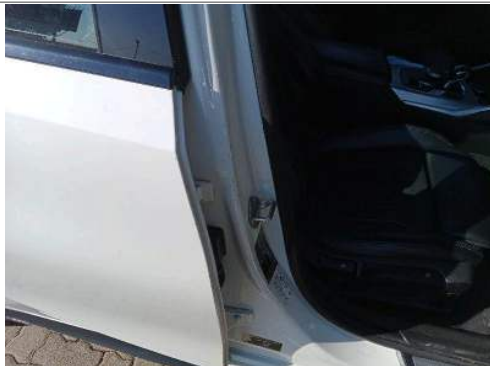
| B • Pillar Right Paintwork • Chipmarks | Repair |

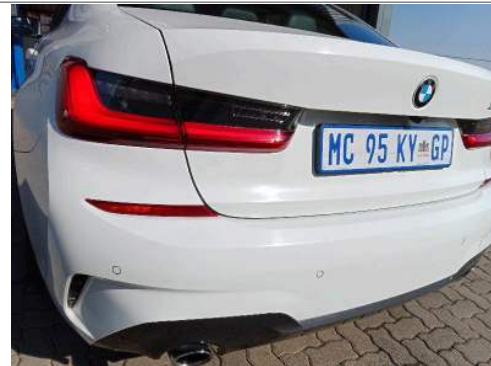
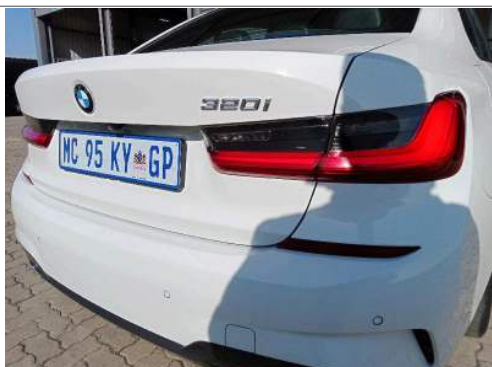
| Rear bumper Paintwork • Scratched | Repair |

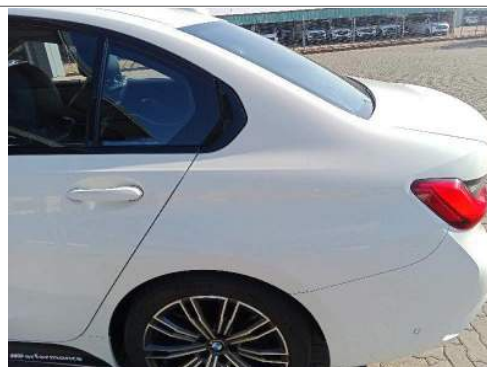
| Rear Fender Left Dented | Smart Repair |

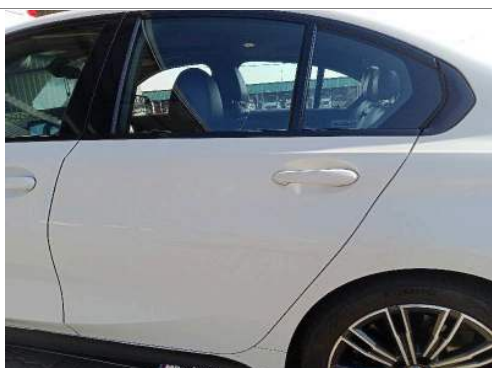
| Door Rear Left Paintwork • Chipmarks | Repair |

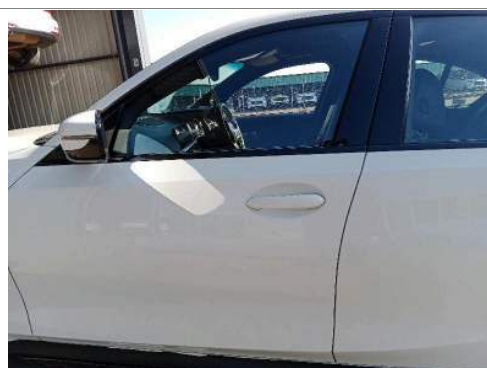
| Door Front Left Residual Traces of Repair | Repair |

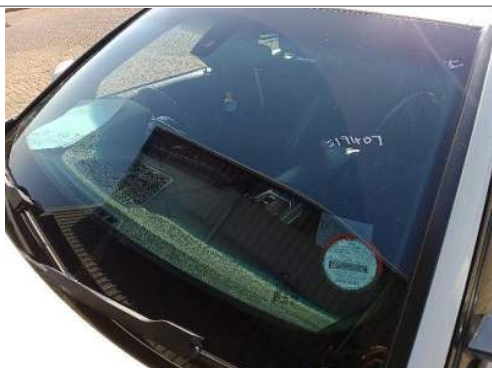
| Windscreen Chipped | Repair |

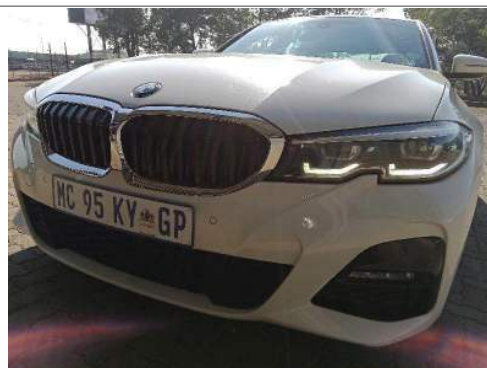
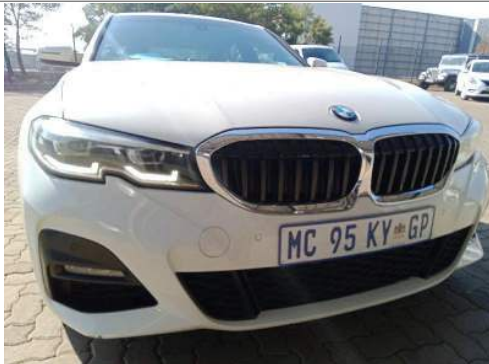
| Front Bumper Paintwork • Scratched | Repair |

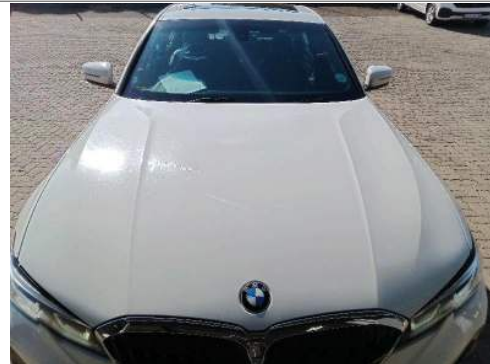
| Bonnet Paintwork • Chipmarks | Repair |

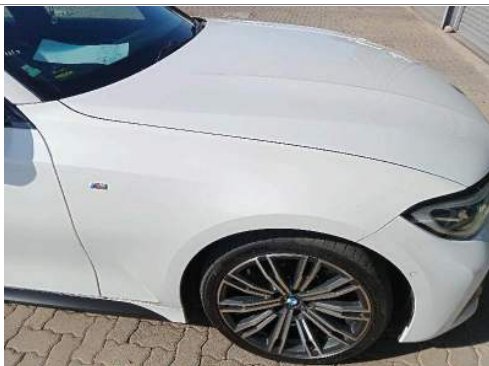
| Front Fender Right Paintwork • Chipmarks | Repair |

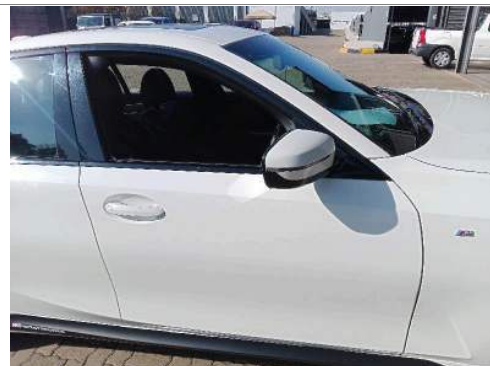
| Door Front Right Dented | Repair |

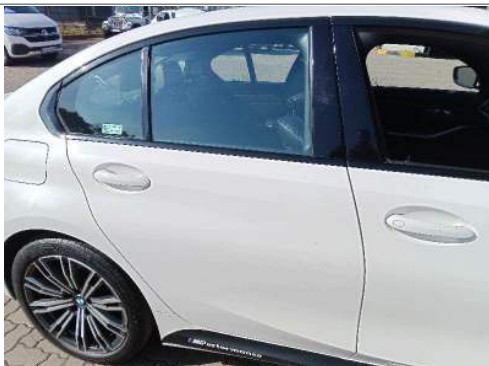
| Door Rear Right Paintwork • Chipmarks | Repair |

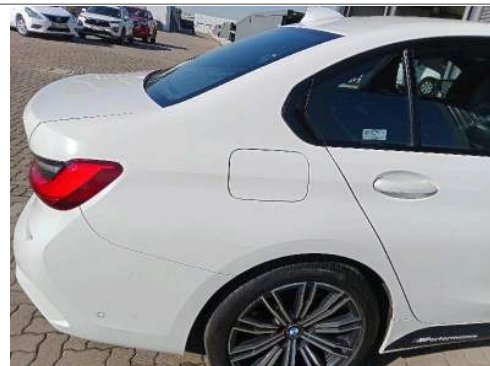
| Rear Fender Right Paintwork • Scratched | Repair |

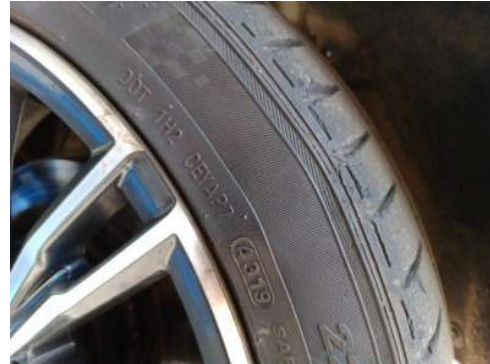
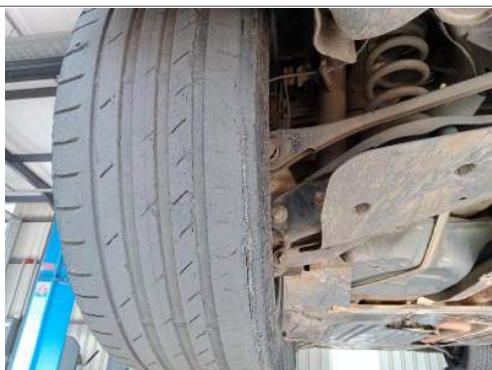
| Tyre Rear Left Damaged | Replace |

| | Size | Load/Speed Index | Manufacture | Model | Type* | Production Date | Tread Depth (mm) |
|---|---|---|---|---|---|---|---|
| Rear Left | 225/45RF18 | 91Y | Kumho | Ecsta | V | 4319 | 0 mm |

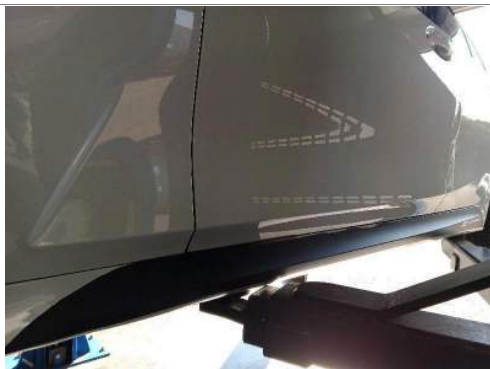
| Rocker Panel Left Paintwork • Flaking | Repair |

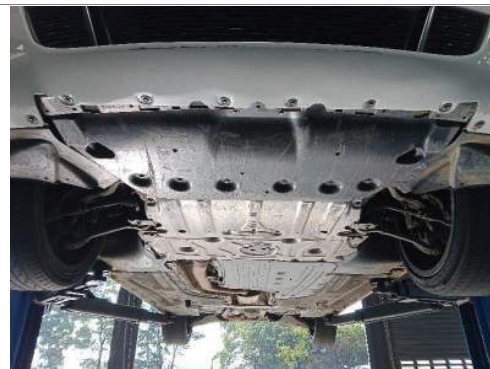
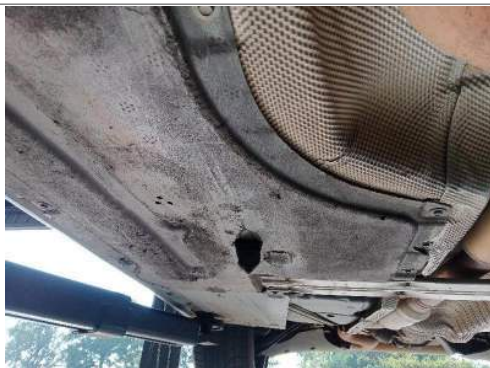
| Belly plates Damaged | Replace |

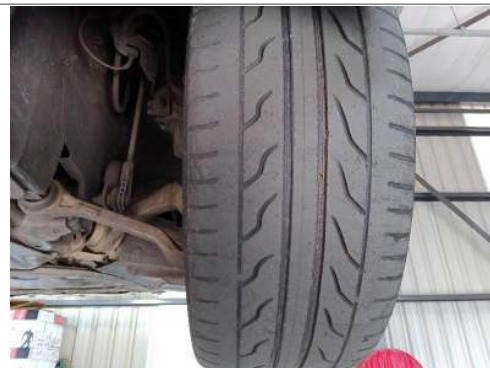
| Tyre Front Right Damaged | Replace |

| | Size | Load/Speed Index | Manufacture | Model | Type* | Production Date | Tread Depth (mm) |
|---|---|---|---|---|---|---|---|
| Front Right | 225/40Z R18 | 92Y | Hankook | Ventus | V | 3221 | 0 mm |

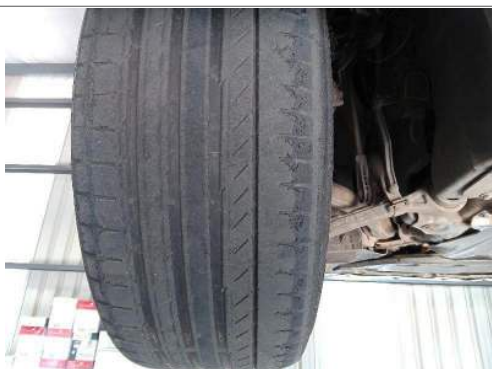
| Tyre Front Left Worn | Replace |

| | Size | Load/Speed Index | Manufacture | Model | Type* | Production Date | Tread Depth (mm) |
|---|---|---|---|---|---|---|---|
| Front Left | 225/40 R18 | 92Y | Continental | Contisport | V | 1019 | 0 mm |

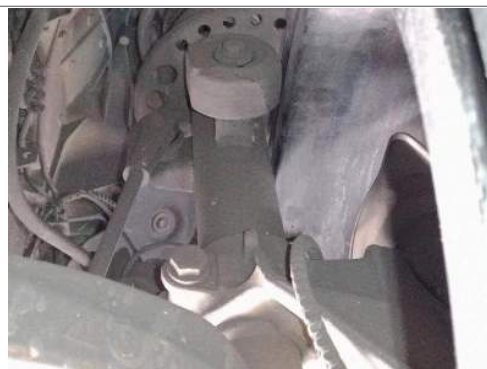
| Shock Absorber Front Left Defective | Replace |

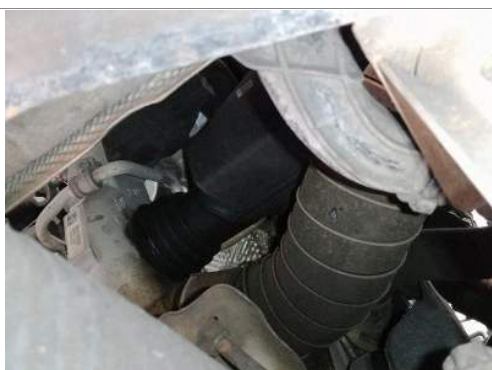
| Hoses Defective | Replace |

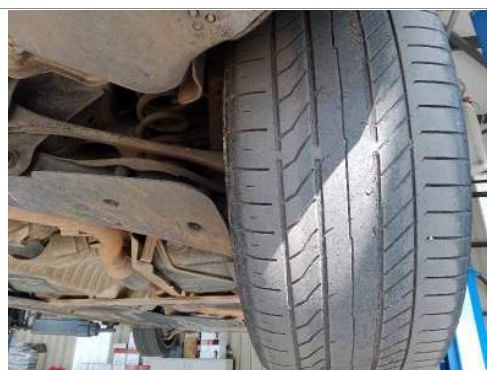
| Tyre Rear Right Damaged | Replace |

| | Size | Load/Speed Index | Manufacture | Model | Type* | Production Date | Tread Depth (mm) |
|---|---|---|---|---|---|---|---|
| Rear Right | 255/40 R18 | 95Y | Continental | Contisport | V | 2921 | 0 mm |
