MFC Auction House  
M57 Pretoria Rd, Glenmarais, KEMPTON PARK  
Gauteng

| Manufacturer | BMW | Registration Number | HD63LBGP |

## CONDITION REPORT

Report No: 2016208595

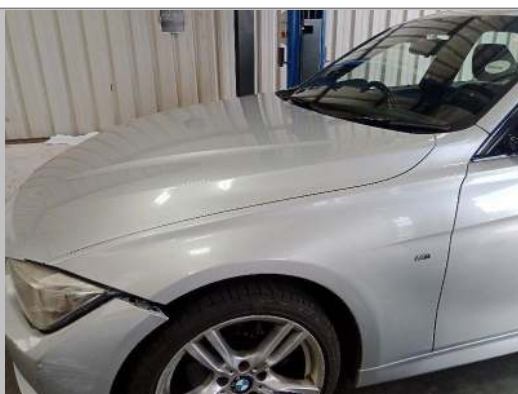
| | Damage | Repair Way |
|---|---|---|
| | Front Fender Left Residual Traces of Repair | Replace |

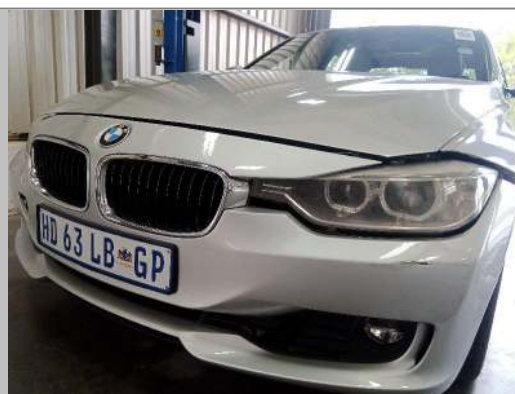
| | Damage | Repair Way |
|---|---|---|
| | Front Bumper Damaged | Repair |

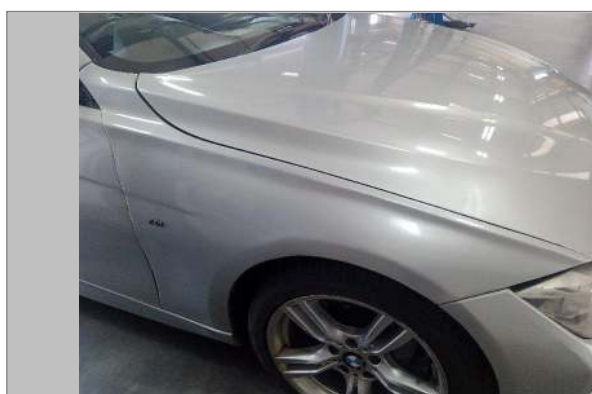
| | Damage | Repair Way |
|---|---|---|
| | Front Fender Right Residual Traces of Repair | Repair |

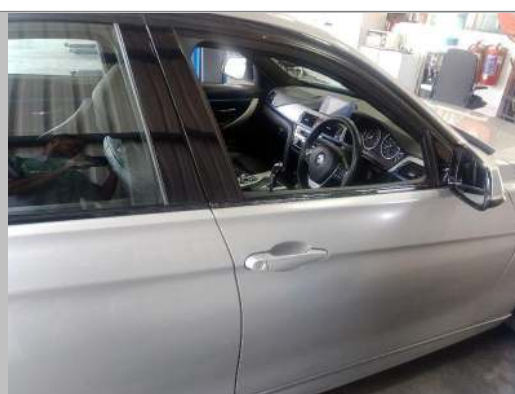
| | Damage | Repair Way |
|---|---|---|
| | Door Front Right Residual Traces of Repair | Repair |

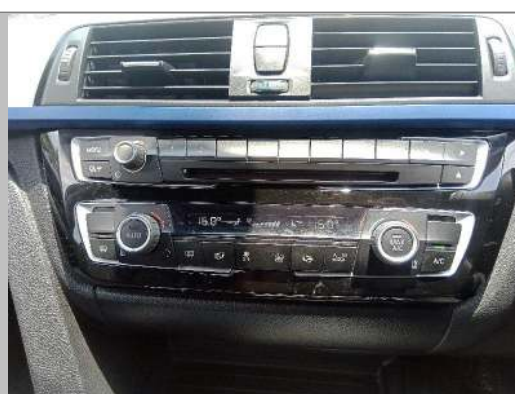
| | Damage | Repair Way |
|---|---|---|
| | Air Conditioner Insufficient | Replace |

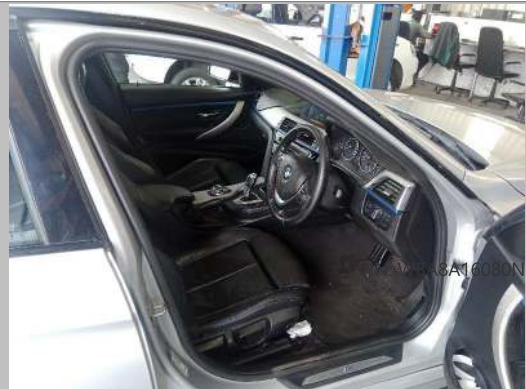
| | Damage | Repair Way |
|---|---|---|
| | Door Sealing Rubber Front Right Torn / Cut | Repair |

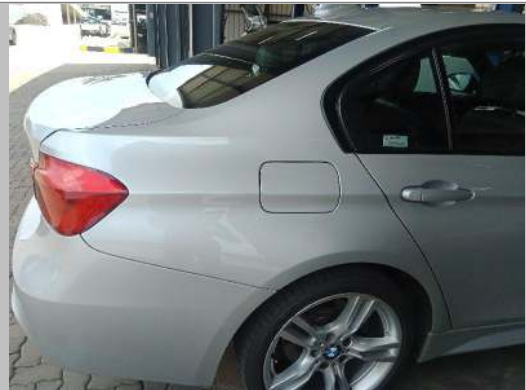
| | Damage | Repair Way |
|---|---|---|
| | Rear Fender Right Paintwork • Scratched | Repair |

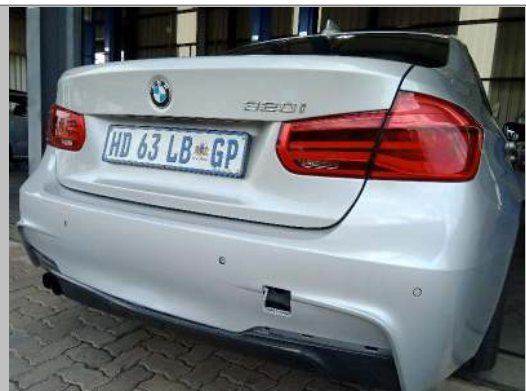
| Damage | Repair Way |
|---|---|
| Rear bumper Residual Traces of Repair | Repair |

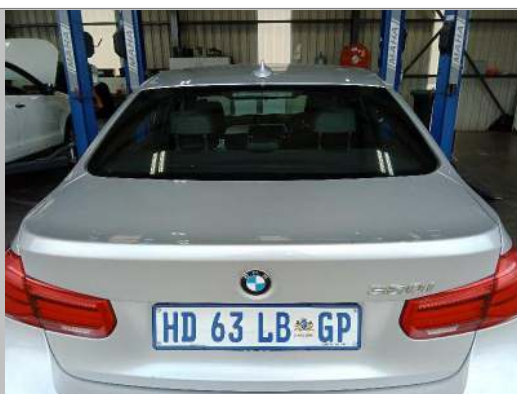
| | Damage | Repair Way |
|---|---|---|
| | Boot Lid / Hatch door Paintwork • Scratched | Repair |

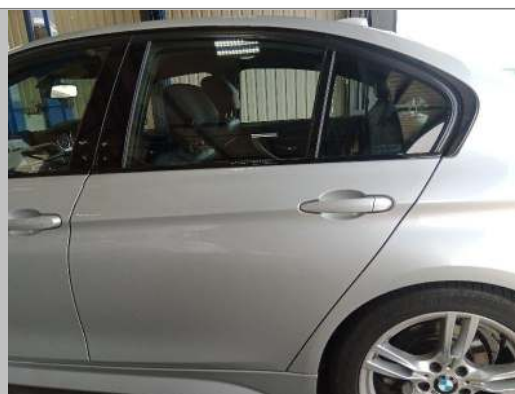
| | Damage | Repair Way |
|---|---|---|
| | Door Rear Left Paintwork • Scratched | Repair |

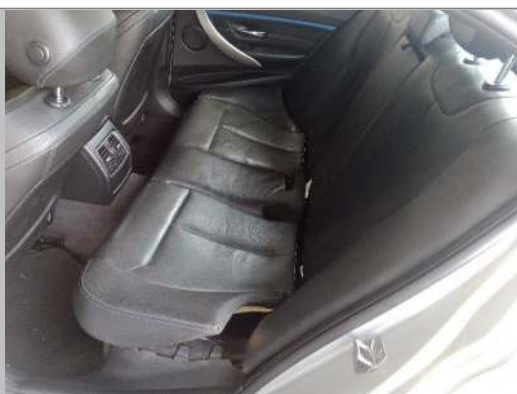
| | Damage | Repair Way |
|---|---|---|
| | Seat Rear Defective | Repair |

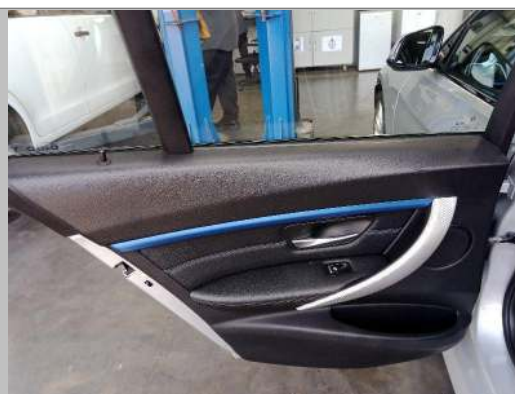
| | Damage | Repair Way |
|---|---|---|
| | Door Panel Rear Left Defective | Repair |

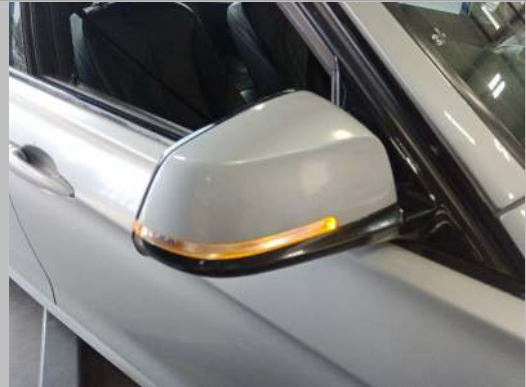
| | Damage | Repair Way |
|---|---|---|
| | Side Mirror Right Paintwork • Scratched | Repair |

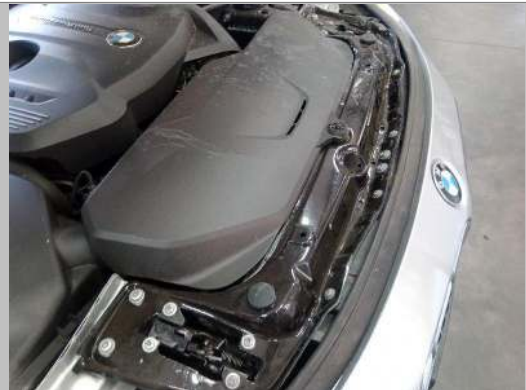
| | Damage | Repair Way |
|---|---|---|
| | Bonnet slam plate (Shock tower/ Inner tray) Residual Traces of Repair | Replace |

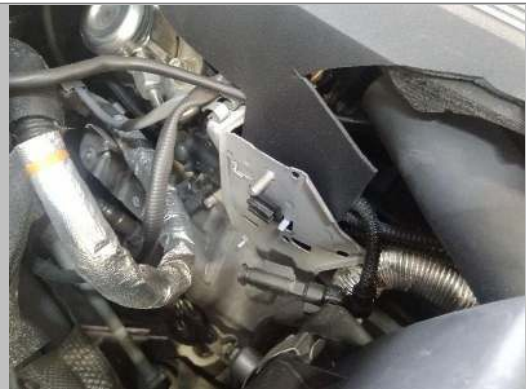
| | Damage | Repair Way |
|---|---|---|
| | Engine Wiring Defective | Repair |

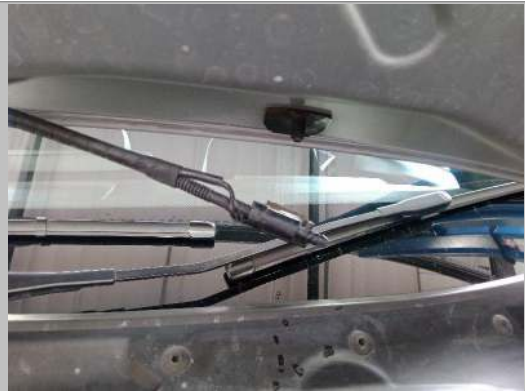
| | Damage | Repair Way |
|---|---|---|
| | Windscreen Washer Defective | Repair |

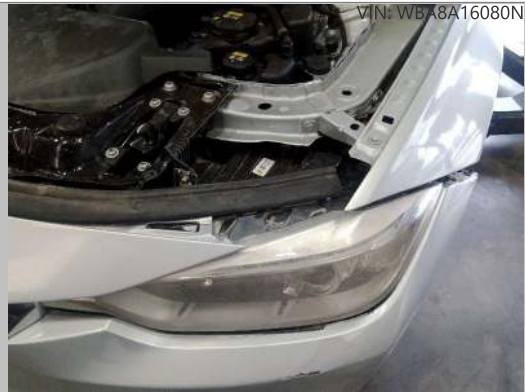
| | Damage | Repair Way |
|---|---|---|
| | Headlight Left Damaged | Replace |

Lights: Vehicle has no lights working on front left and right headlights. Front right headlight bracket damaged.

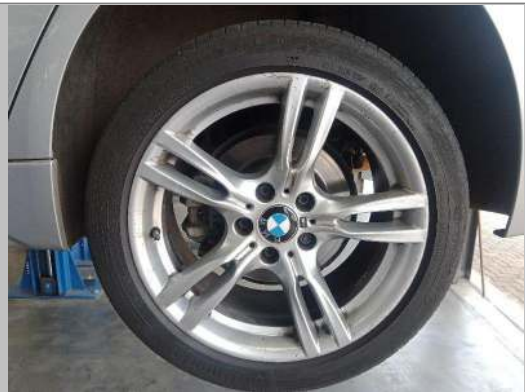
| Damage | Repair Way |
|---|---|
| Tyre Rear Left Defective | Replace |

| | Size | Load/Speed Index | Manufacture | Model | Type* | Production Date | Tread Depth (mm) |
|---|---|---|---|---|---|---|---|
| Rear Left | 255/40 R18 | 95Y | Continental | ContiSport | V | 2217 | 0 mm |

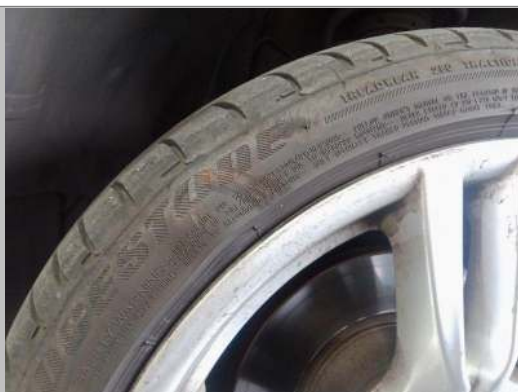
| Damage | Repair Way |
|---|---|
| Tyre Front Left Damaged | Replace |

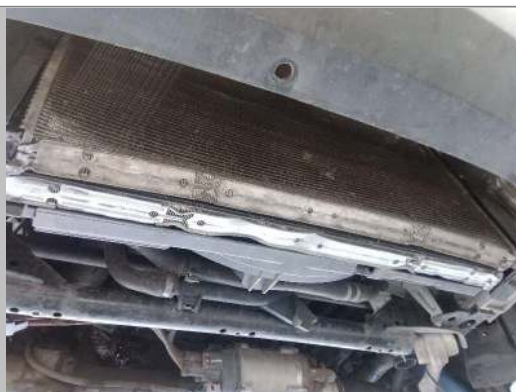
| | Damage | Repair Way |
|---|---|---|
| | Radiator Defective | Replace |

Engine Compartment: Engine bay dirty. Brake fluid level ok. Oil level checked electronically. Left and right bonnet latches faulty. Radiator and Aircon condenser dented. Engine splash plate missing. Engine cover damaged. Computer box cover cracked.

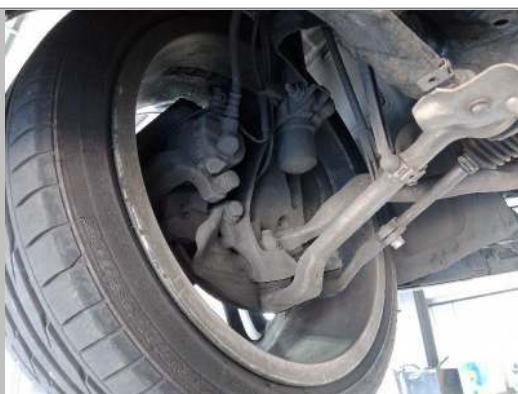
| Damage | Repair Way |
|---|---|
| Rim Front Left Dented | Repair |

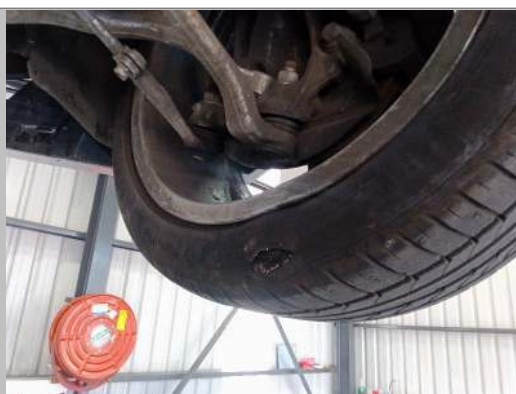
| Damage | Repair Way |
|---|---|
| Tyre Front Right Damaged | Replace |

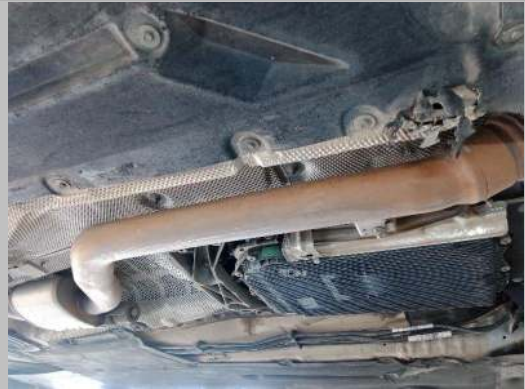
| Damage | Repair Way |
|---|---|
| Engine to silencer pipe Defective | Repair |

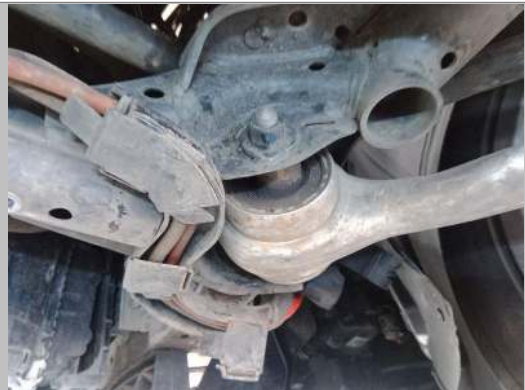
| Damage | Repair Way |
|---|---|
| Control Arm Bush(es) Front Axle Right Cracked | Replace |

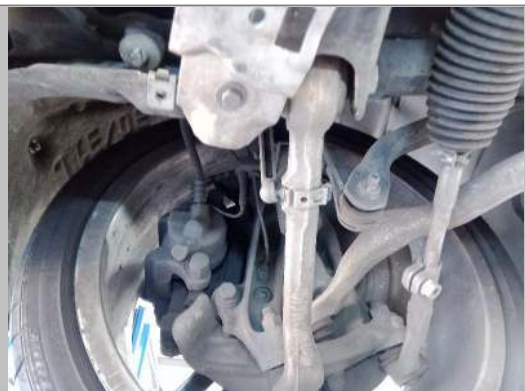
| Damage | Repair Way |
|---|---|
| Control Arm(s) Front Axle Left Defective | Replace |

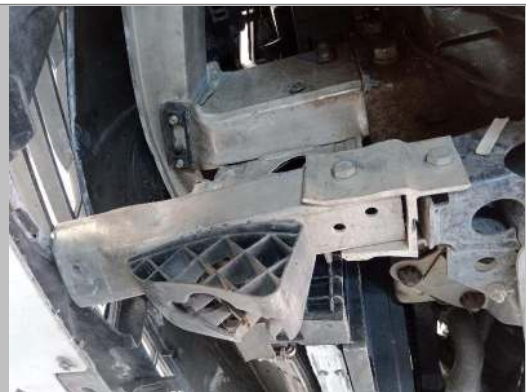
| Damage | Repair Way |
|---|---|
| Radiator Cradle Damaged | Replace |

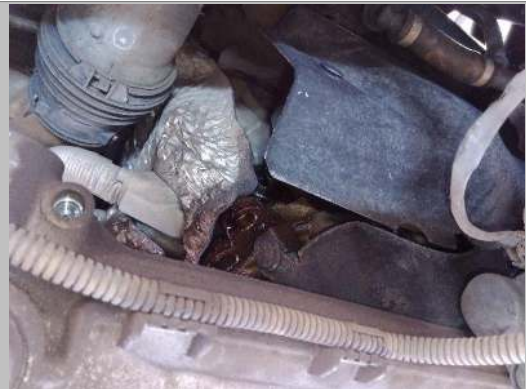
| | Damage | Repair Way |
|---|---|---|
| | Engine Oil Leak | Repair |

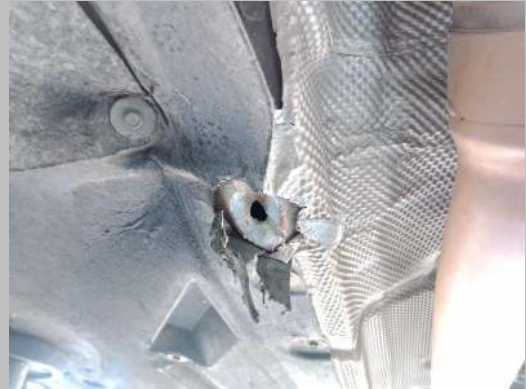
| Damage | Repair Way |
|---|---|
| Chassis Dented | Repair |

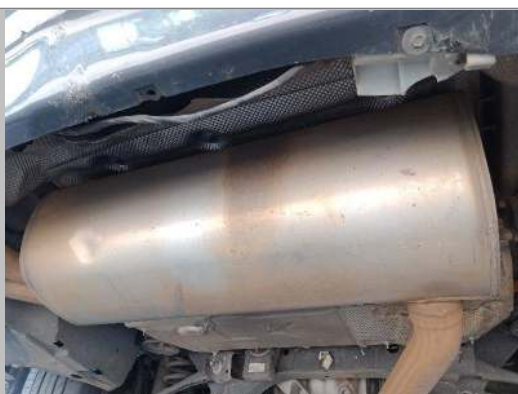
| Damage | Repair Way |
|---|---|
| Silencer Defective | Repair |

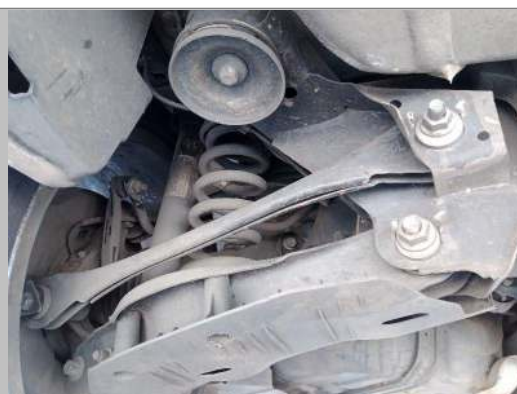
| Damage | Repair Way |
|---|---|
| Control Arm(s) Front Rear Left Damaged | Replace |

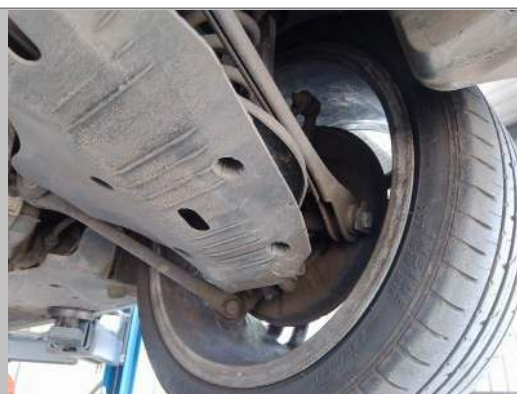
| Damage | Repair Way |
|---|---|
| Rim Rear Right Dented | Repair |

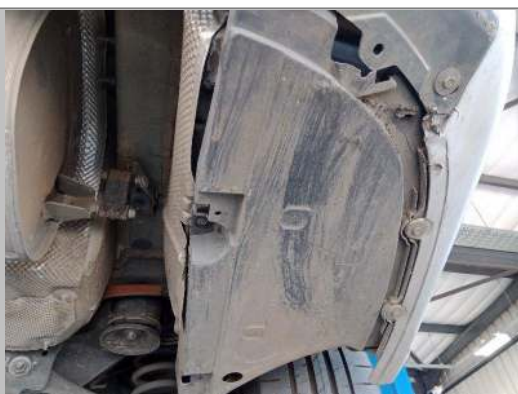
| Damage | Repair Way |
|---|---|
| Belly plates Damaged | Repair |

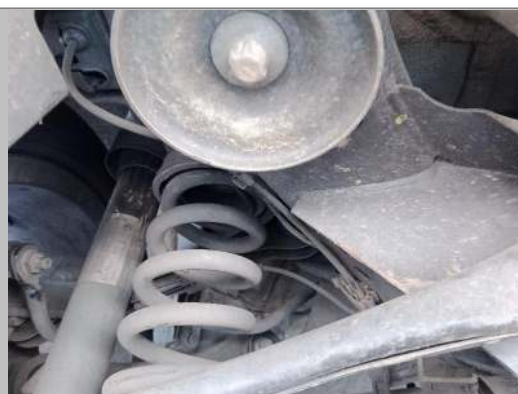
| Damage | Repair Way |
|---|---|
| Rear Axle Defective | Repair |

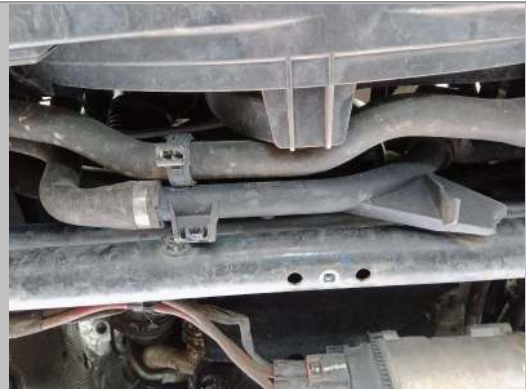
| | Damage | Repair Way |
|---|---|---|
| | Hoses Broken | Replace |
