CONDITION REPORT

Report No: 2016220563

| Manufacturer | BMW | Registration Number | FSK108L |
| Model | 330D | Register Number | |

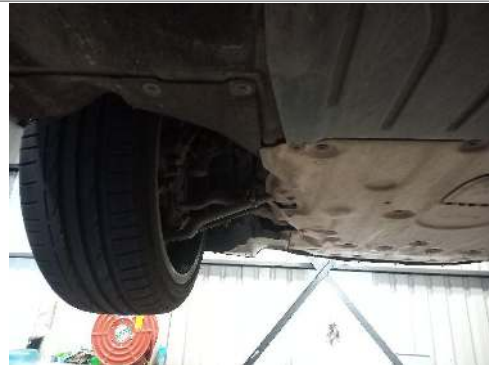
LF TYRE TREAD

| | Size | Load/Speed Index | Manufacture | Model | Type* | Production Date | Tread Depth (mm) |
|---|---|---|---|---|---|---|---|
| Front Left | 225/40R19 | 89Y | Bridgestone | Radial | V | 4122 | 3 mm |

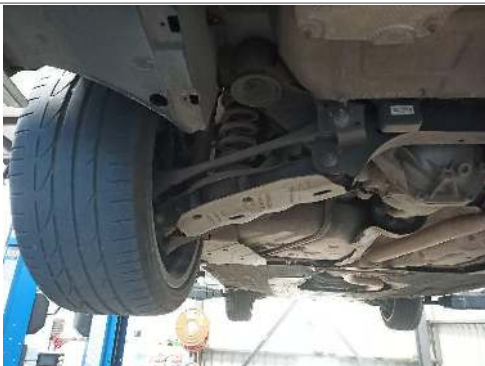
LR TYRE TREAD

| | Size | Load/Speed Index | Manufacture | Model | Type* | Production Date | Tread Depth (mm) |
|---|---|---|---|---|---|---|---|
| Rear Left | 255/35R19 | 92Y | Bridgestone | Radial | V | 2122 | 2 mm |

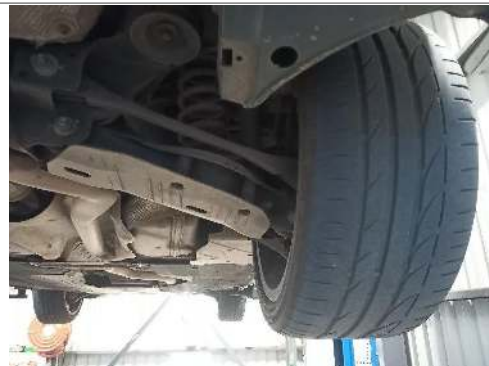
RR TYRE TREAD

| | Size | Load/Speed Index | Manufacture | Model | Type* | Production Date | Tread Depth (mm) |
|---|---|---|---|---|---|---|---|
| Rear Right | 255/35R19 | 92Y | Bridgestone | Radial | V | 1422 | 2 mm |

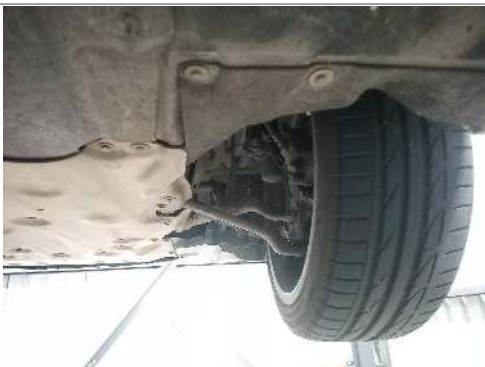
RF TYRE TREAD

| | Size | Load/Speed Index | Manufacture | Model | Type* | Production Date | Tread Depth (mm) |
|---|---|---|---|---|---|---|---|
| Front Right | 225/40R19 | 89Y | Bridgestone | Radial | V | 4122 | 3 mm |

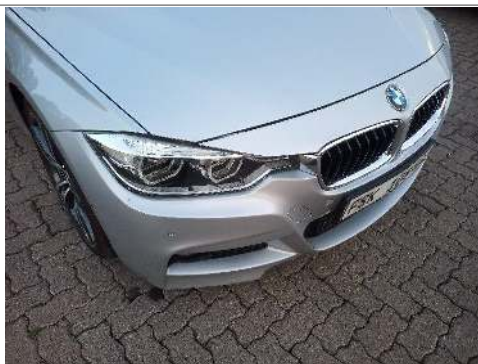
| Damage | Repair Way |
|---|---|
| Front Bumper Damaged | Repair |

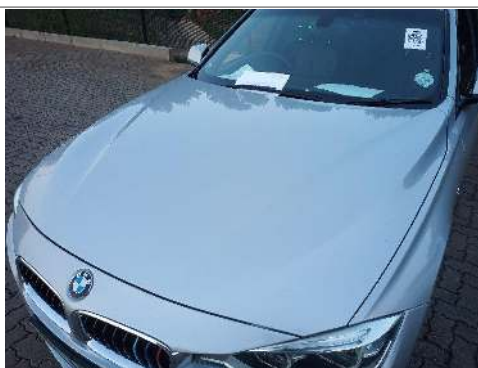
| Damage | Repair Way |
|---|---|
| Bonnet Damaged | Repair |

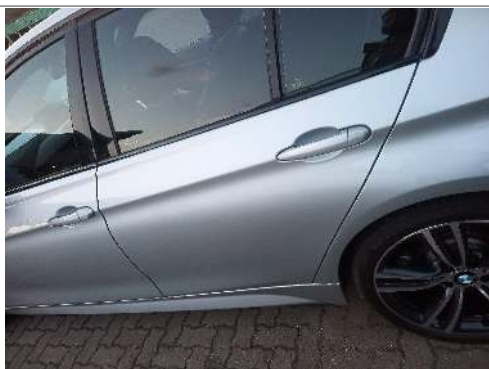
| Damage | Repair Way |
|---|---|
| Door Rear Left Damaged | Repair |

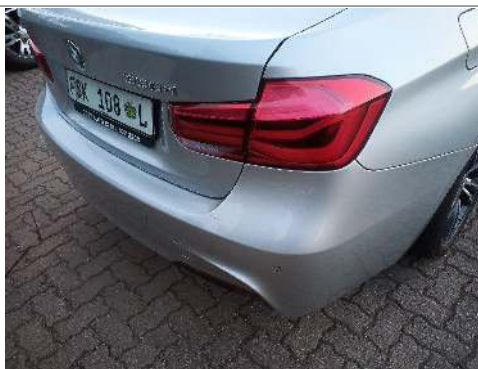
| Damage | Repair Way |
|---|---|
| Rear bumper Damaged | Repair |
