## CONDITION REPORT

Report No: 2016355407

MFC Auction House  
M57 Pretoria Rd, Glenmarais, KEMPTON PARK  
Gauteng

| Manufacturer | BMW | Registration Number | BR61CYGP |

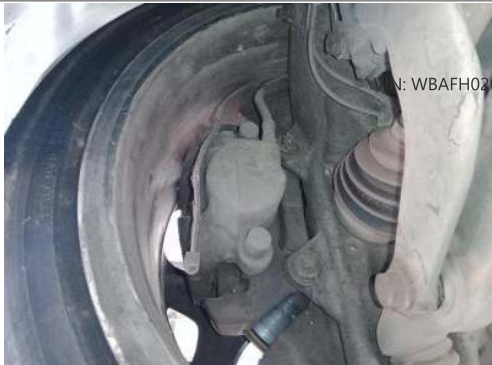
| Damage | Repair Way |
|---|---|
| Brakes | Front left brake wear sensor damaged |

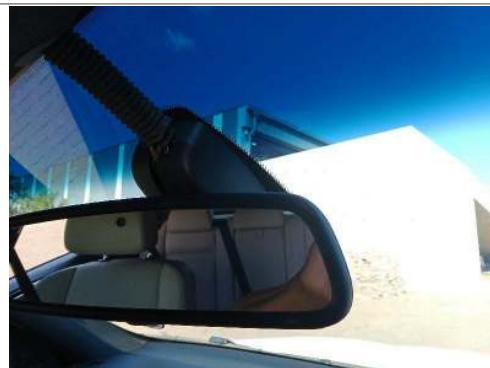
| Damage | Repair Way |
|---|---|
| Interior | Rain sensor cover defective |

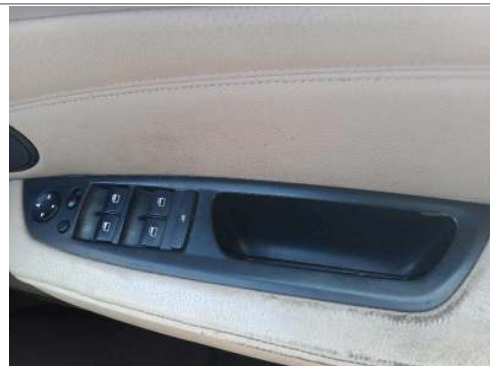
Front right electrical window

| Damage | Repair Way |
|---|---|
| Electrical instruments and components | F/R electrical window switch mechanism damaged |

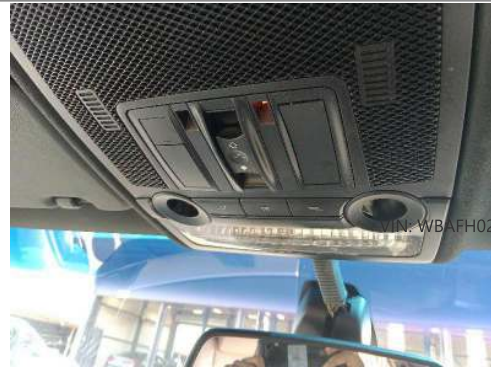
| Damage | Repair Way |
|---|---|
| Sun Roof Switch Malfunction | Replace |

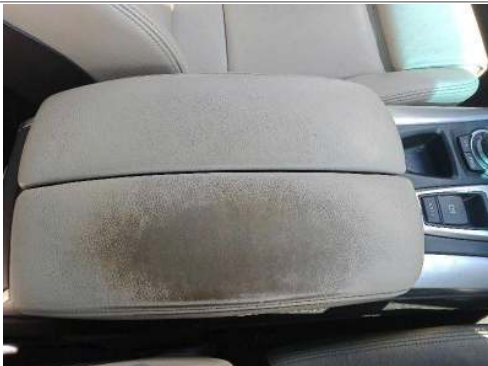
| Damage | Repair Way |
|---|---|
| Center Console / Cubbyhole + Lid Defective | Repair |

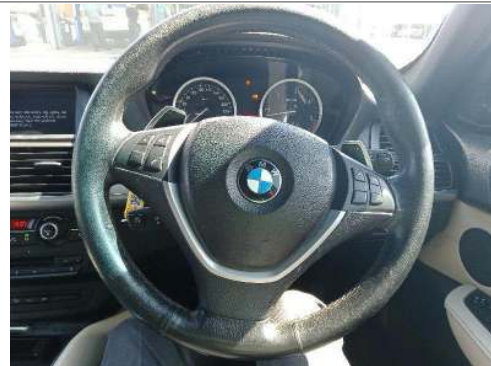
| Damage | Repair Way |
|---|---|
| Steering Wheel Trim Defective | Repair |

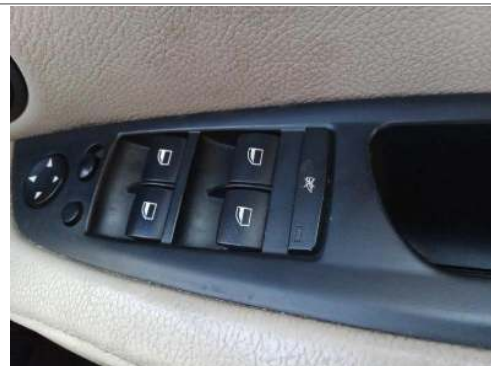
| Damage | Repair Way |
|---|---|
| Switch Electrical Window Winder rear left Damaged | Replace |

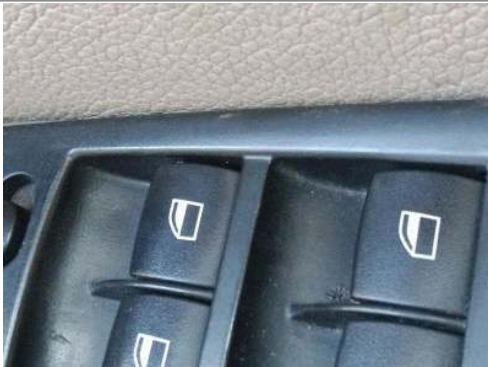
| Damage | Repair Way |
|---|---|
| Switch Electrical Window Winder front right Damaged | Replace |

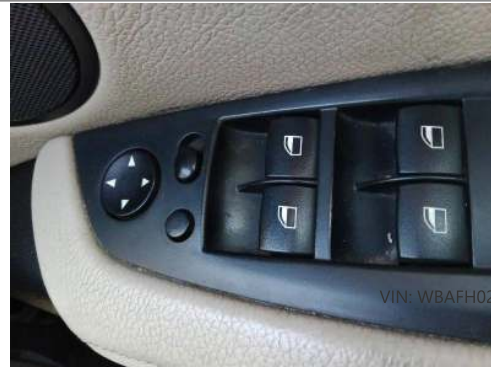
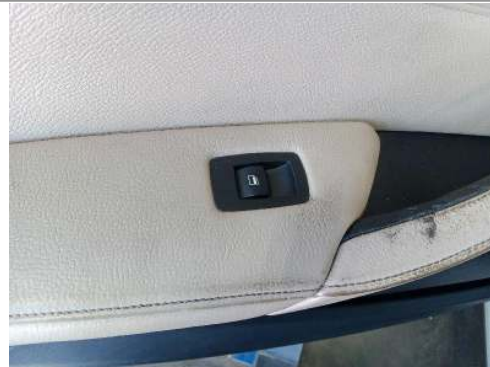
| Damage | Repair Way |
|---|---|
| Switch Electrical Window Winder front left Damaged | Replace |

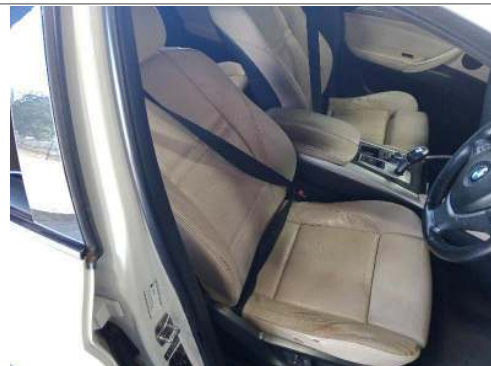
| Damage | Repair Way |
|---|---|
| Seat Front Right Damaged | Repair |

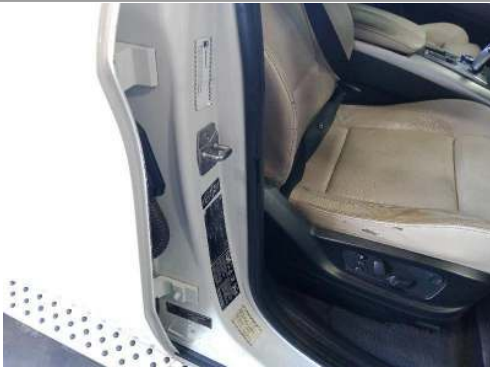
| Damage | Repair Way |
|---|---|
| Door Sealing Rubber Front Right Damaged | Repair |

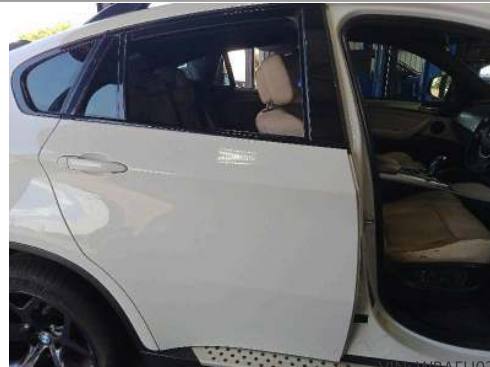
| Damage | Repair Way |
|---|---|
| Door Rear Right Dented | Repair |

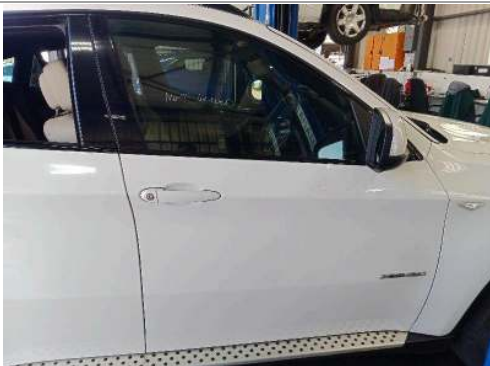
| Damage | Repair Way |
|---|---|
| Door Front Right Dented | Repair |

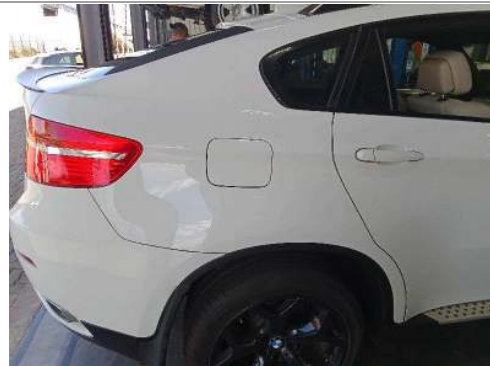
| Damage | Repair Way |
|---|---|
| Rear Fender Right Paintwork • Scratched | Repair |

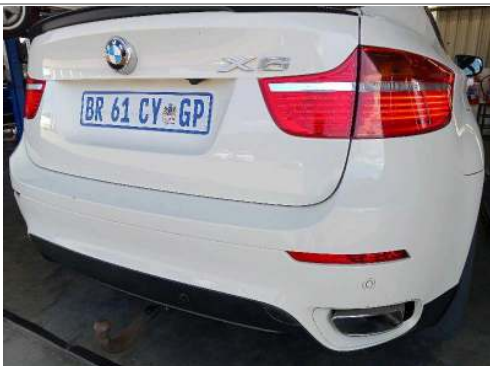
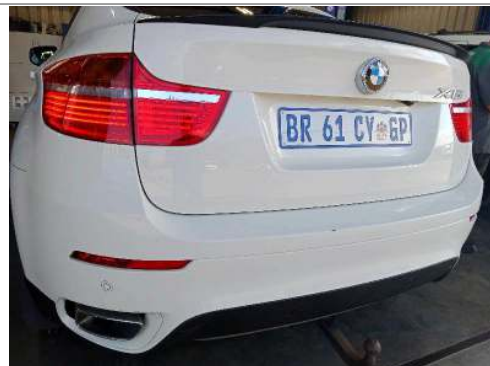
| Damage | Repair Way |
|---|---|
| Rear bumper Paintwork • Scratched | Repair |

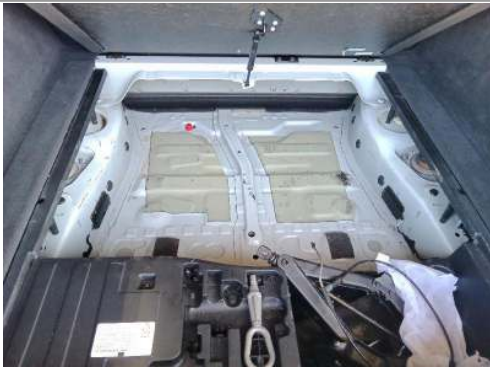
| Damage | Repair Way |
|---|---|
| Inner Boot Floor Pan and Spare Wheel Well Paintwork • Scratched | Repair |

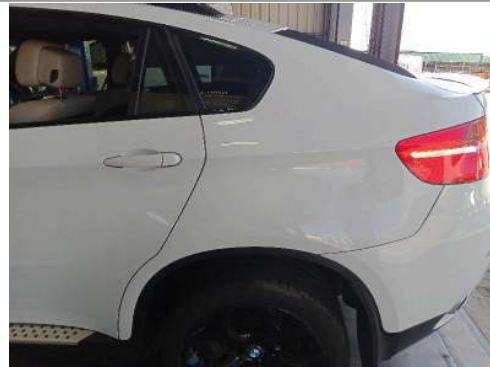
| Damage | Repair Way |
|---|---|
| Rear Fender Left Residual Traces of Repair | Repair |

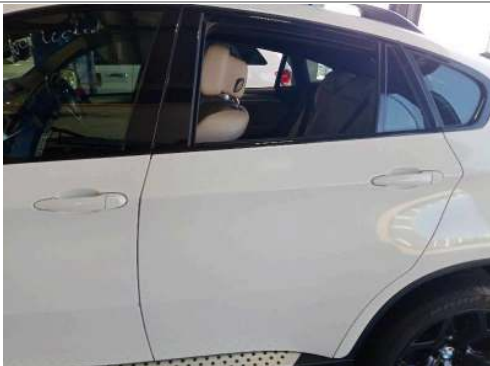
| Damage | Repair Way |
|---|---|
| Door Rear Left Paintwork • Scratched | Repair |

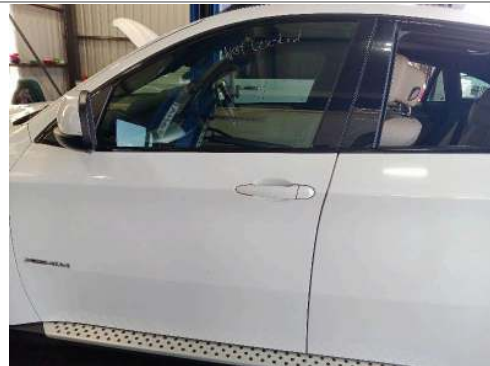
| Damage | Repair Way |
|---|---|
| Door Front Left Residual Traces of Repair | Repair |

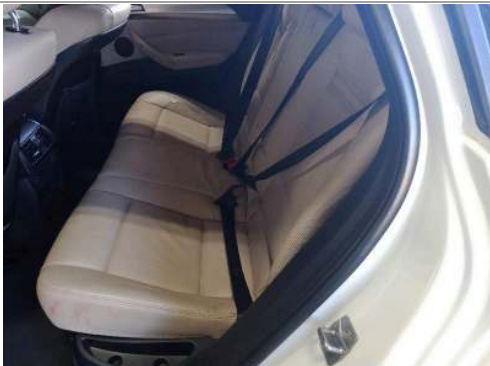
| Damage | Repair Way |
|---|---|
| Seat Rear Dirty | Repair |

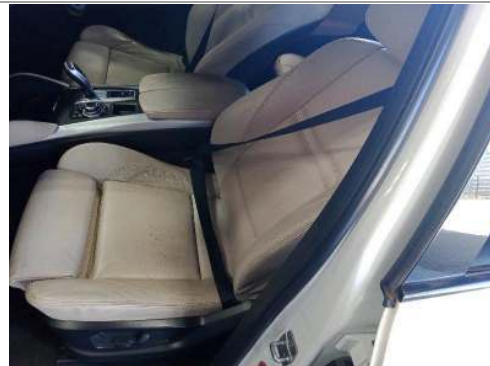
| Damage | Repair Way |
|---|---|
| Seat Front Left Defective | Repair |

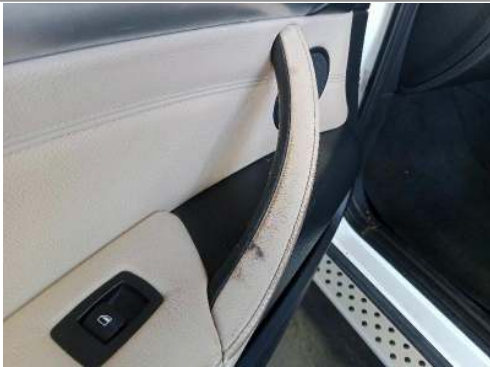
| Damage | Repair Way |
|---|---|
| Door Handle Front Left Defective | Repair |

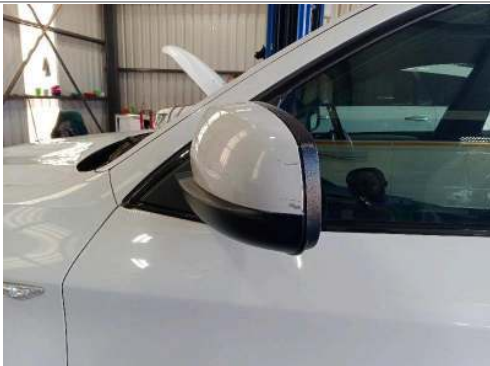
| Damage | Repair Way |
|---|---|
| Side Mirror Left Paintwork • Scratched | Repair |

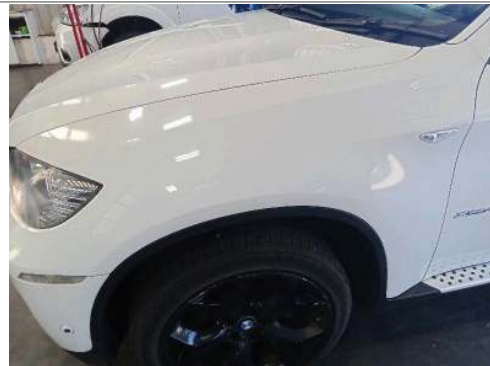
| Damage | Repair Way |
|---|---|
| Front Fender Left Residual Traces of Repair | Repair |

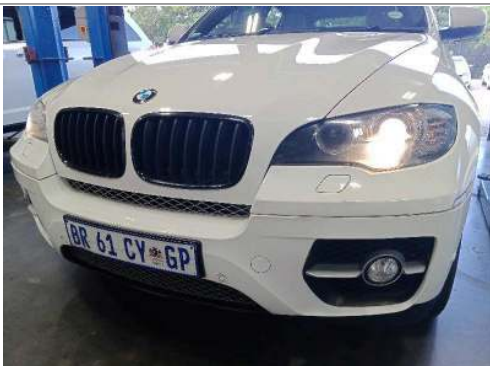
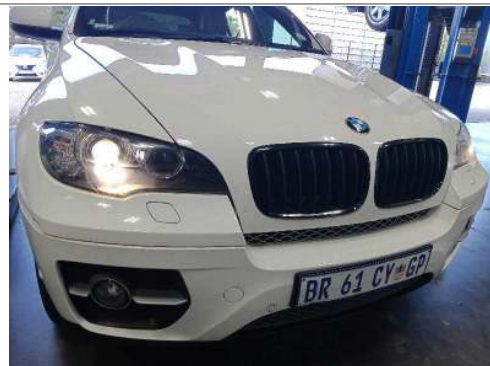
| Damage | Repair Way |
|---|---|
| Front Bumper Residual Traces of Repair | Repair |

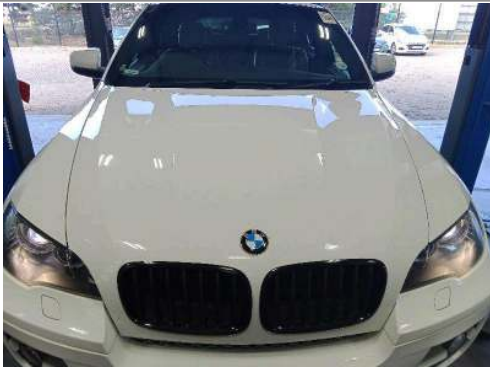
| Damage | Repair Way |
|---|---|
| Bonnet Paintwork • Scratched | Repair |

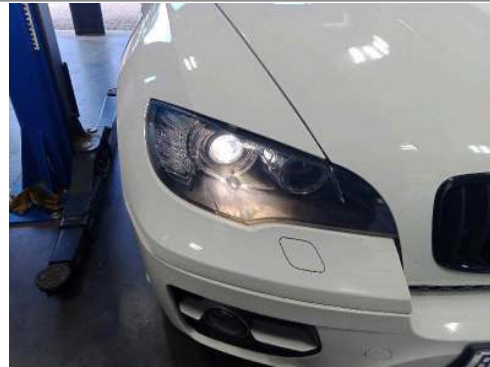
| Damage | Repair Way |
|---|---|
| Headlight Right Defective | Repair |

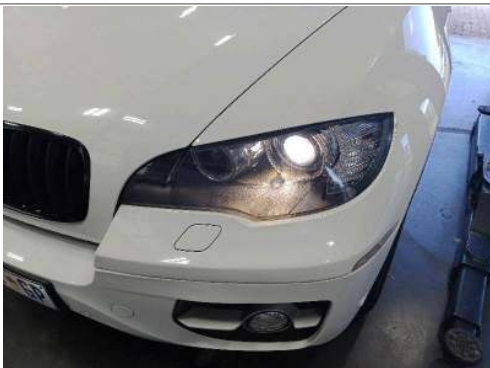
| Damage | Repair Way |
|---|---|
| Headlight Left Defective | Repair |

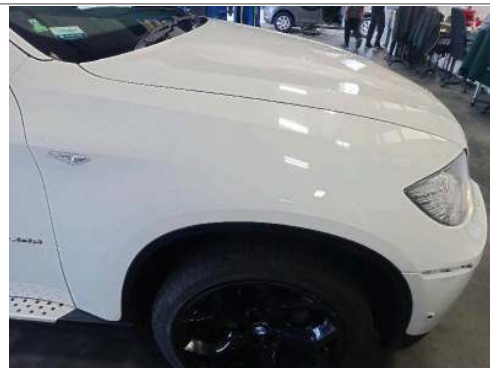
| Damage | Repair Way |
|---|---|
| Front Fender Right Residual Traces of Repair | Repair |

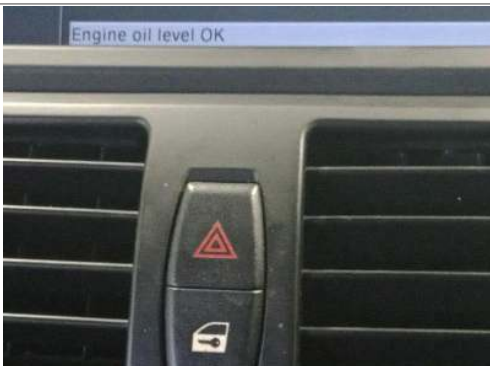
| Damage | Repair Way |
|---|---|
| Hazard Lights Damaged | Replace |

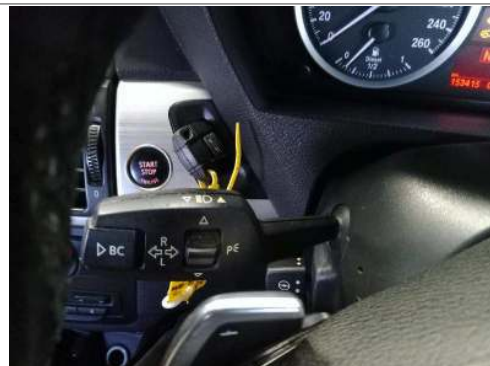
| Damage | Repair Way |
|---|---|
| Indicator Switch Damaged | Replace |

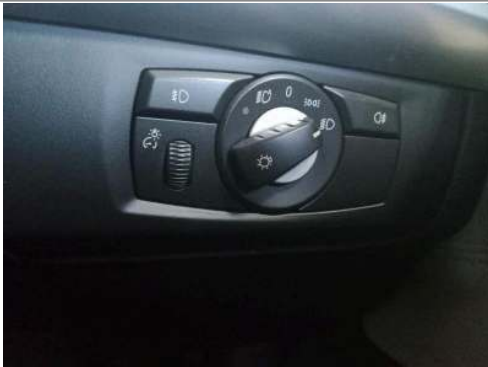
| Damage | Repair Way |
|---|---|
| Head Light Switch Damaged | Replace |

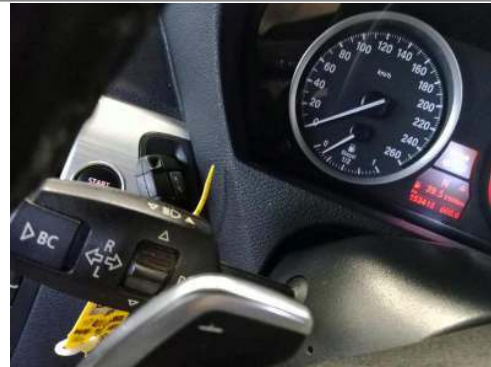
| Damage | Repair Way |
|---|---|
| Dim and Bright Indicator Light Damaged | Replace |

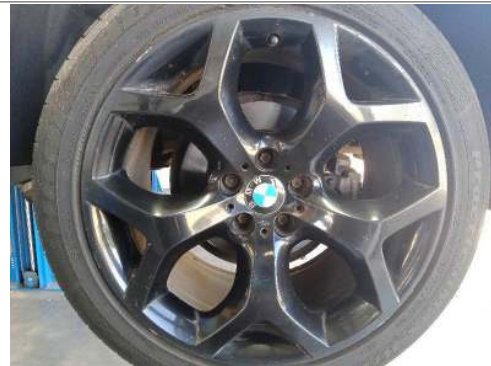
| Damage | Repair Way |
|---|---|
| Rim Rear Left Scratched | Repair |

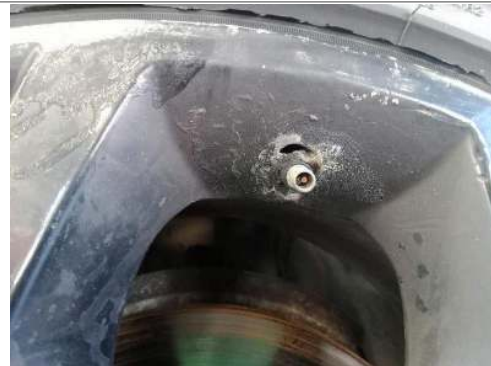
| Damage | Repair Way |
|---|---|
| Tyre Front Left Defective | Repair |

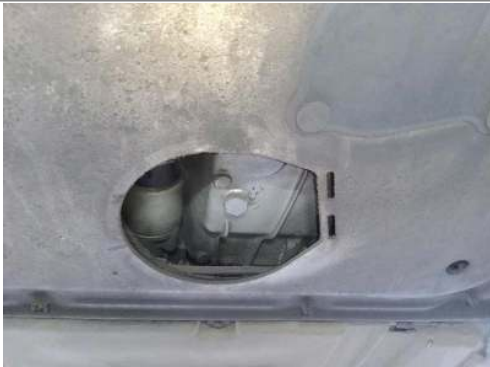
| Damage | Repair Way |
|---|---|
| Gearbox Oil Sweat | Repair |

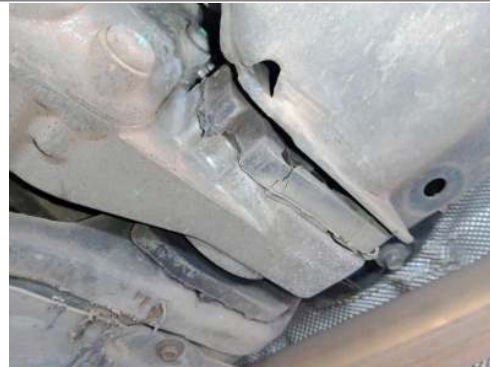
| Damage | Repair Way |
|---|---|
| Gearbox Mountings Cracked | Replace |

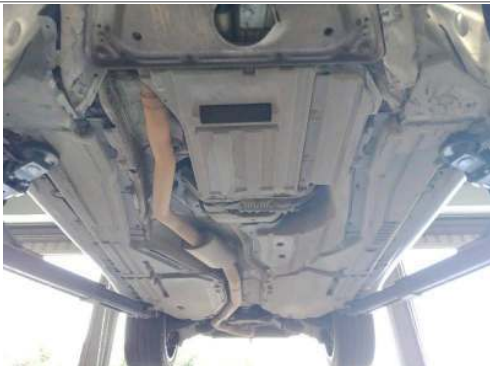
| Damage | Repair Way |
|---|---|
| Belly plates Defective | Repair |

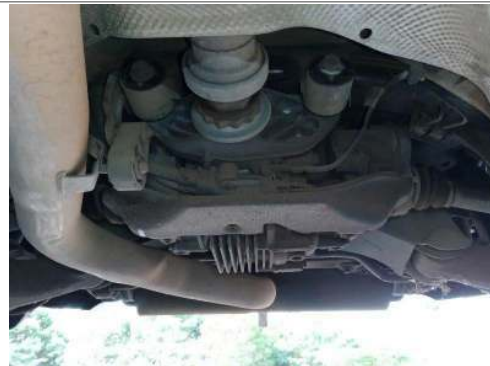
| Damage | Repair Way |
|---|---|
| Differential Oil Sweat | Repair |

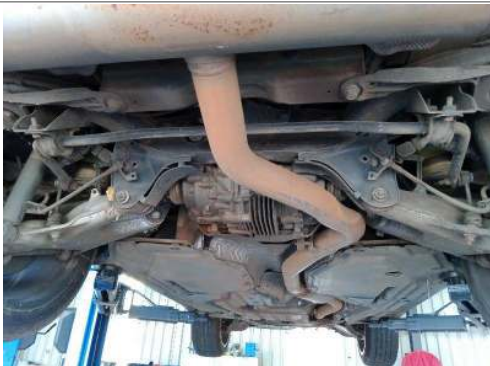
| Damage | Repair Way |
|---|---|
| Engine to silencer pipe Defective | Repair |

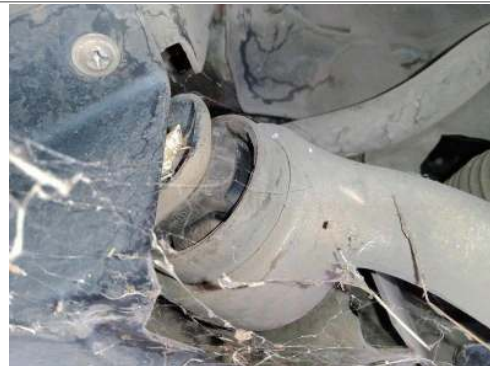
| Damage | Repair Way |
|---|---|
| Control Arm Bush(es) Front Axle Left Cracked | Replace |
