| Manufacturer | BMW | Registration Number | CY238235 |
| Model | 335I | Register Number | |

## CONDITION REPORT

Report No: 2016348187

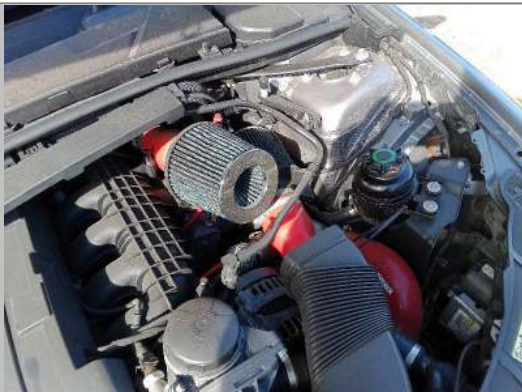
| Damage | Repair Way |
|---|---|
| Air cleaner Defective | Repair |

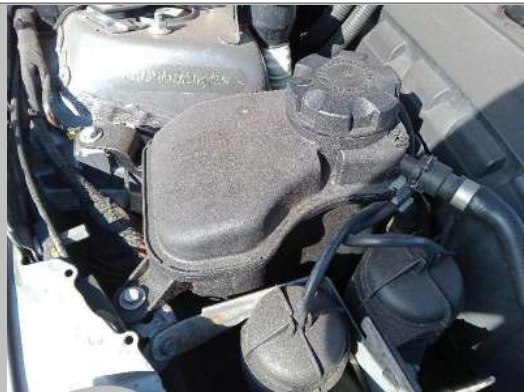
| Damage | Repair Way |
|---|---|
| Water level Insufficient | Repair |

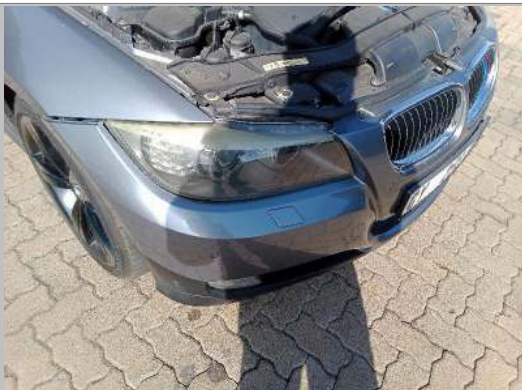
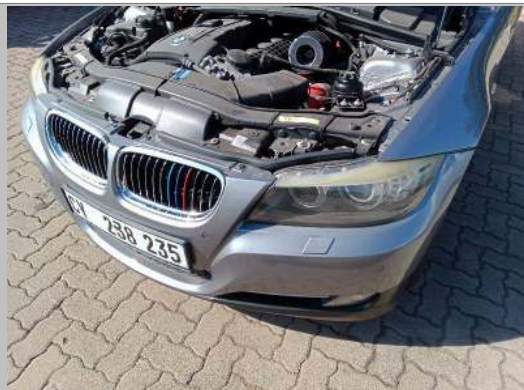
| Damage | Repair Way |
|---|---|
| Front Bumper Damaged | Repair |

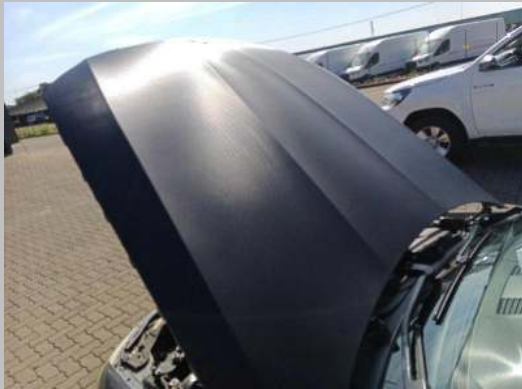
| Damage | Repair Way |
|---|---|
| Bonnet Damaged | Repair |

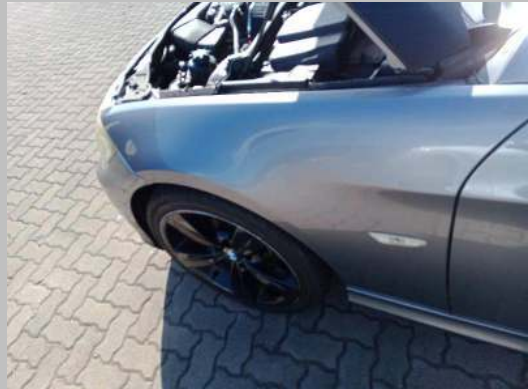
| Damage | Repair Way |
|---|---|
| Front Fender Left Damaged | Repair |

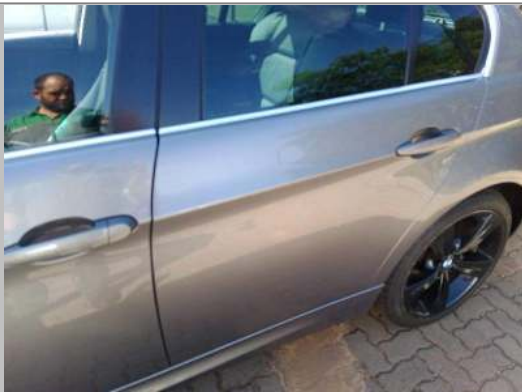
| Damage | Repair Way |
|---|---|
| Door Rear Left Damaged | Repair |

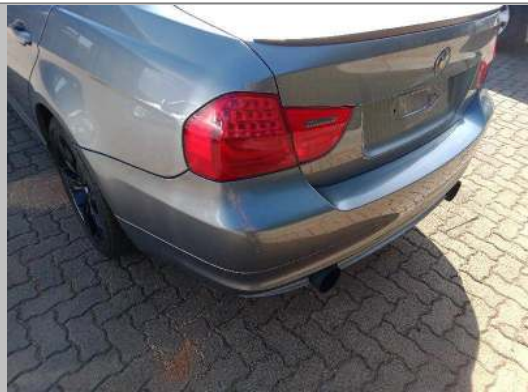
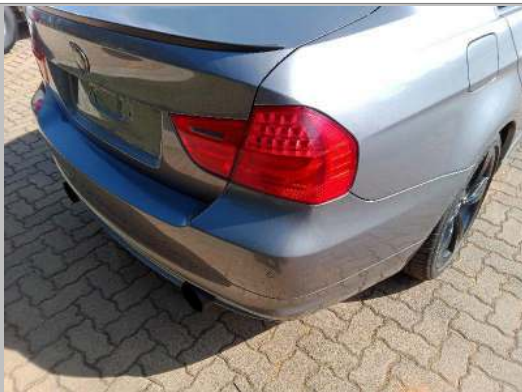
| Damage | Repair Way |
|---|---|
| Rear bumper Damaged | Repair |

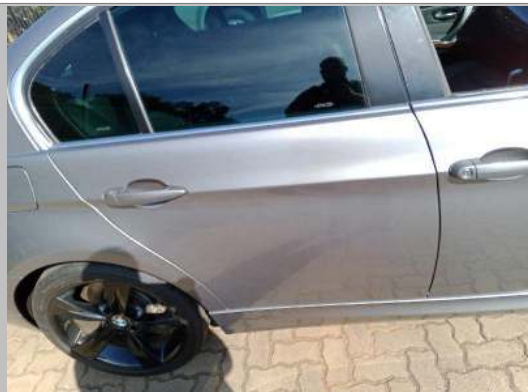
| Damage | Repair Way |
|---|---|
| Door Rear Right Damaged | Repair |

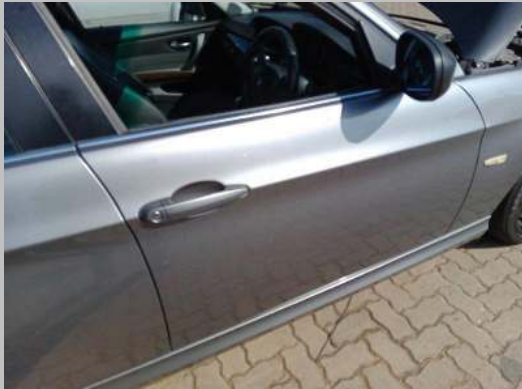
| Damage | Repair Way |
|---|---|
| Door Front Right Damaged | Repair |

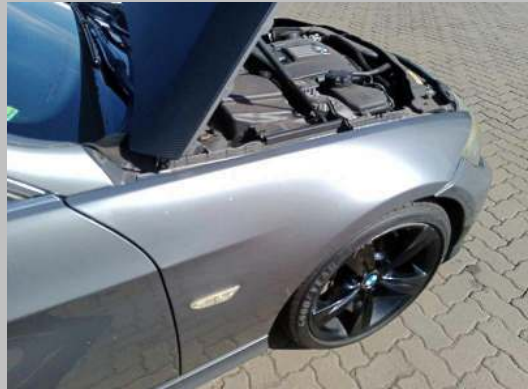
| Damage | Repair Way |
|---|---|
| Front Fender Right Damaged | Repair |

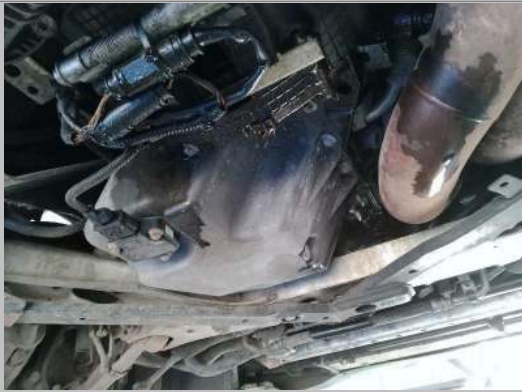
| Damage | Repair Way |
|---|---|
| Engine Oil Leak | Repair |

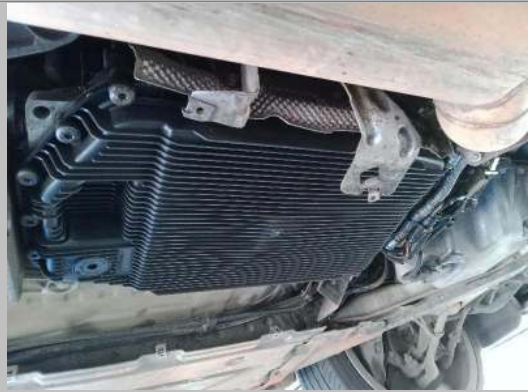
| Damage | Repair Way |
|---|---|
| Gearbox Oil Leak | Repair |

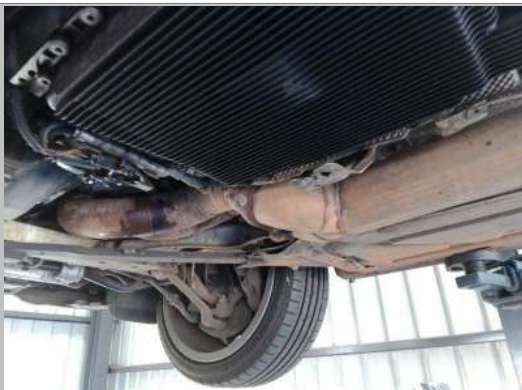
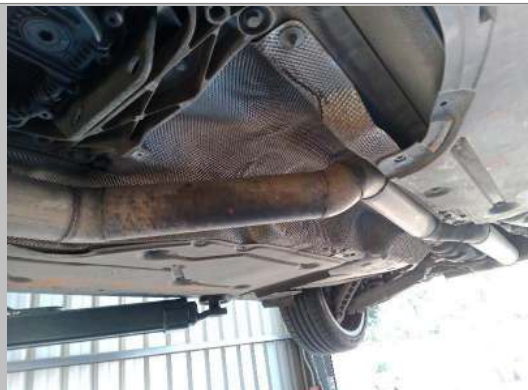
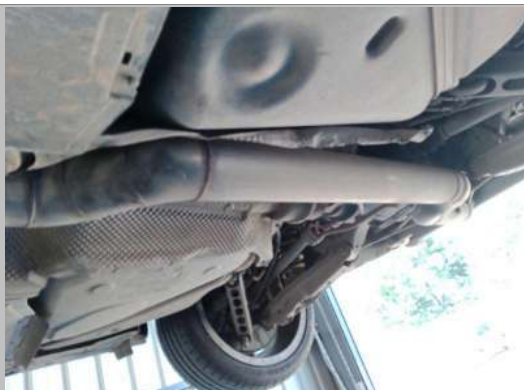
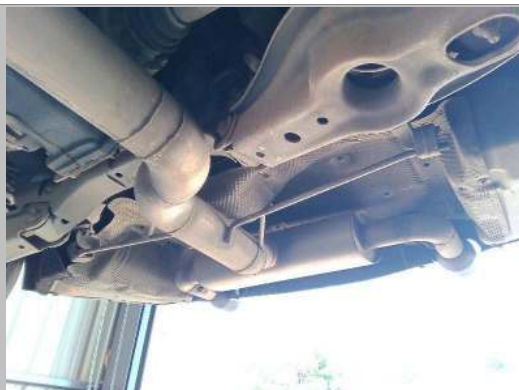
| Damage | Repair Way |
|---|---|
| Engine to silencer pipe Welded | Repair |

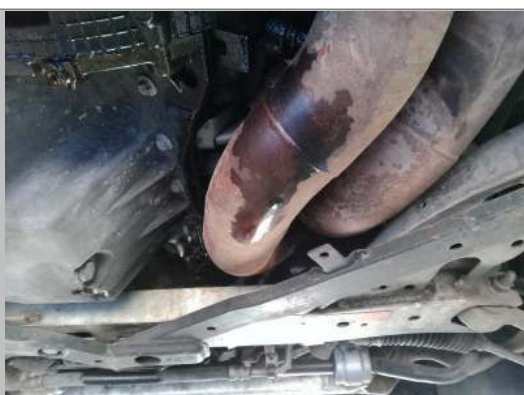
| Damage | Repair Way |
|---|---|
| Catalytic converter Missing | Replace |

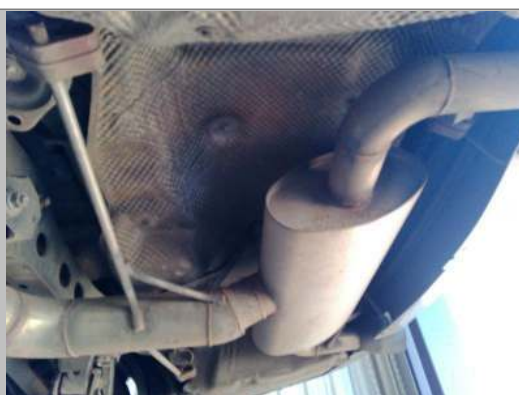
| Damage | Repair Way |
|---|---|
| Silencer Defective | Repair |

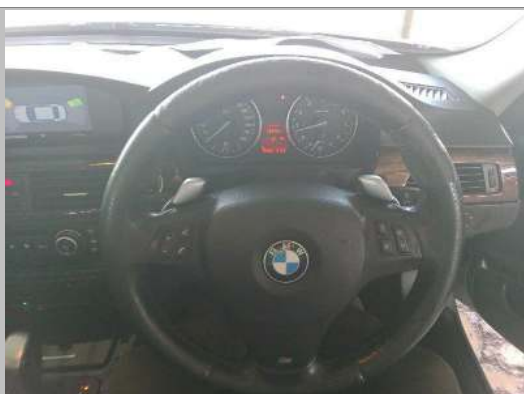
| Damage | Repair Way |
|---|---|
| Steering Wheel Trim Worn | Repair |
