## CONDITION REPORT

Report No: 2016608489

MFC Auction House  
M57 Pretoria Rd, Glenmarais, KEMPTON PARK  
Gauteng

| Model | X5 XDRIVE40D DSL AT [2010-2014] | Register Number | |

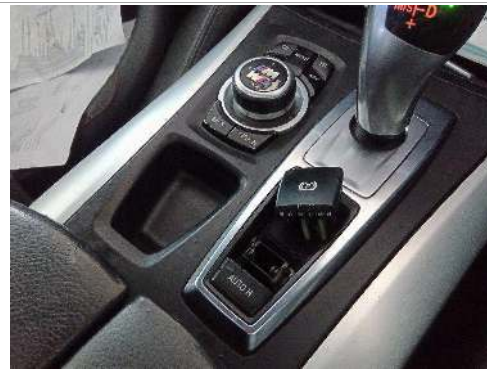
| Damage | Repair Way |
|---|---|
| brakes | electronic handbrake switch damaged |

electronic brake switch damage

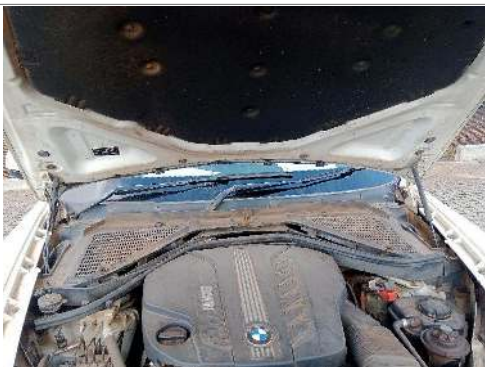
| Damage | Repair Way |
|---|---|
| Bonnet stay and shocks Damaged | Replace |

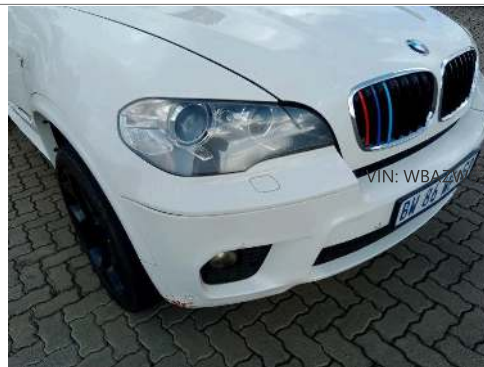
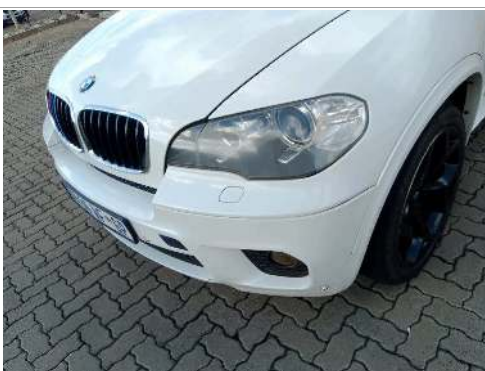
| Damage | Repair Way |
|---|---|
| Front Bumper Damaged | Repair |

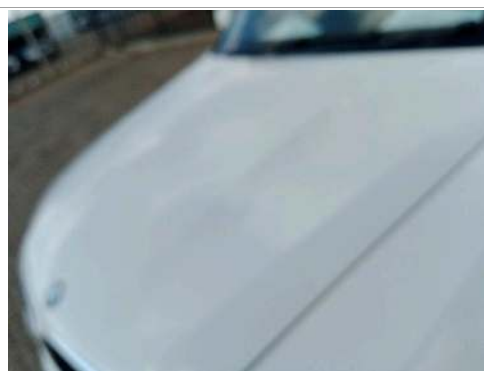
| Damage | Repair Way |
|---|---|
| Bonnet Damaged | Repair |

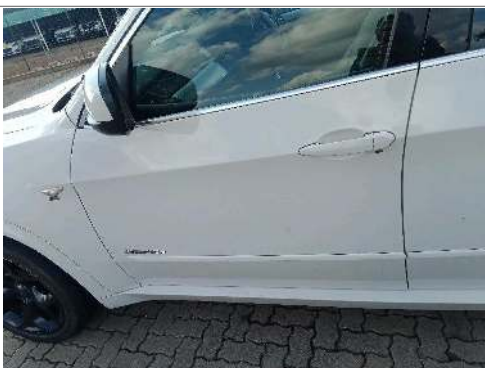
| Damage | Repair Way |
|---|---|
| Door Front Left Damaged | Repair |

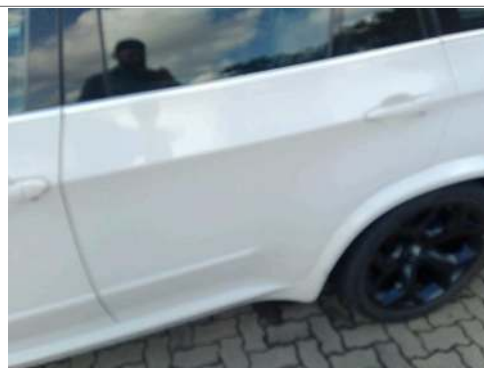
| Damage | Repair Way |
|---|---|
| Door Rear Left Damaged | Repair |

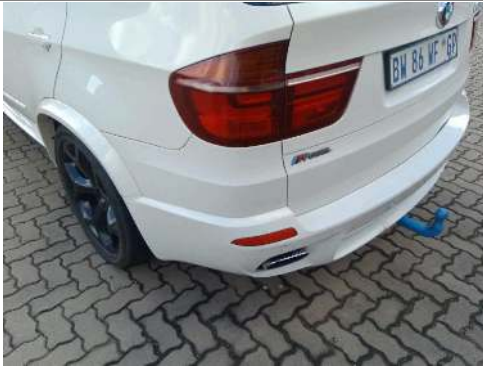
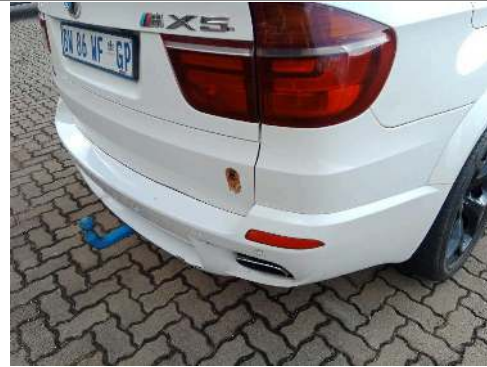
| Damage | Repair Way |
|---|---|
| Rear bumper Damaged | Repair |

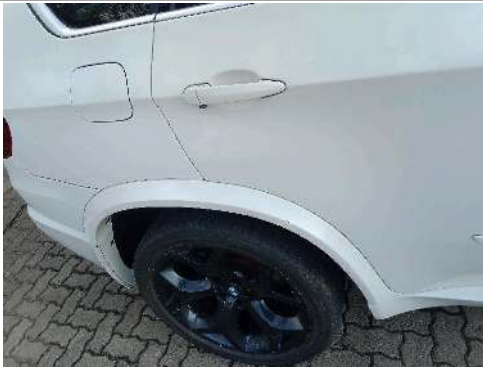
| Damage | Repair Way |
|---|---|
| Rear Fender Right Damaged | Repair |

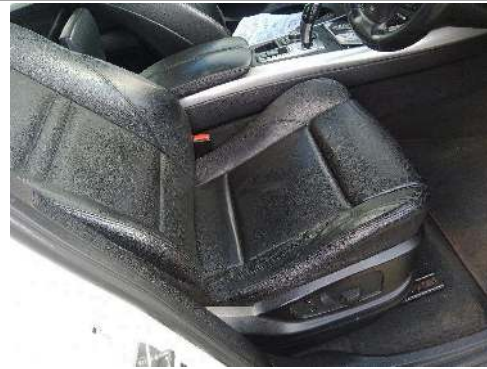
| Damage | Repair Way |
|---|---|
| Seat Front Right Damaged | Repair |

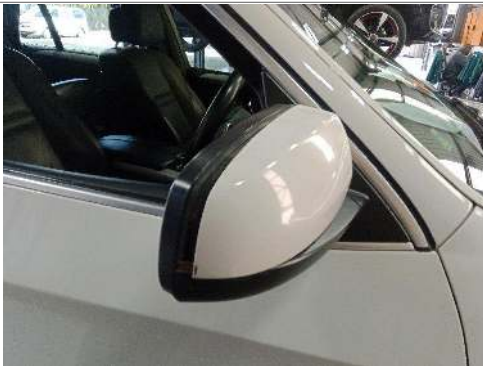
| Damage | Repair Way |
|---|---|
| Side Mirror Right Damaged | Repair |

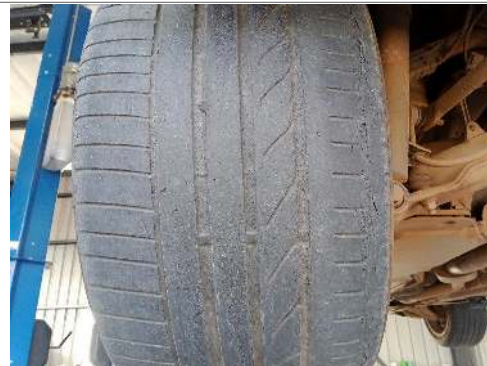
| Damage | Repair Way |
|---|---|
| Tyre Rear Left Worn | Replace |

| | Size | Load/Speed Index | Manufacture | Model | Type* | Production Date | Tread Depth (mm) |
|---|---|---|---|---|---|---|---|
| Rear Left | 315/35R20 | 110W | Bridgestone | Radial | V | 4716 | 0 mm |

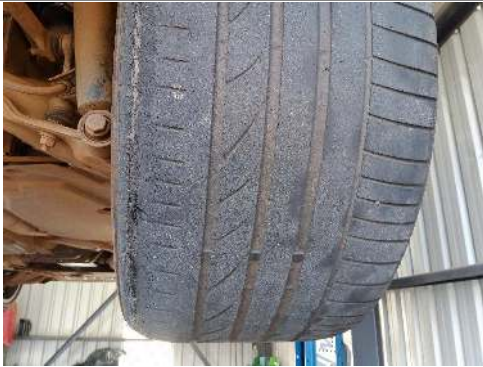
| Damage | Repair Way |
|---|---|
| Tyre Rear Right Worn | Replace |

| | Size | Load/Speed Index | Manufacture | Model | Type* | Production Date | Tread Depth (mm) |
|---|---|---|---|---|---|---|---|
| Rear Right | 315/35R20 | 110W | Bridgestone | Radial | V | 4716 | 0 mm |

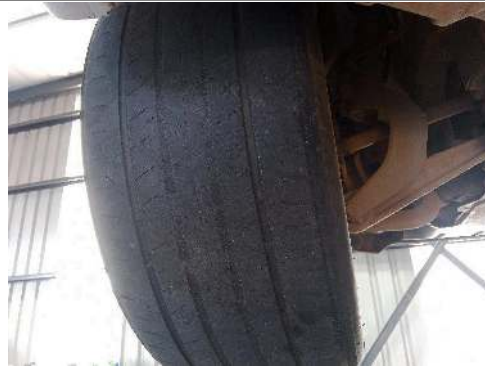
| Damage | Repair Way |
|---|---|
| Tyre Front Left Worn | Replace |

| | Size | Load/Speed Index | Manufacture | Model | Type* | Production Date | Tread Depth (mm) |
|---|---|---|---|---|---|---|---|
| Front Left | 275/40R20 | 106W | Bridgestone | Radial | V | 1421 | 0 mm |

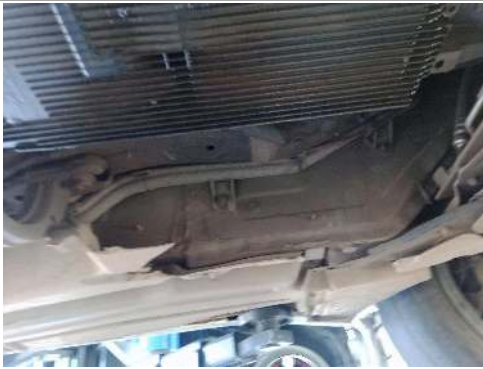
| Damage | Repair Way |
|---|---|
| Prop Shaft Damaged | Repair |

Road Test: front prop shop missing from x drive system. vehicle suspension not working correctly vehicle unsafe to drive.

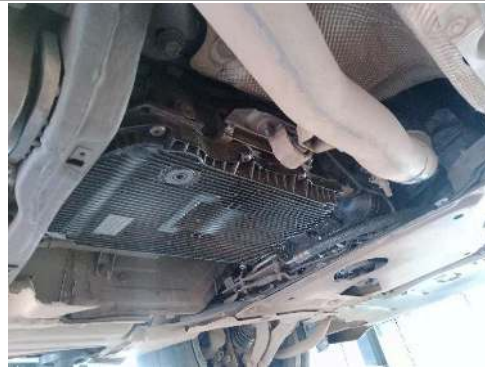
| Damage | Repair Way |
|---|---|
| Gearbox Oil Leak | Repair |

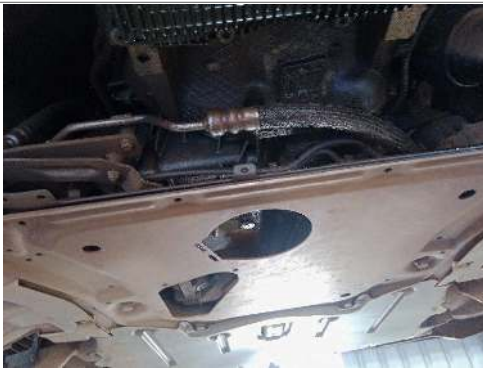
| Damage | Repair Way |
|---|---|
| Engine Oil Leak | Repair |

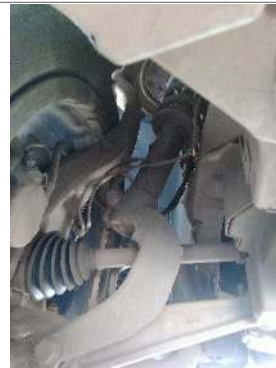
| Damage | Repair Way |
|---|---|
| Shock Absorber Front Left Worn | Replace |

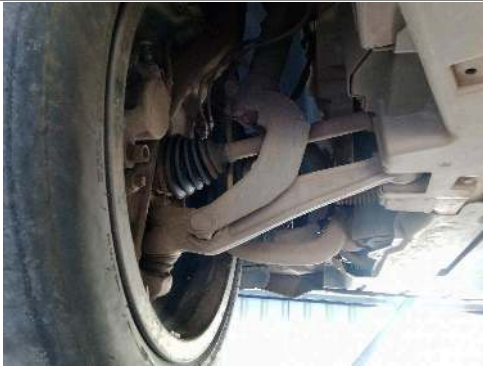
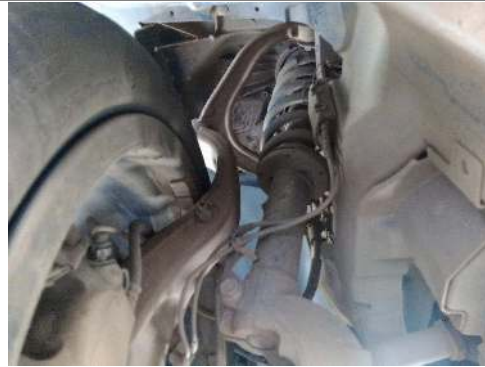
| Damage | Repair Way |
|---|---|
| Control Arm Bush(es) Front Axle Left Worn | Replace |

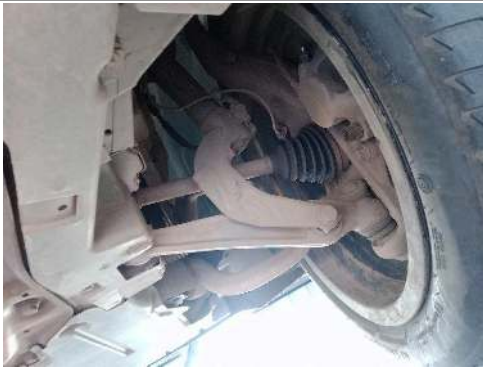
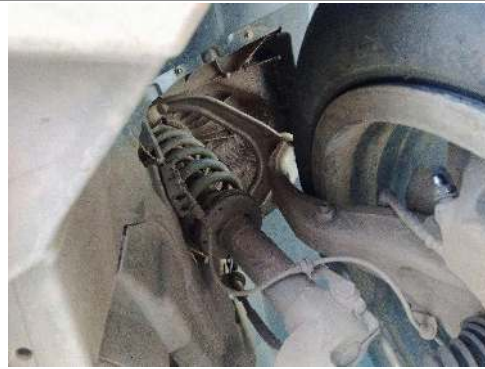
| Damage | Repair Way |
|---|---|
| Control Arm Bush(es) Front Axle Right Worn | Replace |

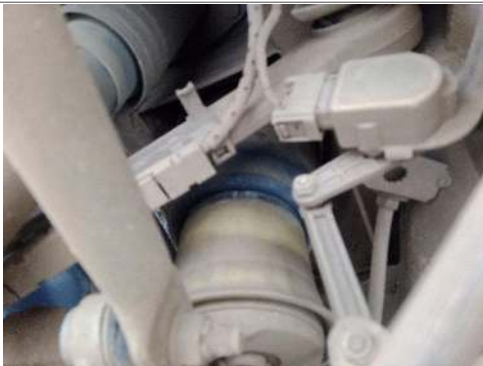
| Damage | Repair Way |
|---|---|
| Air Suspension Rear Left Damaged | Replace |

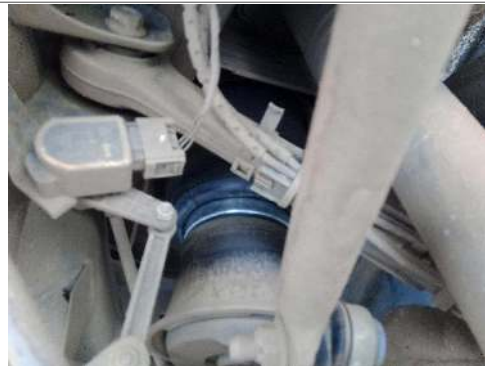
| Damage | Repair Way |
|---|---|
| Air Suspension Rear Right Damaged | Replace |

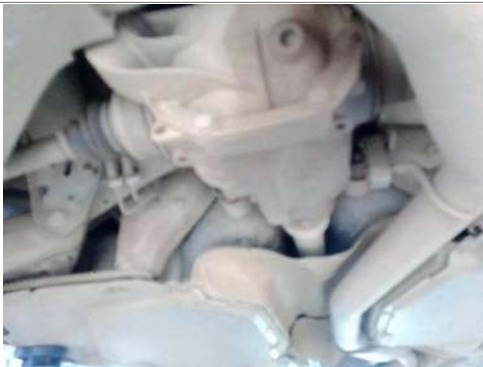
| Damage | Repair Way |
|---|---|
| Differential Oil Leak | Repair |
