## CONDITION REPORT

Report No: 2016871497

| Manufacturer | MERCEDES-BENZ | Registration Number | HT29KVG |
| Model | C250 CDI BLUEEFFICIENCY DSL 7-SP AT (2011-2014) | Register Number | |

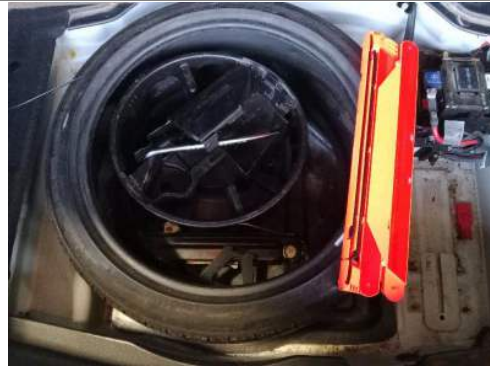
Spare tyre and Accessories

| Damage | Repair Way |
|---|---|
| Tyres and rims | Only loose tyre inside boot of vehicle |

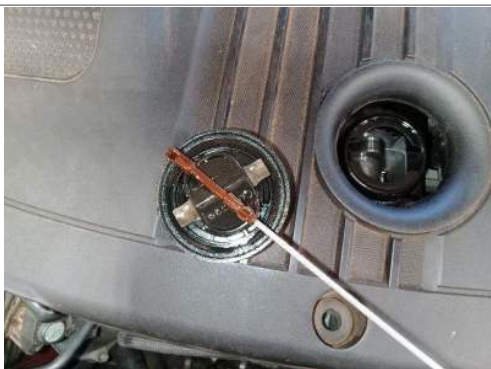
Oil cap and dipstick

| Damage | Repair Way |
|---|---|
| Dipstick holder broken | Replace |

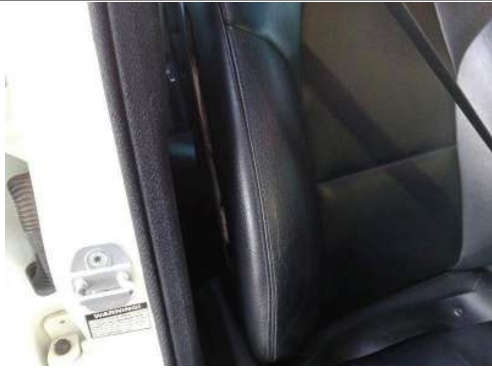
| Damage | Repair Way |
|---|---|
| Seat Front Right Damaged | Repair |

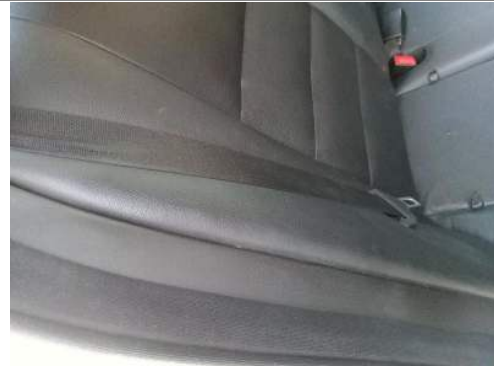
| Damage | Repair Way |
|---|---|
| Seat Belt Rear Right Damaged | Replace |

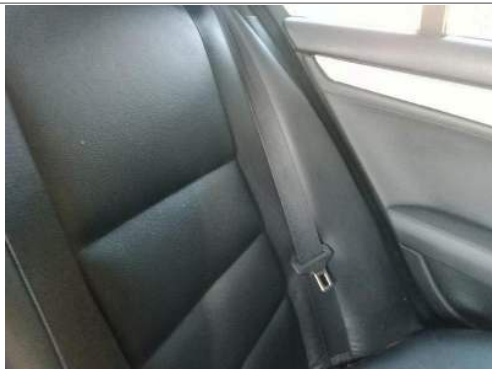
| Damage | Repair Way |
|---|---|
| Seat Belt Rear Left Damaged | Repair |

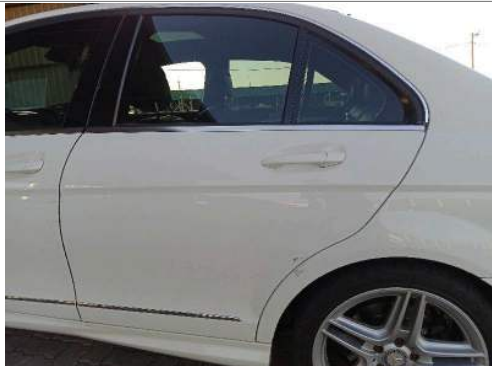
| Damage | Repair Way |
|---|---|
| Door Rear Left Paintwork • Scratched | Repair |

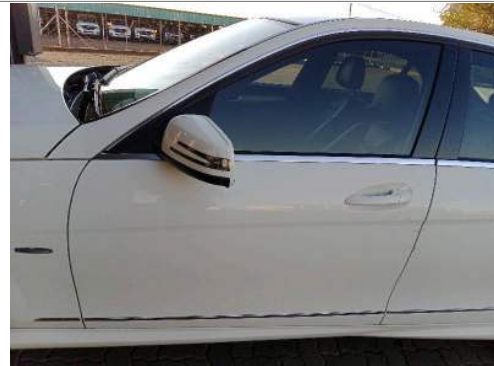
| Damage | Repair Way |
|---|---|
| Door Front Left Paintwork • Scratched | Repair |

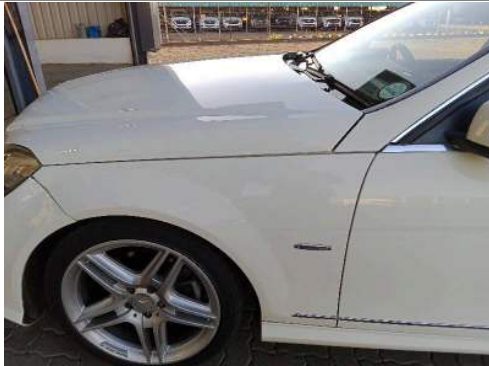
| Damage | Repair Way |
|---|---|
| Front Fender Left Residual Traces of Repair | Repair |

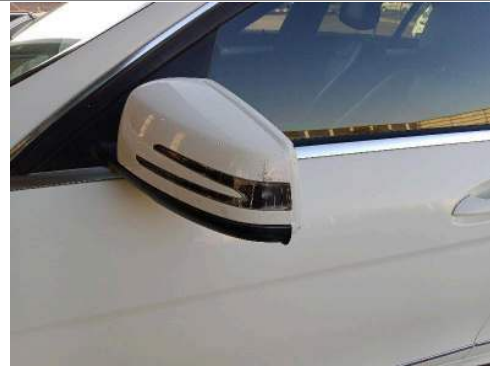
| Damage | Repair Way |
|---|---|
| Indicator Light Front Left Damaged | Replace |

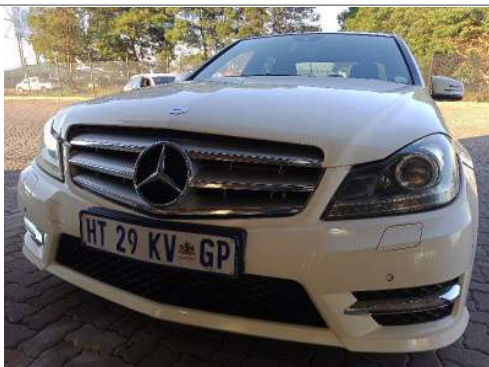
| Damage | Repair Way |
|---|---|
| Front Bumper Damaged | Repair |

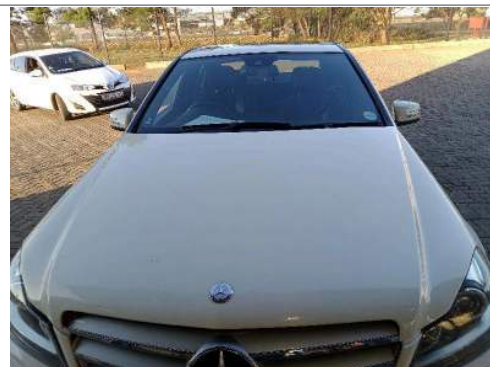
| Damage | Repair Way |
|---|---|
| Bonnet Residual Traces of Repair | Repair |

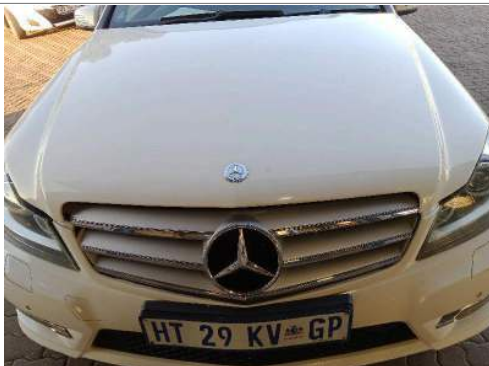
| Damage | Repair Way |
|---|---|
| Grill Damaged | Replace |

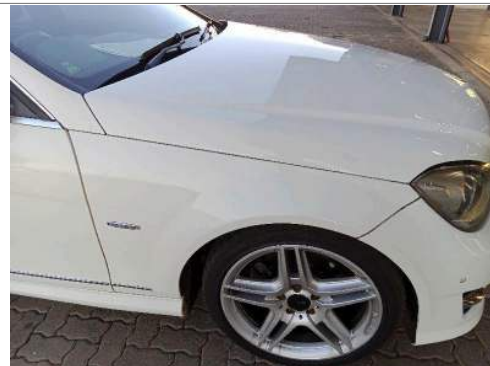
| Damage | Repair Way |
|---|---|
| Front Fender Right Residual Traces of Repair | Repair |

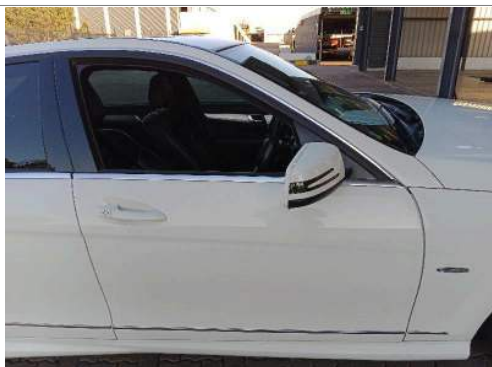
| Damage | Repair Way |
|---|---|
| Door Front Right Residual Traces of Repair | Repair |

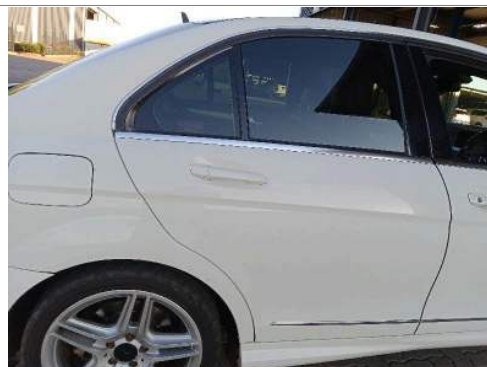
| Damage | Repair Way |
|---|---|
| Door Rear Right Residual Traces of Repair | Repair |

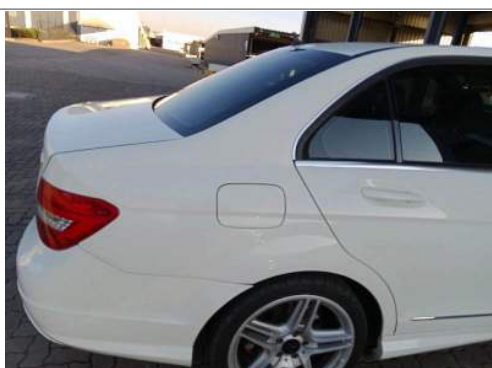
| Damage | Repair Way |
|---|---|
| Rear Fender Right Paintwork • Scratched | Repair |

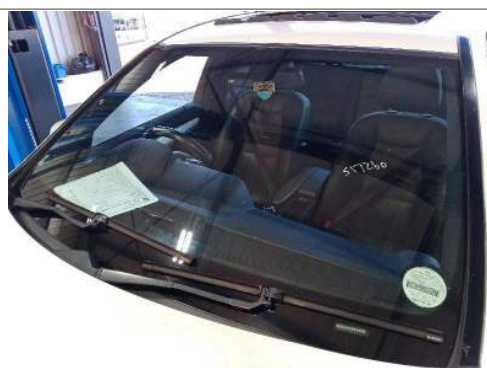
| Damage | Repair Way |
|---|---|
| Windscreen Chipped | Repair |

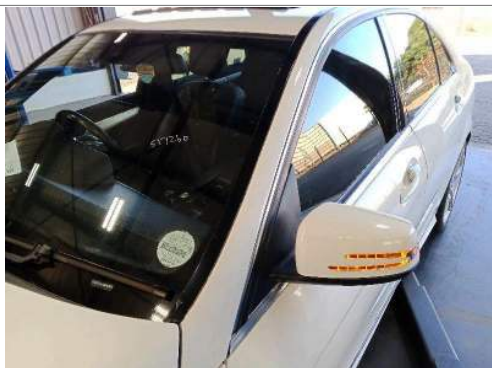
| Damage | Repair Way |
|---|---|
| A • Pillar Left Residual Traces of Repair | Repair |

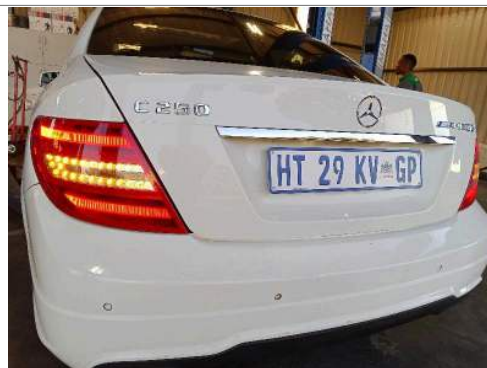
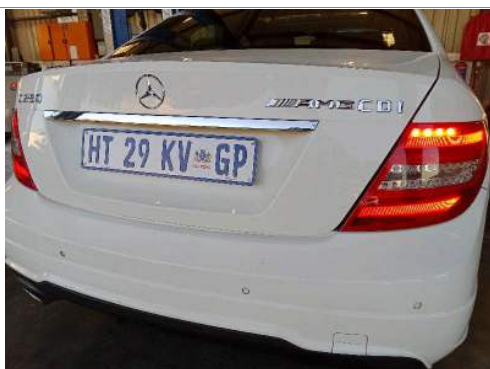
| Damage | Repair Way |
|---|---|
| Rear bumper Damaged | Repair |

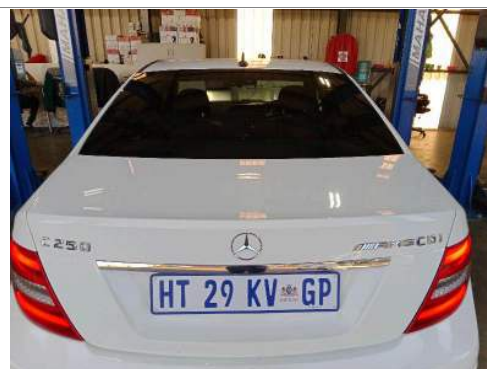
| Damage | Repair Way |
|---|---|
| Boot Lid / Hatch door Paintwork • Chipmarks | Repair |

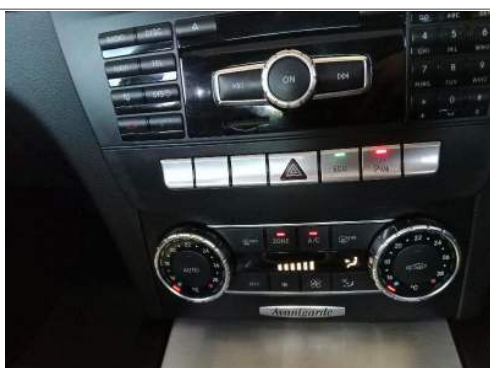
| Damage | Repair Way |
|---|---|
| Air Conditioner Insufficient | Replace |

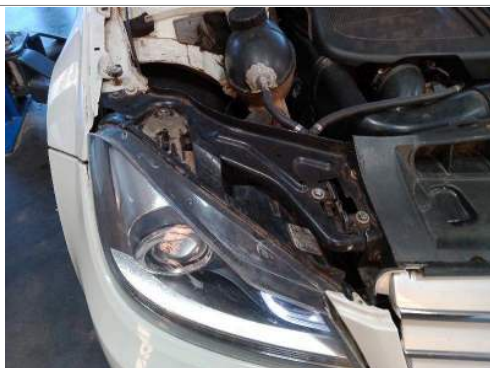
| Damage | Repair Way |
|---|---|
| Headlight Right Damaged | Replace |

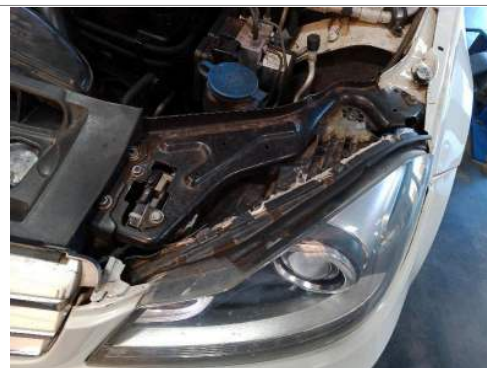
| Damage | Repair Way |
|---|---|
| Headlight Left Damaged | Replace |

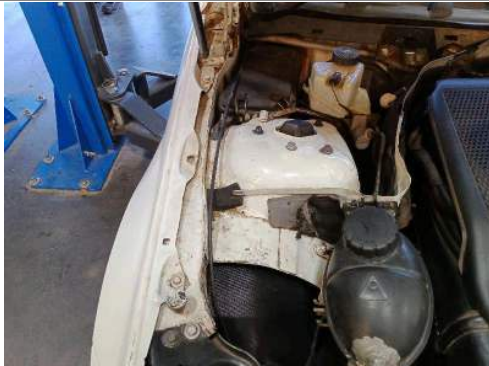
| Damage | Repair Way |
|---|---|
| Front Fender Right / Inner Tray Damaged | Repair |

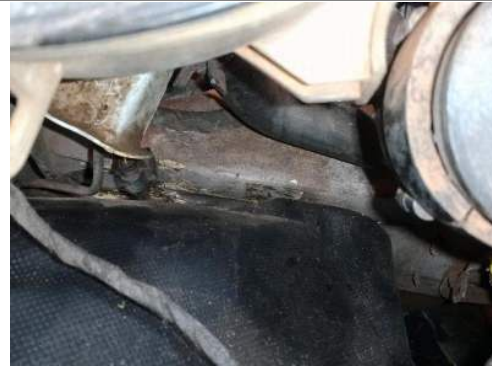
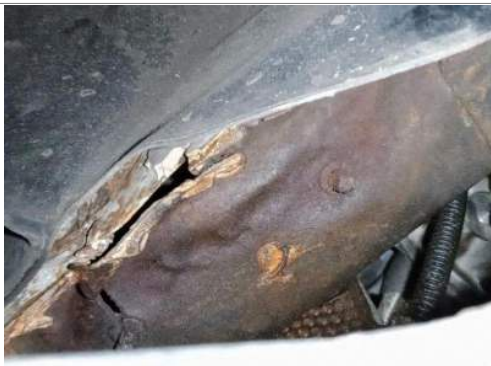
| Damage | Repair Way |
|---|---|
| Main Beam Right Welded | Repair |
| Body and Exterior | Vehicle safety integrity compromised |
| Body and Exterior | Vehicle a cut and joint on front right main beam |

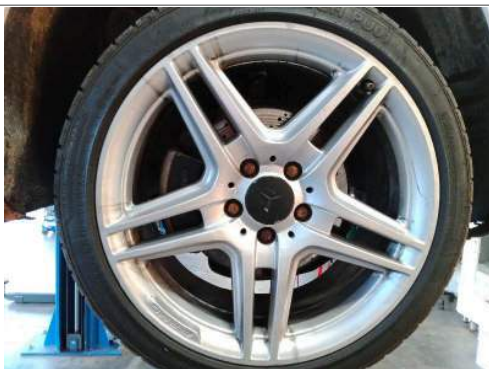
| Damage | Repair Way |
|---|---|
| Rim Front Right Defective | Repair |

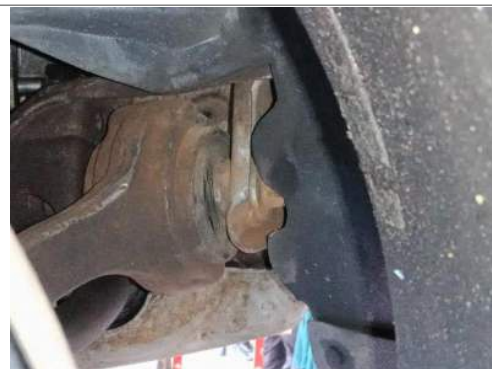
| Damage | Repair Way |
|---|---|
| Control Arm Bush(es) Front Axle Right Cracked | Replace |

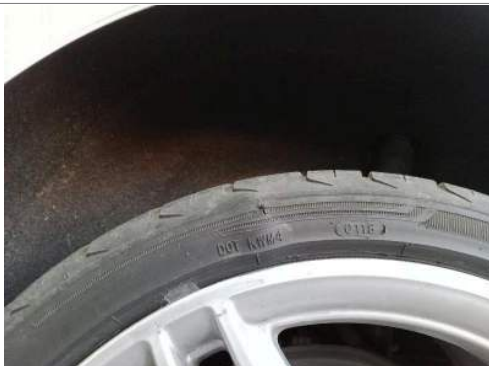
| Damage | Repair Way |
|---|---|
| Tyre Rear Left Damaged | Replace |

| | Size | Load/Speed Index | Manufacture | Model | Type* | Production Date | Tread Depth (mm) |
|---|---|---|---|---|---|---|---|
| Rear Left | 255/35Z R18 | 94W | Toledo | TL1000 | V | 0118 | 0 mm |

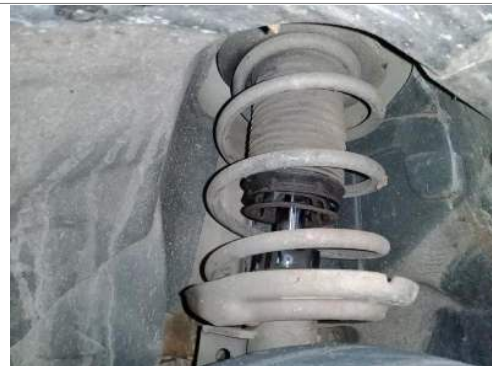
| Damage | Repair Way |
|---|---|
| Shock Absorber Front Left Leak | Replace |

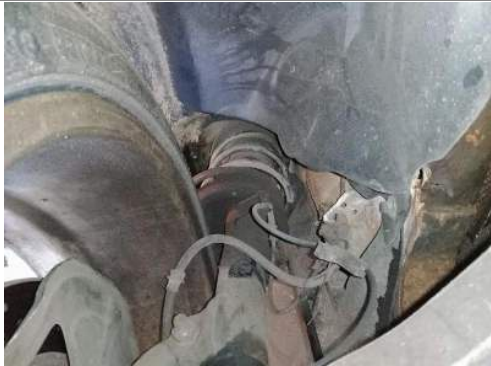
| Damage | Repair Way |
|---|---|
| Shock Absorber Front Right Leak | Replace |

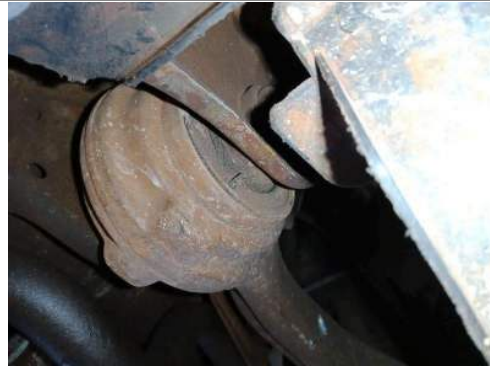
| Damage | Repair Way |
|---|---|
| Control Arm Bush(es) Front Axle Left Cracked | Replace |

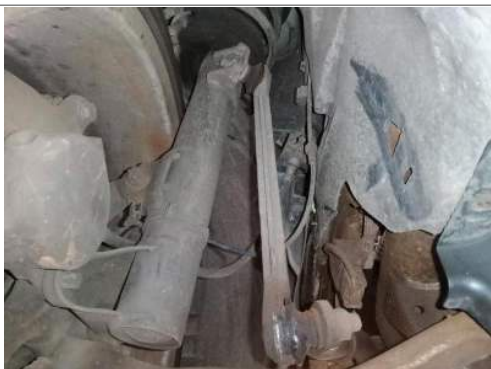
| Damage | Repair Way |
|---|---|
| Stabilizer Mounting Front Left Damaged | Replace |

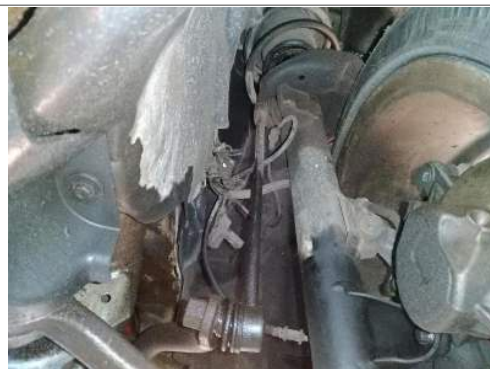
| Damage | Repair Way |
|---|---|
| Stabilizer Mounting Front Right Defective | Replace |

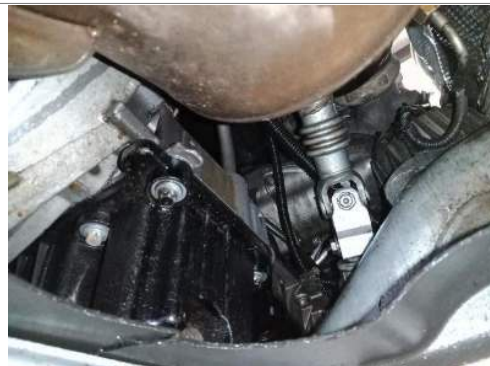
| Damage | Repair Way |
|---|---|
| Engine Oil Leak | Repair |

| Damage | Repair Way |
|---|---|
| Engine Smoke Excessive | Repair |

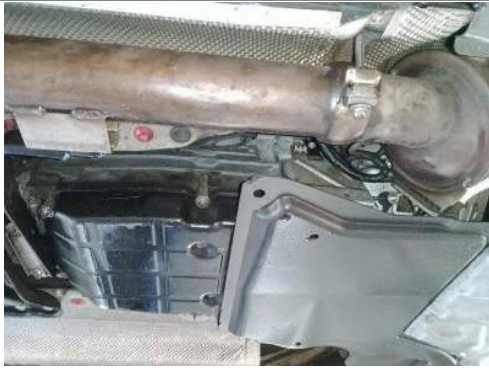
| Damage | Repair Way |
|---|---|
| Gearbox Oil Leak | Repair |

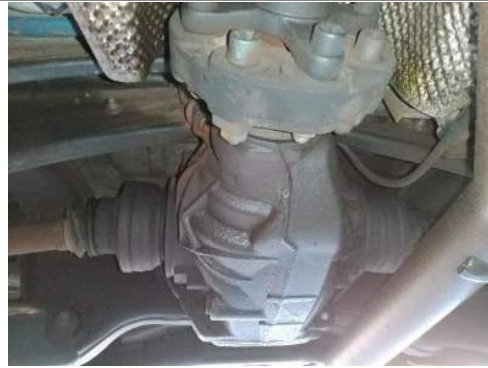
| Damage | Repair Way |
|---|---|
| Differential Oil Leak | Repair |

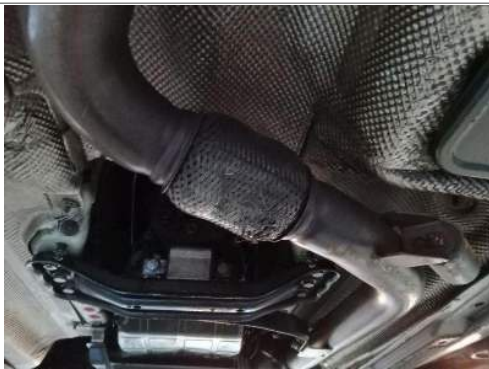
| Damage | Repair Way |
|---|---|
| Engine to silencer pipe Damaged | Repair |

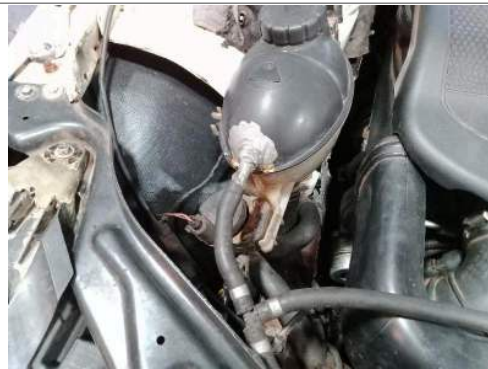
| Damage | Repair Way |
|---|---|
| Hoses Defective | Replace |

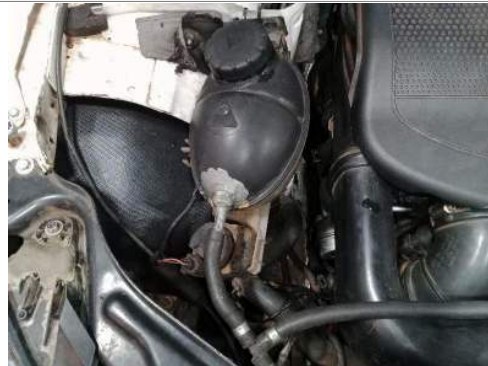
| Damage | Repair Way |
|---|---|
| Expansion Bottle Damaged | Replace |

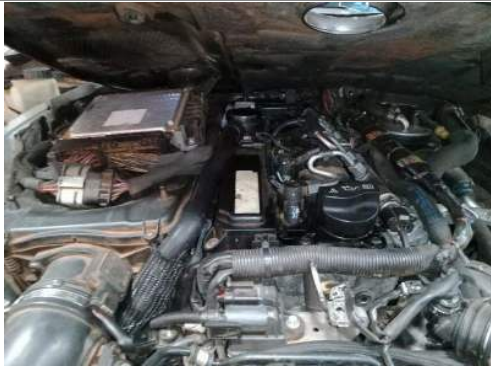
| Damage | Repair Way |
|---|---|
| Engine Wiring Defective | Repair |

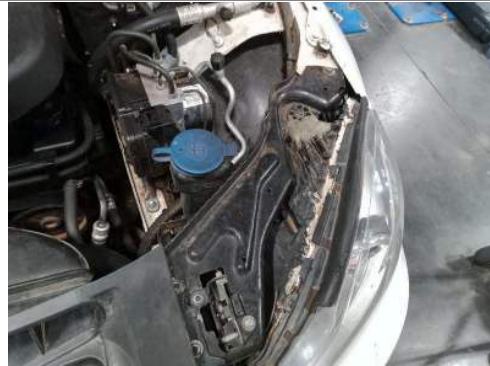
| Damage | Repair Way |
|---|---|
| Bonnet slam plate (Shock tower/ Inner tray) Dented | Repair |

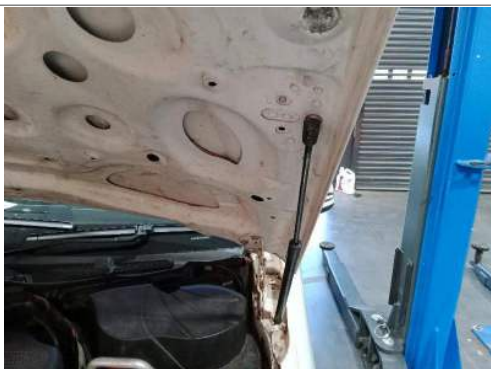
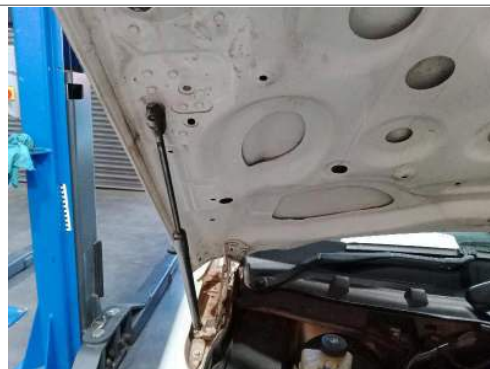
| Damage | Repair Way |
|---|---|
| Bonnet stay and shocks Damaged | Replace |

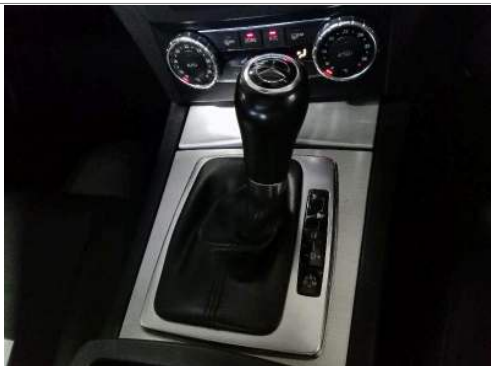
| Damage | Repair Way |
|---|---|
| Gear Selections Malfunction | Repair |
