MFC Auction House  
M57 Pretoria Rd, Glenmarais, KEMPTON PARK  
Gauteng

| Manufacturer | MERCEDES-BENZ | Registration Number | CY56973 |

## CONDITION REPORT

Report No: 2016219037

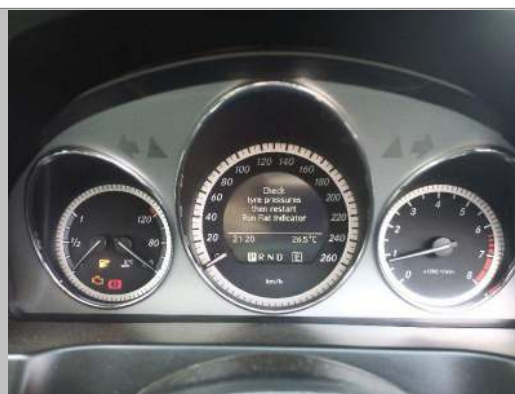
DASHBOARD (W/ ENGINE RUNNING)

General Comments: ACCORDING TO AGE AND MILEAGE OF VEHICLE NORMAL WEAR AND TEAR ON INTERIOR, EXTERIOR, ELECTRICAL AND MECHANICAL PARTS. SHOCK ABSORBER TEST NOT PERFORMED. ENGINE MANAGEMENT LIGHTS ILLUMINATED ON CLUSTER. VEHICLE ELECTRONICS MALFUNCTIONING.

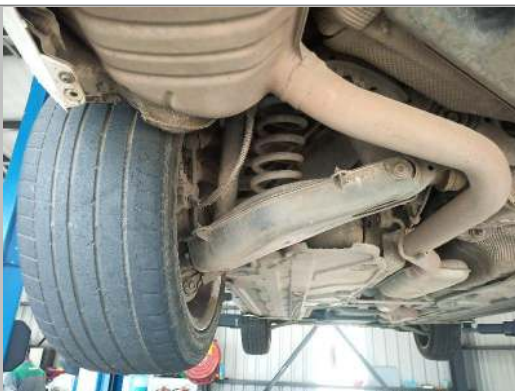
LR TYRE TREAD

| | Size | Load/Speed Index | Manufacture | Model | Type* | Production Date | Tread Depth (mm) |
|---|---|---|---|---|---|---|---|
| Rear Left | 225/45R17 | 94W | Achilles | Radial | V | 4017 | 0 mm |

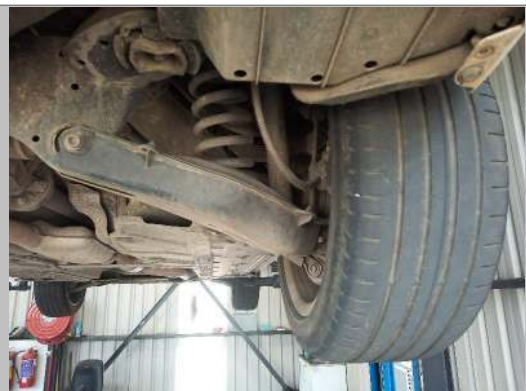
RR TYRE TREAD

| | Size | Load/Speed Index | Manufacture | Model | Type* | Production Date | Tread Depth (mm) |
|---|---|---|---|---|---|---|---|
| Rear Right | 225/45R17 | 94Y | Goodyear | Eagle | V | 2714 | 0 mm |

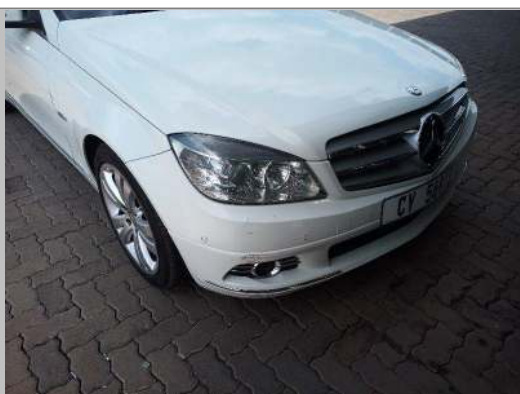
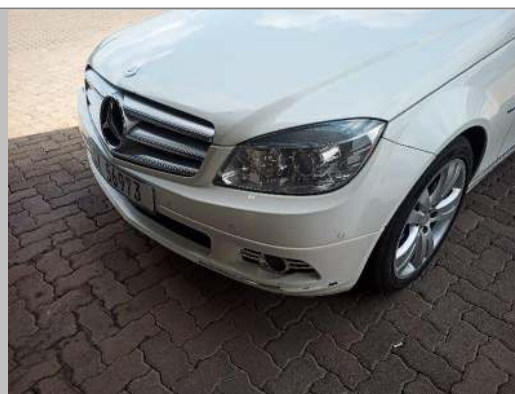
| | Damage | Repair Way |
|---|---|---|
| | Front Bumper Damaged | Repair |

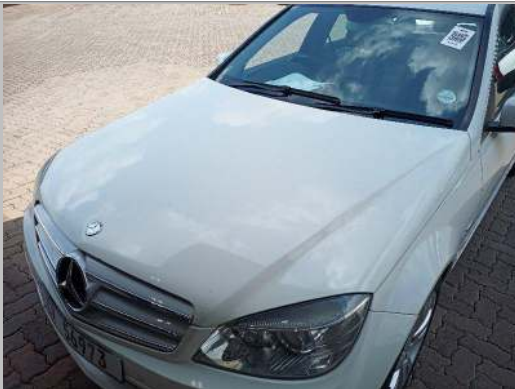
| | Damage | Repair Way |
|---|---|---|
| | Bonnet Damaged | Repair |

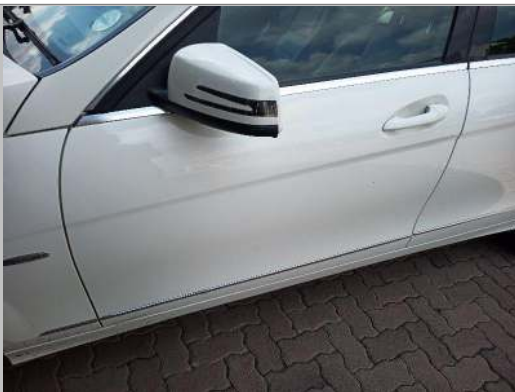
| | Damage | Repair Way |
|---|---|---|
| | Door Front Left Damaged | Repair |

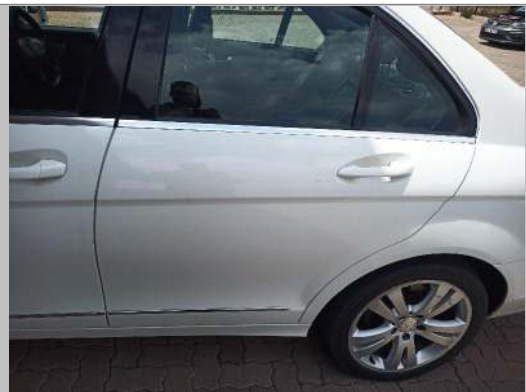
| | Damage | Repair Way |
|---|---|---|
| | Door Rear Left Damaged | Repair |

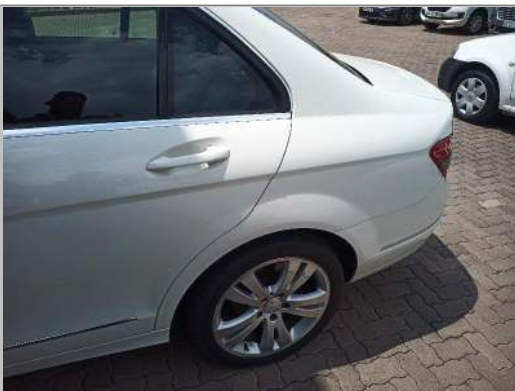
| | Damage | Repair Way |
|---|---|---|
| | Rear Fender Left Damaged | Repair |

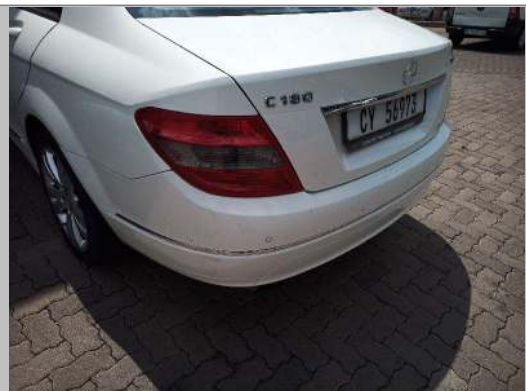
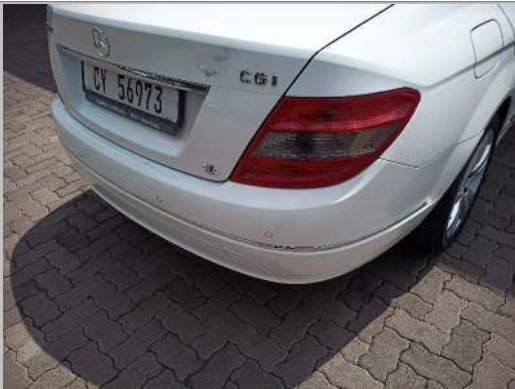
| | Damage | Repair Way |
|---|---|---|
| | Rear bumper Damaged | Repair |

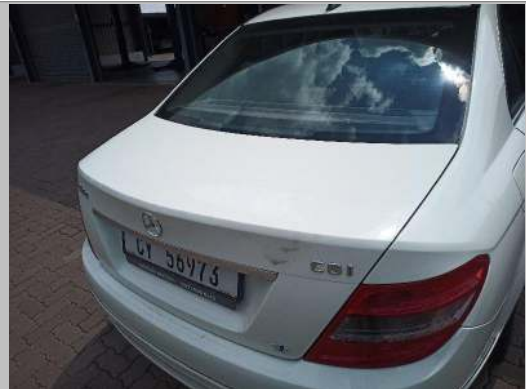
| | Damage | Repair Way |
|---|---|---|
| | Boot Lid / Hatch door Damaged | Repair |

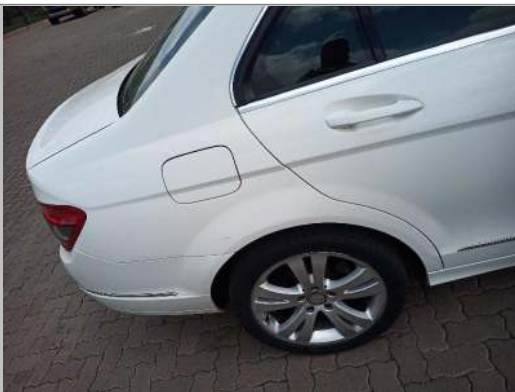
| | Damage | Repair Way |
|---|---|---|
| | Rear Fender Right Damaged | Repair |

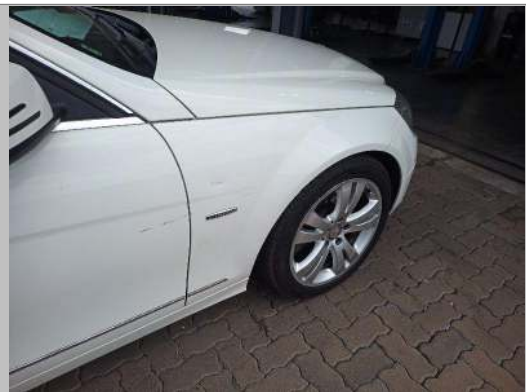
| | Damage | Repair Way |
|---|---|---|
| | Front Fender Right Damaged | Repair |

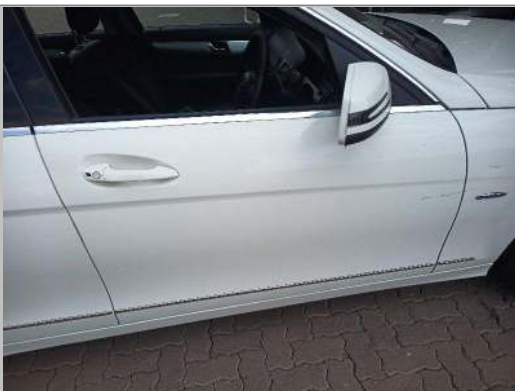
| | Damage | Repair Way |
|---|---|---|
| | Door Front Right Damaged | Repair |

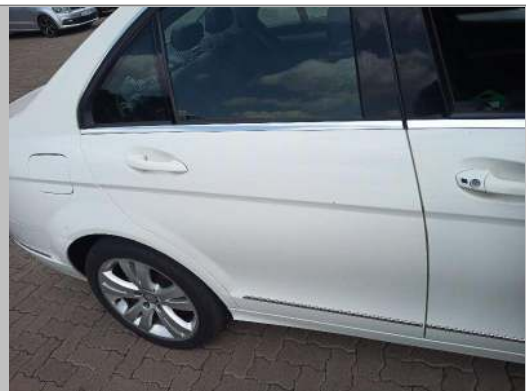
| | Damage | Repair Way |
|---|---|---|
| | Door Rear Right Damaged | Repair |

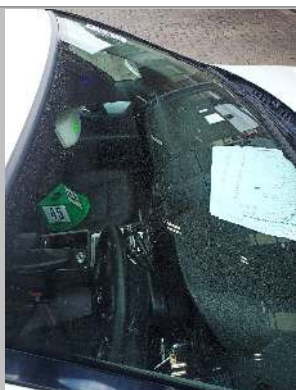
| | Damage | Repair Way |
|---|---|---|
| | Windscreen Chipped | Replace |

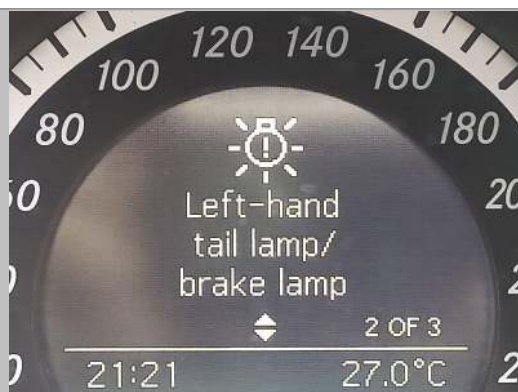
| | Damage | Repair Way |
|---|---|---|
| | Brake Light Left Defective | Repair |

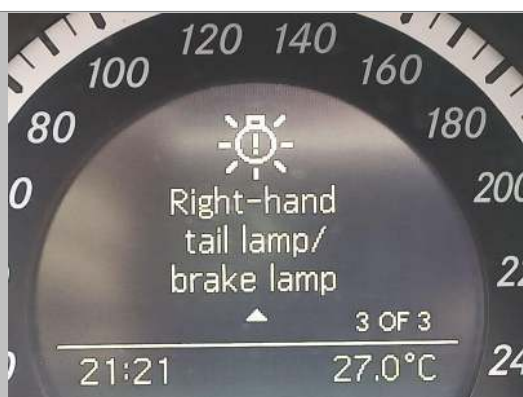
| | Damage | Repair Way |
|---|---|---|
| | Brake Light Right Defective | Replace |

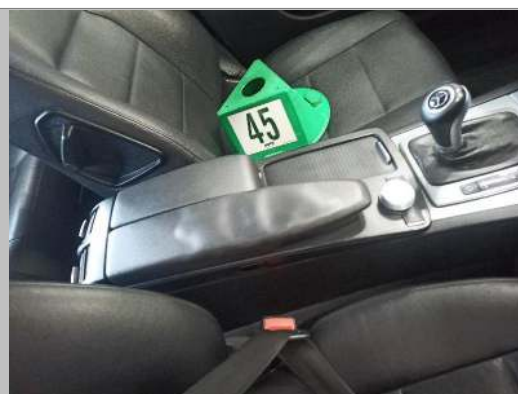
| | Damage | Repair Way |
|---|---|---|
| | Center Console / Cubbyhole + Lid Damaged | Repair |

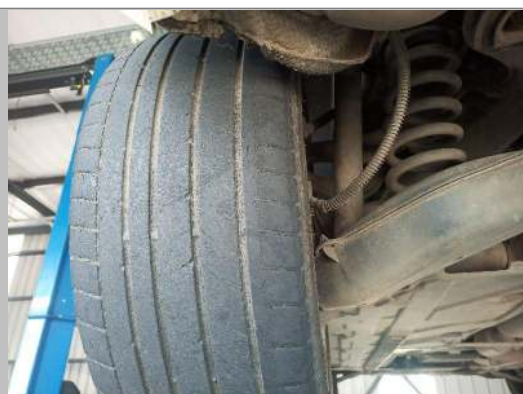
| | Damage | Repair Way |
|---|---|---|
| | Tyre Rear Left Worn | Replace |

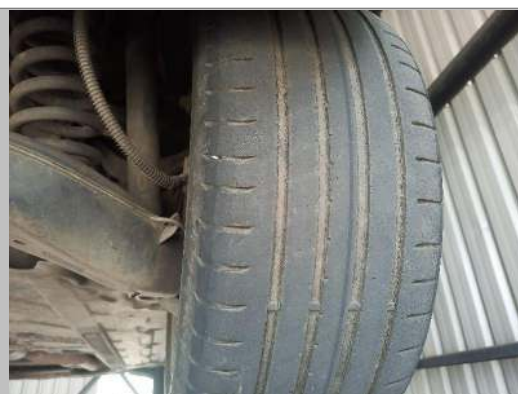
| | Damage | Repair Way |
|---|---|---|
| | Tyre Rear Right Worn | Replace |

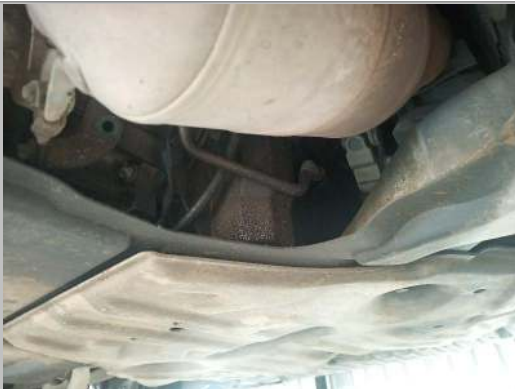
| | Damage | Repair Way |
|---|---|---|
| | Engine Oil Leak | Repair |

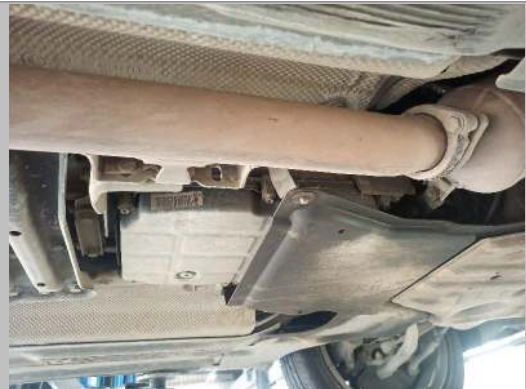
| | Damage | Repair Way |
|---|---|---|
| | Gearbox Oil Leak | Repair |

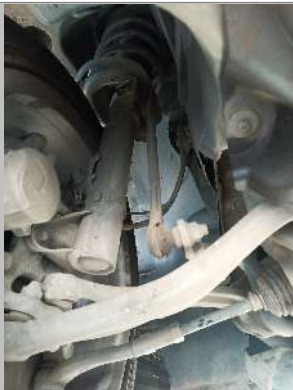
| | Damage | Repair Way |
|---|---|---|
| | Stabilizer Mounting Front Left Damaged | Replace |

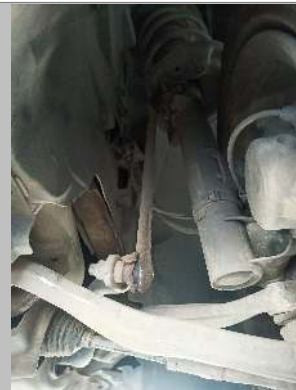
| | Damage | Repair Way |
|---|---|---|
| | Stabilizer Mounting Front Right Damaged | Replace |

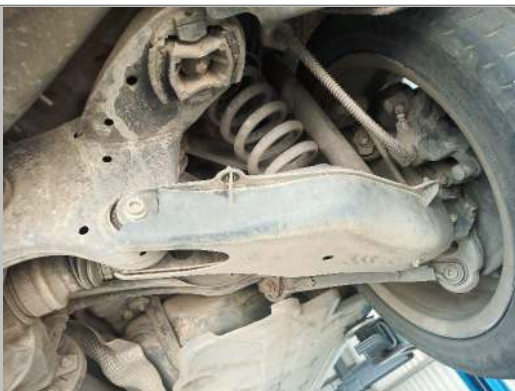
| | Damage | Repair Way |
|---|---|---|
| | Control Arm Bush(es) Rear Axle Right Worn | Replace |

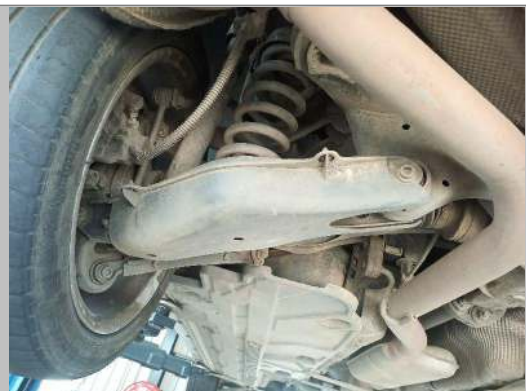
| | Damage | Repair Way |
|---|---|---|
| | Control Arm Bush(es) Rear Axle Left Worn | Replace |

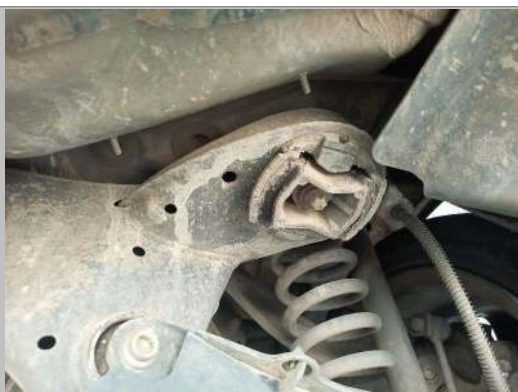
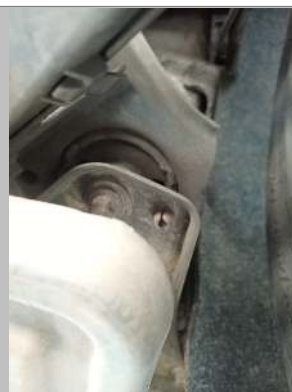
| | Damage | Repair Way |
|---|---|---|
| | Mounting rubber(s) Rear Right Worn | Replace |

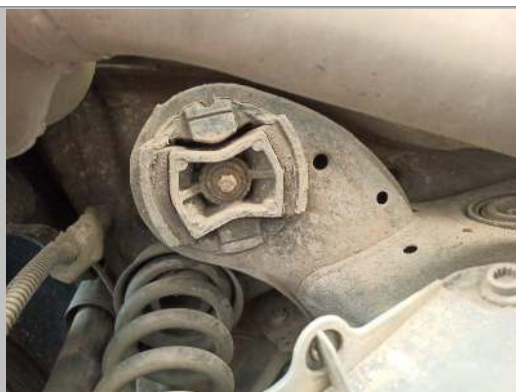
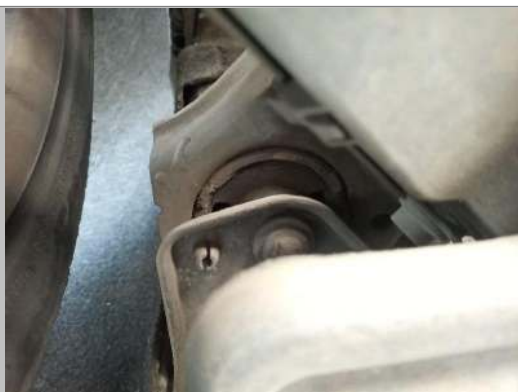
| | Damage | Repair Way |
|---|---|---|
| | Mounting rubber(s) Rear Left Worn | Replace |
