CONDITION REPORT

Report No: 2016200569

MFC Auction House
M57 Pretoria Rd, Glenmarais, KEMPTON PARK
Gauteng

Vehicle Type	PASSENGER VEHICLE	Registered Owner	MFC
Manufacturer	MERCEDES-BENZ	Registration Number	JW08DZGP
Model	C180	Register Number	
VIN	WDD2050402R293345	Date Of First Licensing	
Engine Number		Last COR	
Doors	4	License Expiry Date	31/12/2023
Color	WHITE	Power / Displacement	
Year Model		Paint Finish	TWO COAT UNI
Km Reading	129,378 KM	Fuel	PETROL
Cab / Body Type	SEDAN	Transmission	AUTOMATIC

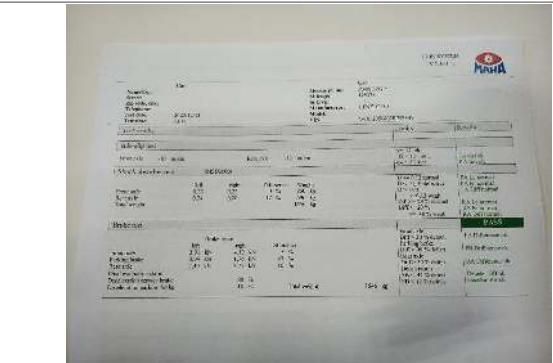
Brake and shock test

Left	Right		
	Braking Force [kN]	Braking Force [kN]	Axle Weight [kg]	Deceleration [m/s ²]
Front	3.91	4.12	-	
Rear	2.49	2.77	-	
Emergency / Parking	0.94	1.76	-

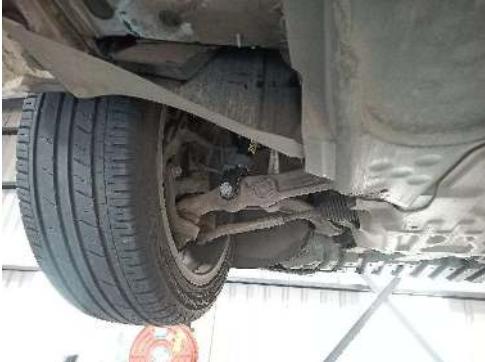
LF TYRE TREAD

Size	Load/Speed Index	Manufacture	Model	Type*	Production Date	Tread Depth (mm)
Front Left	225/45R18	95W	Royalblack	Radial	V	1322	4 mm
Front Right	225/45R18	95W	Royalblack	Radial	V	2122	3 mm
Rear Left	245/40R18	97W	Kapsen	Radial	V	1222	3 mm
Rear Right	245/40R18	97W	Kapsen	Radial	V	1222	3 mm
