MFC Auction House  
M57 Pretoria Rd, Glenmarais, KEMPTON PARK  
Gauteng

## Assignment

| Manufacturer | MERCEDES-BENZ | Registration Number | FB26NYGP |

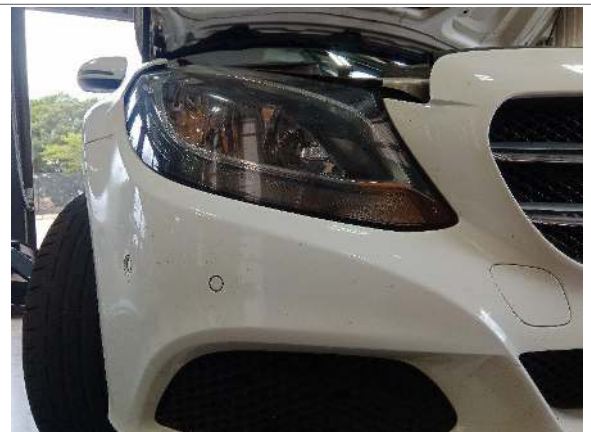
R/F day time running light def

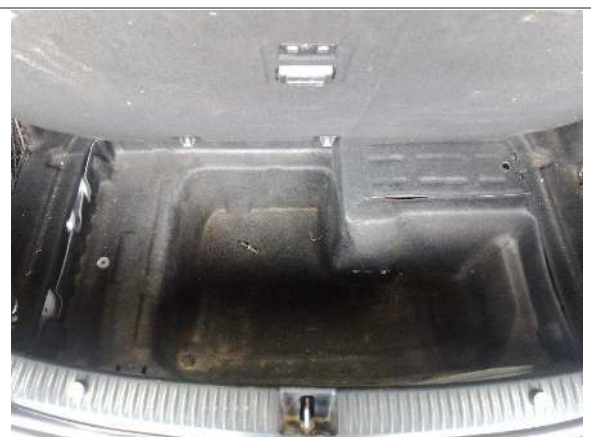
No sparewheel

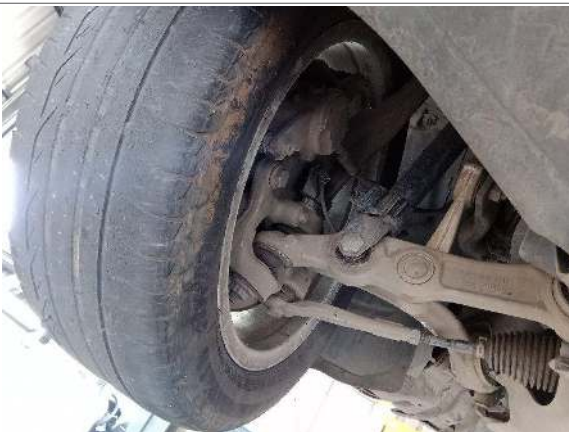
LF TYRE TREAD

| | Size | Load/Speed Index | Manufacture | Model | Type* | Production Date | Tread Depth (mm) |
|---|---|---|---|---|---|---|---|
| Front Left | 225/50R17 | 94W | Bridgestone | Turanza | V | 1815 | 1 mm |

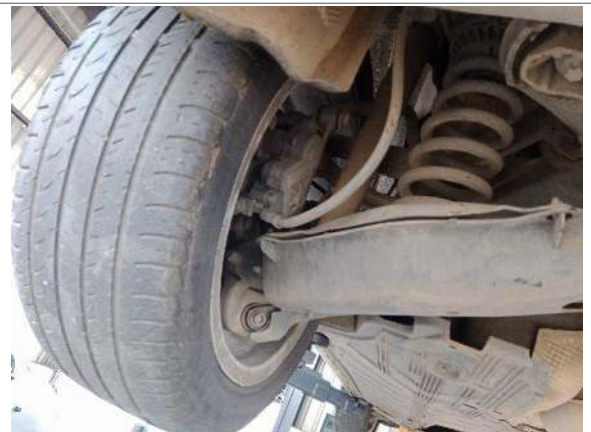
LR TYRE TREAD

| | Size | Load/Speed Index | Manufacture | Model | Type* | Production Date | Tread Depth (mm) |
|---|---|---|---|---|---|---|---|
| Rear Left | 225/45R17 | 94W | Hilo | Vantage | V | 2119 | 2 mm |

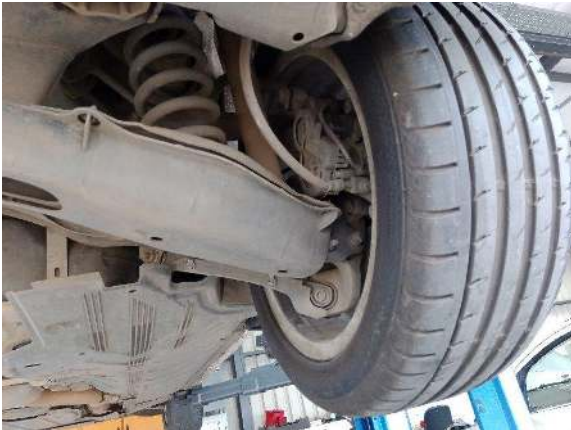
RR TYRE TREAD

| | Size | Load/Speed Index | Manufacture | Model | Type* | Production Date | Tread Depth (mm) |
|---|---|---|---|---|---|---|---|
| Rear Right | 225/45R17 | 91W | Continental | Contact | V | 1622 | 3 mm |

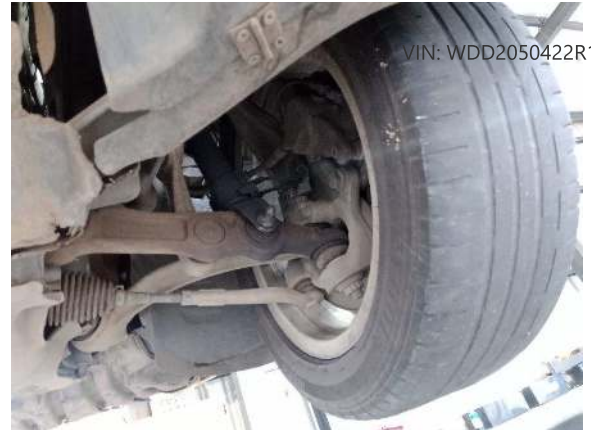
RF TYRE TREAD

| | Size | Load/Speed Index | Manufacture | Model | Type* | Production Date | Tread Depth (mm) |
|---|---|---|---|---|---|---|---|
| Front Right | 225/50R17 | 94W | Bridgestone | Potenza | V | 3520 | 1 mm |

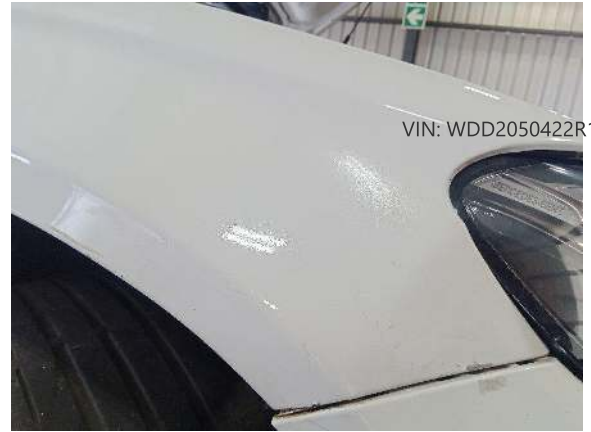
| Damage | Repair Way |
|---|---|
| Front Fender Right Dented | Repair |

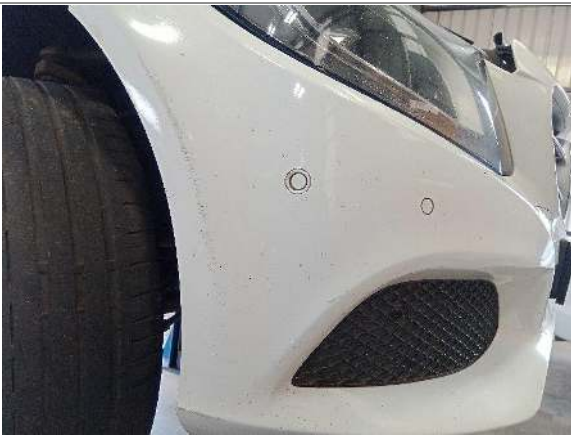
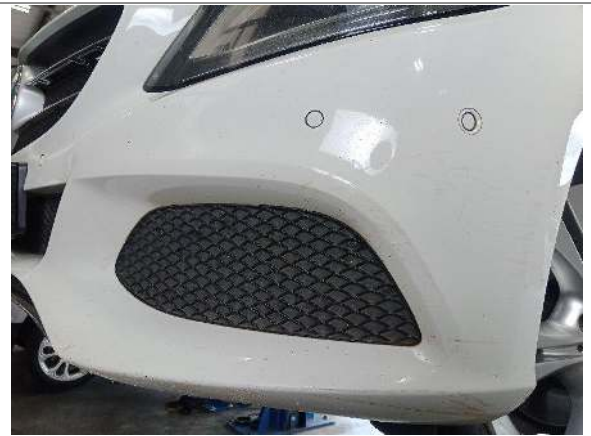
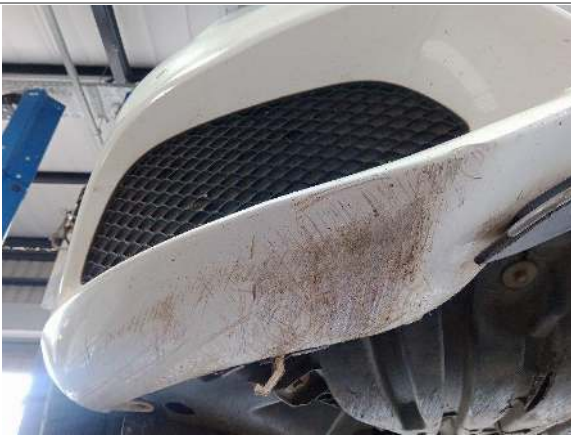
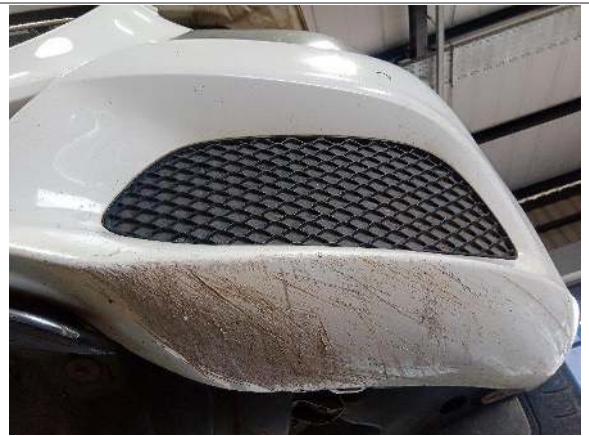
| Damage | Repair Way |
|---|---|
| Front Bumper Paintwork • Scratched | Repair |

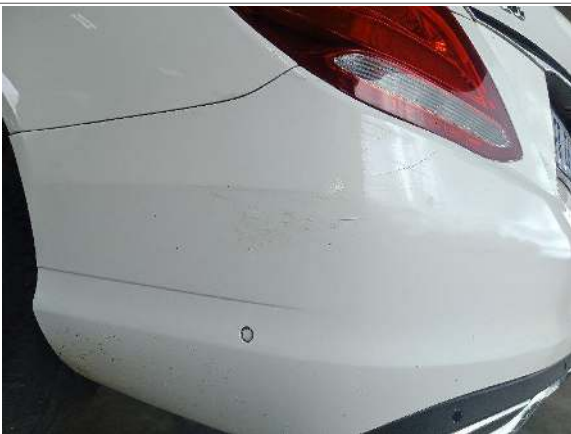
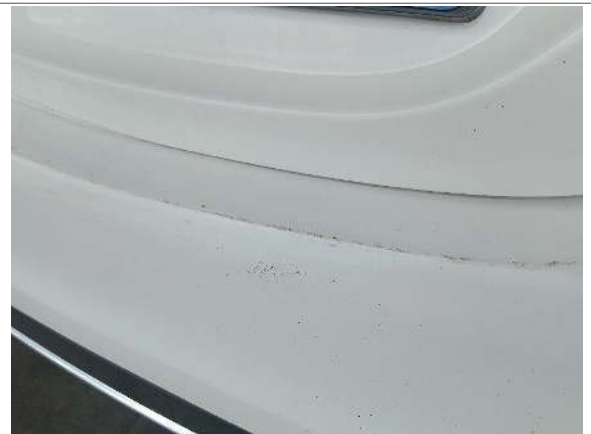
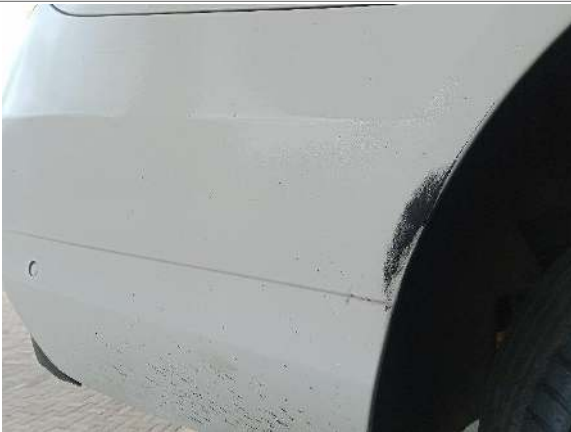
| Damage | Repair Way |
|---|---|
| Rear bumper Paintwork • Scratched | Repair |

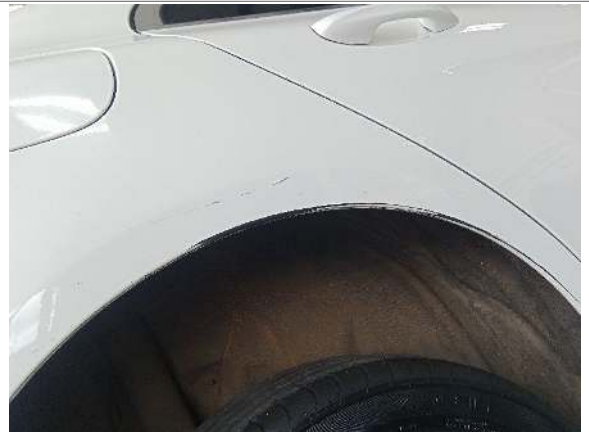
| Damage | Repair Way |
|---|---|
| Rear Fender Right Paintwork • Scratched | Repair |

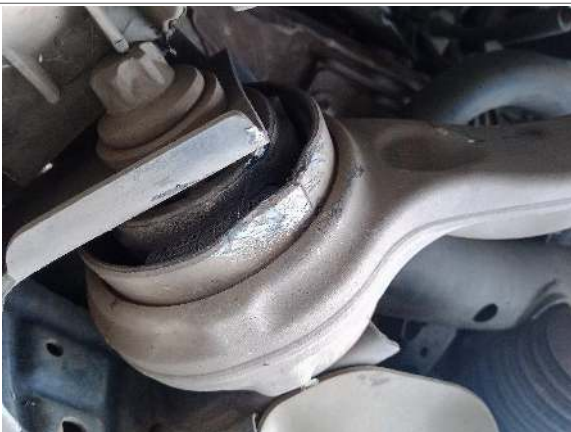
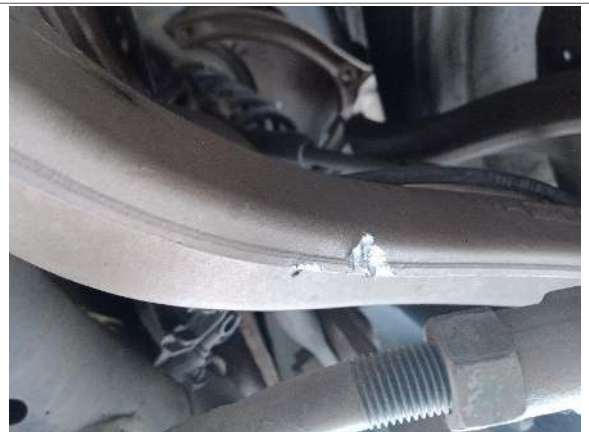
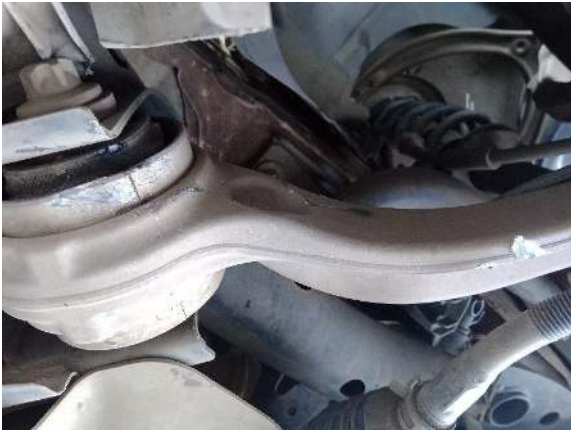
| Damage | Repair Way |
|---|---|
| Control Arm Bush(es) Front Axle Left Damaged | Replace |

General Comments: ACCORDING TO THE AGE AND MILEAGE OF THE VEHICLE NORMAL WEAR AND TEAR MARKS ON BODY INTERIOR EXTERIOR AND MECHANICAL ENGINEERING PARTS.  
Engine Compartment: Bottom of engine is fully covered.  
Body • Exterior: Minor dents scratches and stone chips on some body panels. Sings of spray work done on some body panels.  
Axle and Suspension: Excessive noise from front suspension.  
Undercarriage: Bottom of undercarriage is covered.

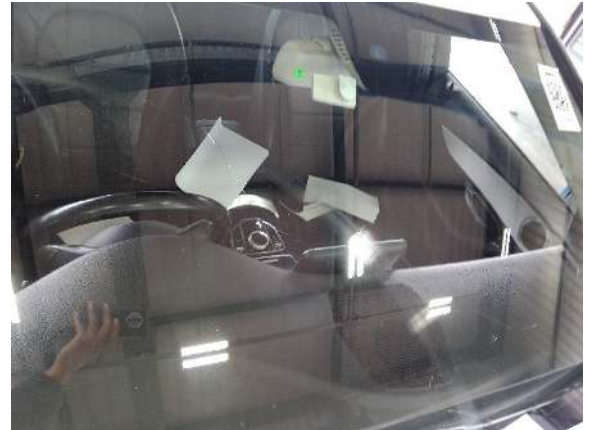
| Damage | Repair Way |
|---|---|
| Windscreen Cracked | Replace |

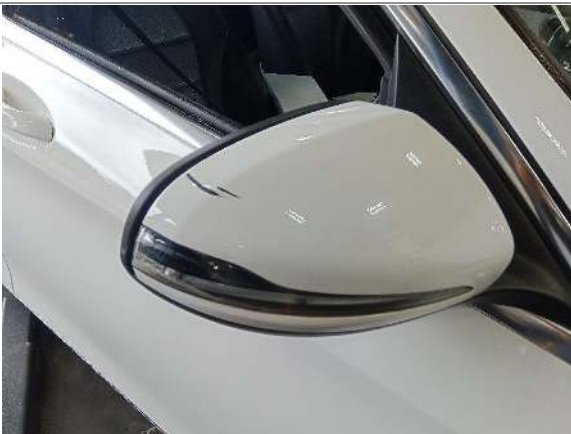
| Damage | Repair Way |
|---|---|
| Side Mirror Right Paintwork • Scratched | Repair |

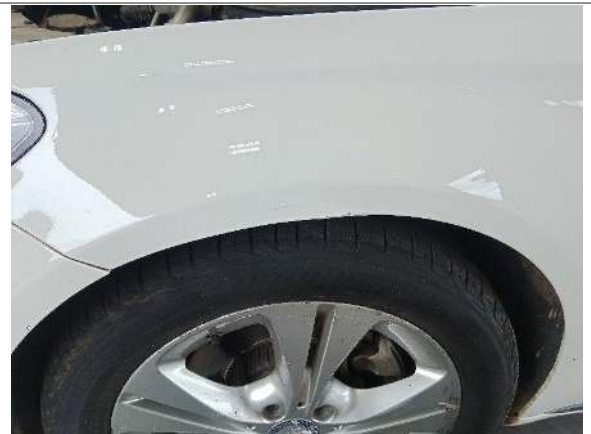
| Damage | Repair Way |
|---|---|
| Front Fender Left Dented | Repair |

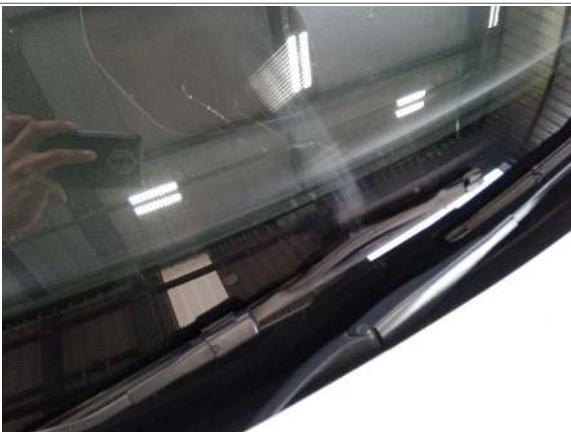
| Damage | Repair Way |
|---|---|
| Windscreen Wiper Worn | Replace |

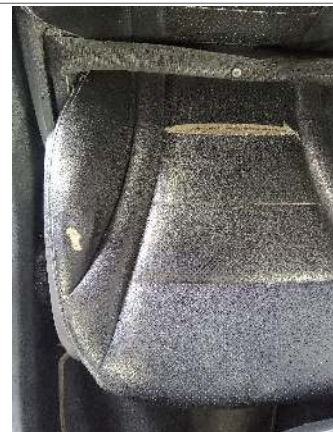
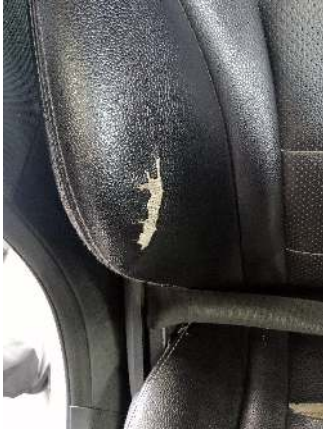
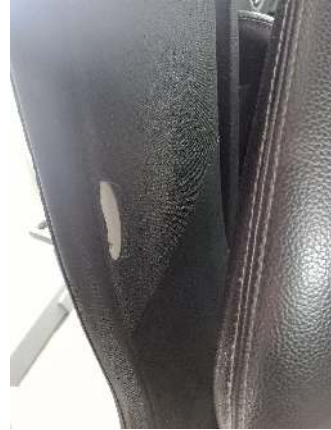
| Damage | Repair Way |
|---|---|
| Seat Front Right Torn / Cut | Repair |

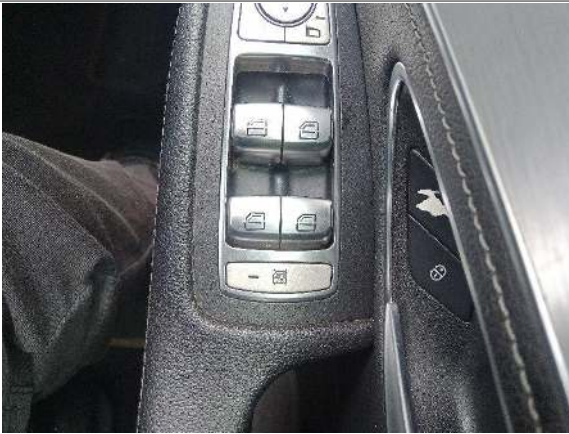
| Damage | Repair Way |
|---|---|
| Switch Electrical Window Winder rear right Defective | Repair |
