## CONDITION REPORT

Report No: 2016211827

MFC Auction House  
M57 Pretoria Rd, Glenmarais, KEMPTON PARK  
Gauteng

| Manufacturer | FORD | Registration Number | HN15RGGP |

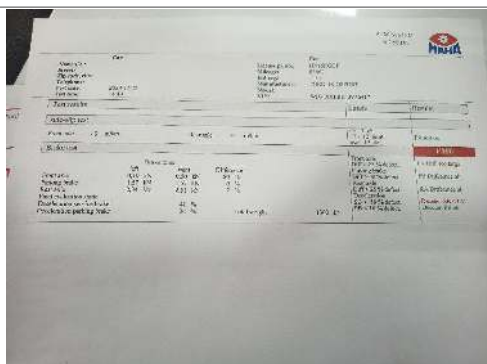
Brake test

| | Left | Right | | |
|---|---|---|---|---|
| Front | 0.1 | 0.5 | - | |
| Rear | 2.35 | 2.51 | - | |
| Emergency / Parking | 1.57 | 1.57 | - | |

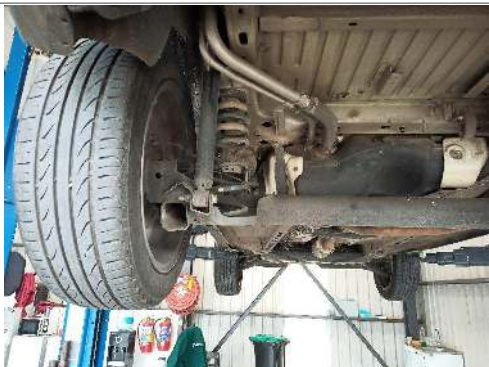
LR TYRE TREAD

| | Size | Load/Speed Index | Manufacture | Model | Type* | Production Date | Tread Depth (mm) |
|---|---|---|---|---|---|---|---|
| Rear Left | 205/50R17 | 93W | Landsail | Radial | V | 3321 | 1 mm |

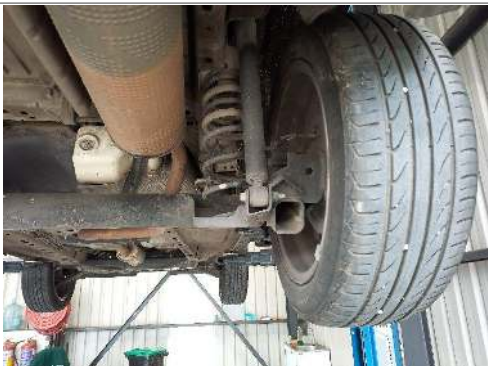
RR TYRE TREAD

| | Size | Load/Speed Index | Manufacture | Model | Type* | Production Date | Tread Depth (mm) |
|---|---|---|---|---|---|---|---|
| Rear Right | 205/50R17 | 93W | Landsail | Radial | V | 3321 | 1 mm |

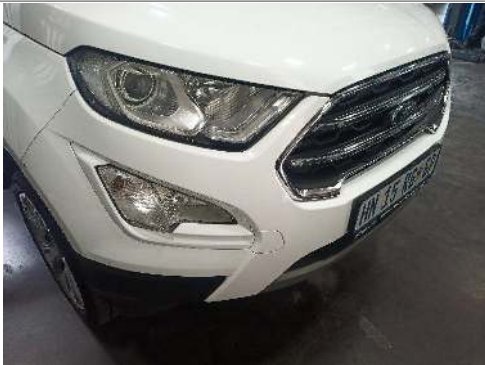
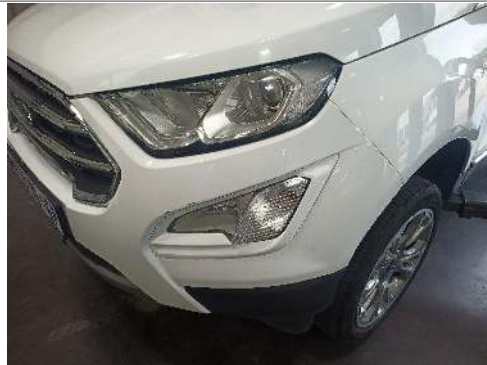
| Damage | Repair Way |
|---|---|
| Front Bumper Damaged | Repair |

Front Bumper

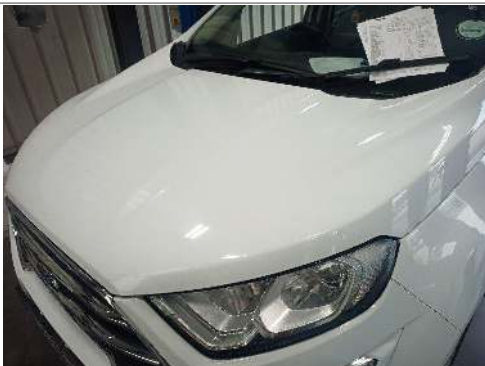
| Damage | Repair Way |
|---|---|
| Bonnet Damaged | Repair |

Bonnet

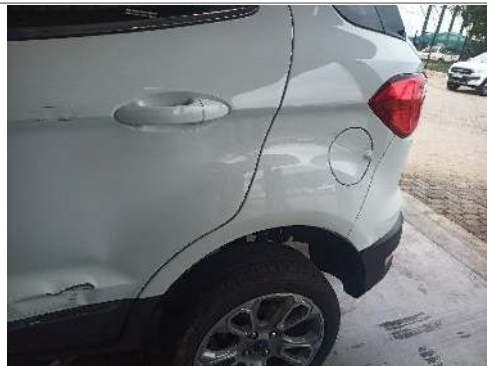
| Damage | Repair Way |
|---|---|
| Rear Fender Left Damaged | Repair |

Rear Fender Left

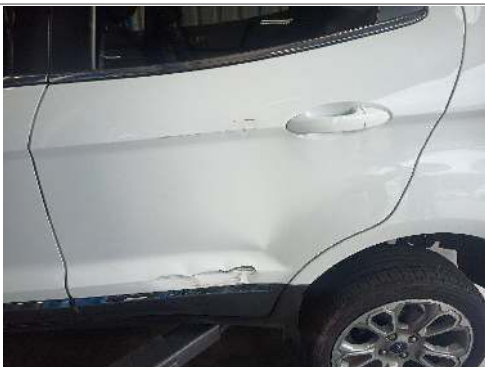
| Damage | Repair Way |
|---|---|
| Door Rear Left Damaged | Repair |

Door Rear Left

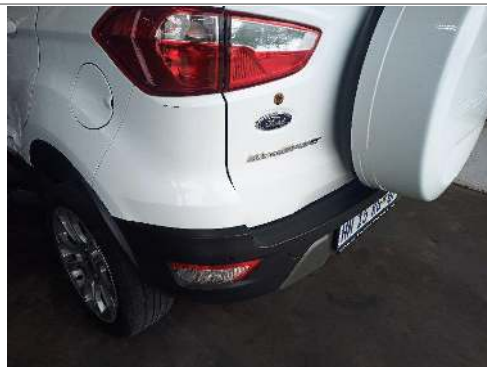
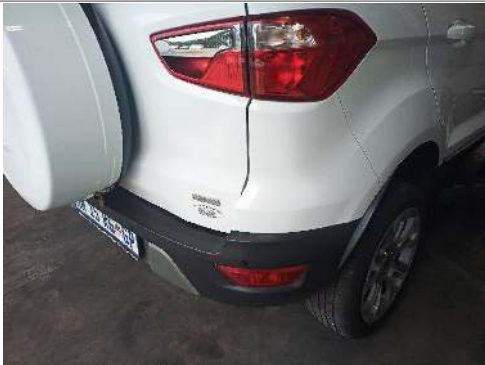
| Damage | Repair Way |
|---|---|
| Rear bumper Damaged | Repair |

Rear bumper

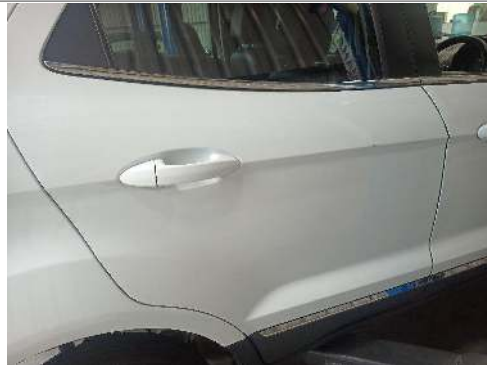
| Damage | Repair Way |
|---|---|
| Door Rear Right Damaged | Repair |

Door Rear Right
