CONDITION REPORT

Report No: 2016207074

MFC Auction House
M57 Pretoria Rd, Glenmarais, KEMPTON PARK
Gauteng

| Manufacturer | FORD | Registration Number | JD76CTGP |

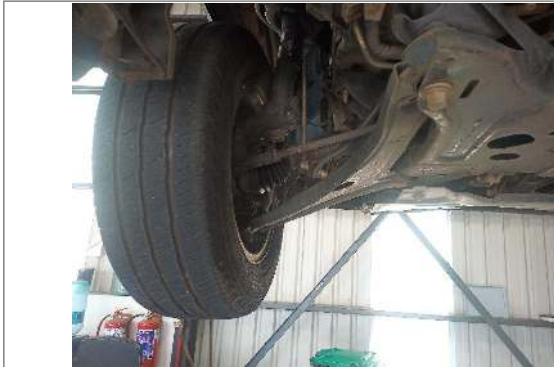
LF TYRE TREAD

| | Size | Load/Speed Index | Manufacture | Model | Type* | Production Date | Tread Depth (mm) |
|---|---|---|---|---|---|---|---|
| Front Left | 215/65R16 | 109T | Continental | Vanco | V | 1719 | 2 mm |

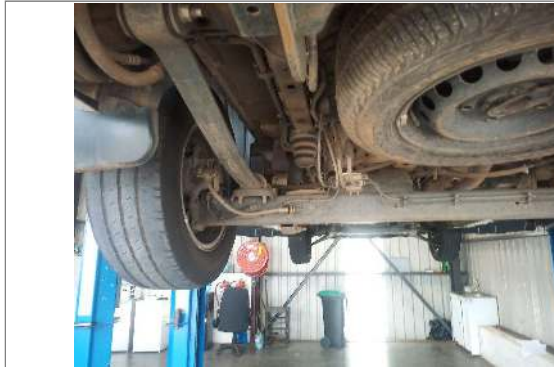
LR TYRE TREAD

| | Size | Load/Speed Index | Manufacture | Model | Type* | Production Date | Tread Depth (mm) |
|---|---|---|---|---|---|---|---|
| Rear Left | 215/65R16 | 109T | Continental | Vanco | V | 1921 | 0 mm |

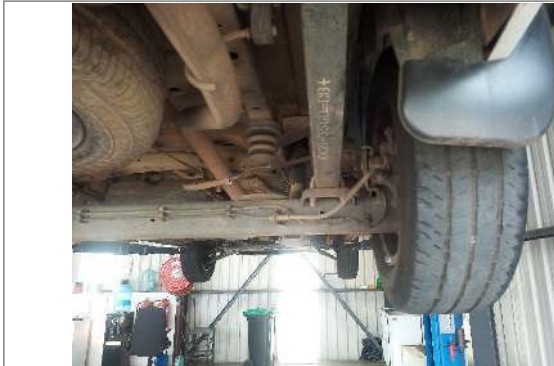
RR TYRE TREAD

| | Size | Load/Speed Index | Manufacture | Model | Type* | Production Date | Tread Depth (mm) |
|---|---|---|---|---|---|---|---|
| Rear Right | 215/65R16 | 109T | Continental | Vanco | V | 1921 | 0 mm |

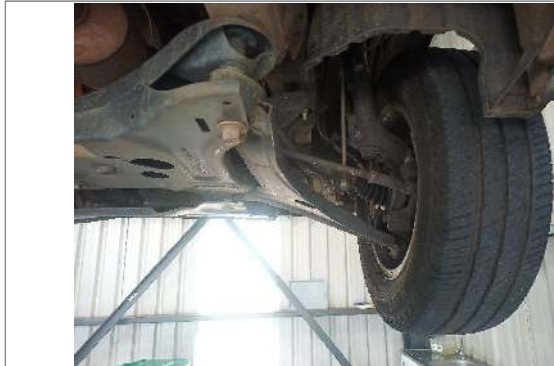
RF TYRE TREAD

| | Size | Load/Speed Index | Manufacture | Model | Type* | Production Date | Tread Depth (mm) |
|---|---|---|---|---|---|---|---|
| Front Right | 215/65R16 | 109T | Continental | Vanco | V | 1719 | 2 mm |

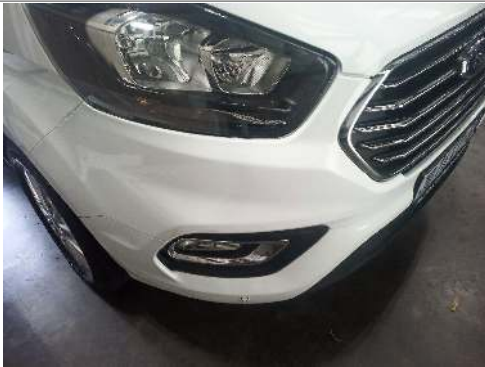
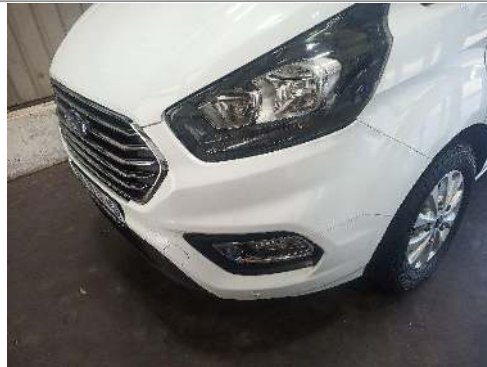
| Damage | Repair Way |
|---|---|
| Front Bumper Damaged | Repair |

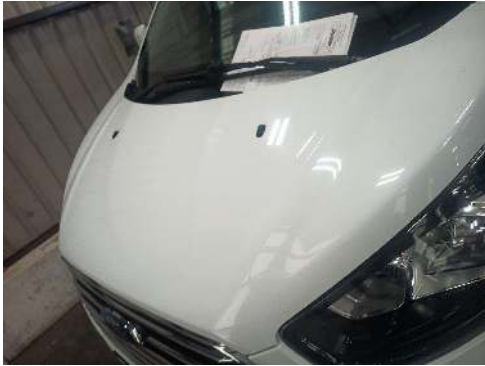
| Damage | Repair Way |
|---|---|
| Bonnet Damaged | Repair |

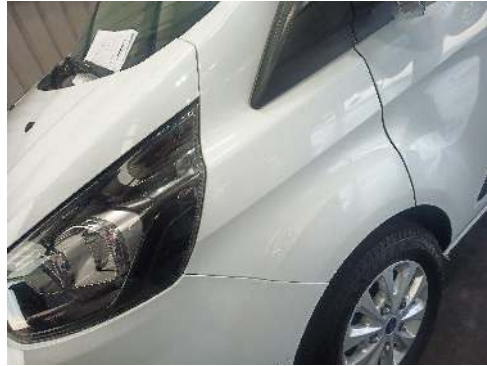
| Damage | Repair Way |
|---|---|
| Front Fender Left Damaged | Repair |

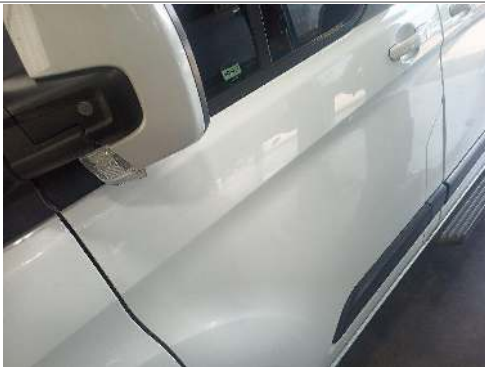
| Damage | Repair Way |
|---|---|
| Door Front Left Damaged | Repair |

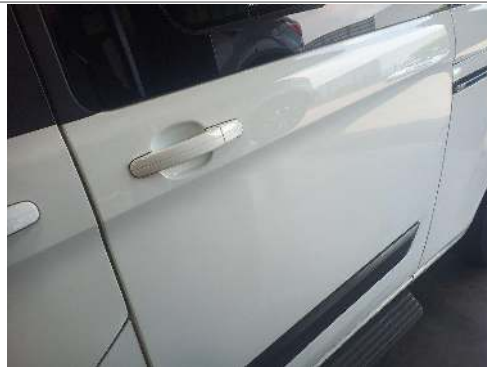
| Damage | Repair Way |
|---|---|
| Door Rear Left Damaged | Repair |

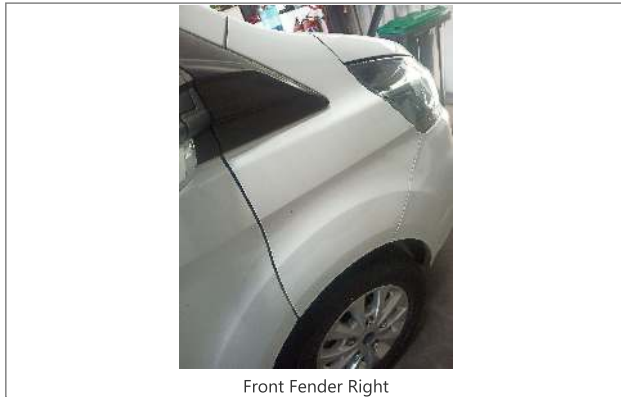
| Damage | Repair Way |
|---|---|
| Front Fender Right Damaged | Repair |

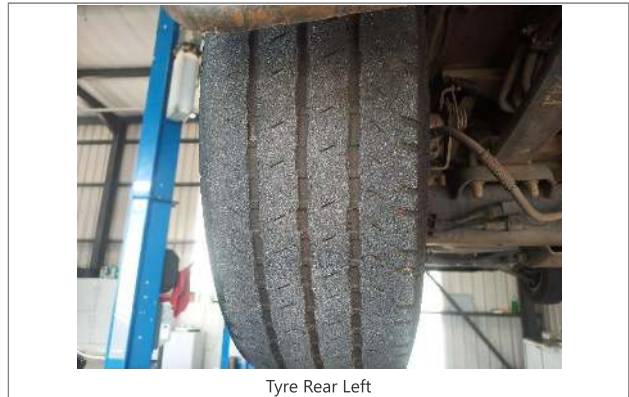
| Damage | Repair Way |
|---|---|
| Tyre Rear Left Worn | Replace |

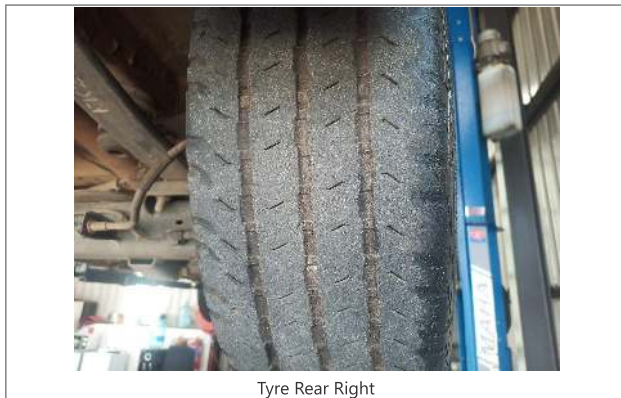
| Damage | Repair Way |
|---|---|
| Tyre Rear Right Worn | Replace |
