CONDITION REPORT

Report No: 2016252626

MFC Auction House
M57 Pretoria Rd, Glenmarais, KEMPTON PARK
Gauteng

Vehicle Type	PASSENGER VEHICLE	Registered Owner	MFC AUCTION HOUSE
Manufacturer	FORD	Registration Number	FJ36GSGP
Model	FIESTA	Register Number	
VIN	WF0DXXGAKDGR54328	Date Of First Licensing	
Engine Number		Last COR	
Doors	5	License Expiry Date	31/12/2023
Color	GREY	Power / Displacement	
Year Model		Paint Finish	M - METALLIC
Km Reading	135,284 KM	Fuel	PETROL
Cab / Body Type	HATCHBACK	Transmission	MANUAL

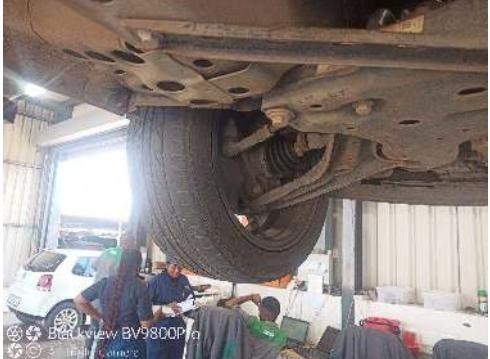
LF TYRE TREAD

Size	Load/Speed Index	Manufacture	Model	Type*	Production Date	Tread Depth (mm)
Front Left	195/50R15	82V	Hankook	Ventus	V	0620	2 mm
Front Right	195/50R15	82V	Hankook	Ventus	V	0520	3 mm
Rear Left	195/50R15	82V	Hankook	Ventus	V	0520	3 mm
Rear Right	175/65R14	82T	Continental	Contact	V	0316	4 mm
Spare	195/50R15	82H	Hankook	Ventus	V	///	4 mm

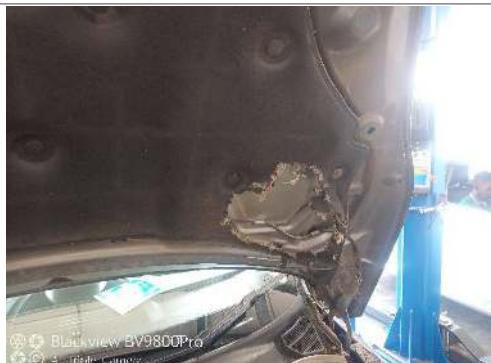
Damage	Repair Way
Under bonnet insulation cover Damaged	Replace
Front Bumper Paintwork • Scratched	Repair
Front Fender Left Dented	Repair
Front Fender Right Paintwork • Scratched	Repair
Rear Fender Right Dented	Repair
Door Front Left Dented	Repair
Door Front Right Dented	Repair
Door Rear Left Paintwork • Discoloured	Repair
Rear bumper Paintwork • Scratched	Repair
CV Joint(s) Boot(s) Front Right (inner/outer) Defective	Repair
