CONDITION REPORT

Report No: 2016249247

MFC Auction House  
M57 Pretoria Rd, Glenmarais, KEMPTON PARK  
Gauteng

| Manufacturer | FORD | Registration Number | KP86BBGP |

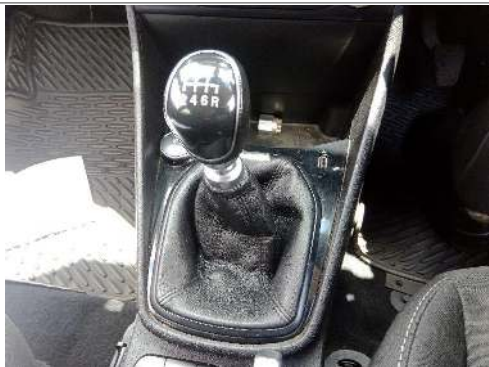
Manual Transmission

| Damage | Repair Way |
|---|---|
| Gearbox Oil Leak | Repair |

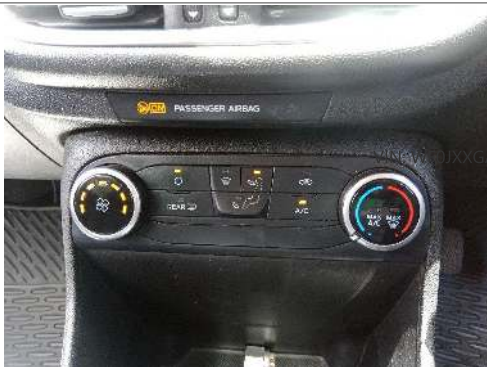
| Damage | Repair Way |
|---|---|
| Air Conditioner Insufficient | Replace |

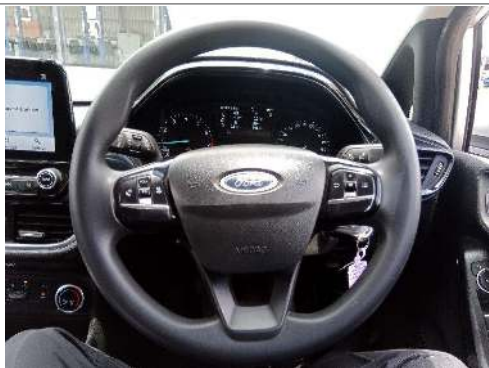
| Damage | Repair Way |
|---|---|
| Steering Wheel Trim Defective | Repair |

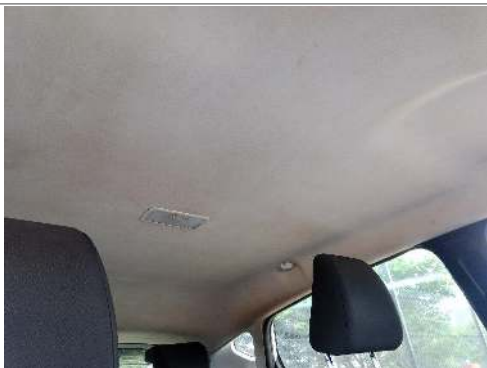
| Damage | Repair Way |
|---|---|
| Hood Lining Defective | Repair |

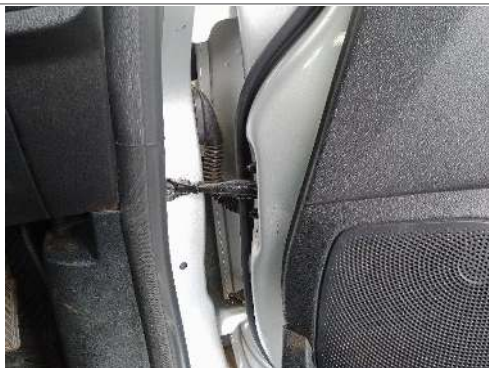
| Damage | Repair Way |
|---|---|
| Doorstopper Front Right Defective | Replace |

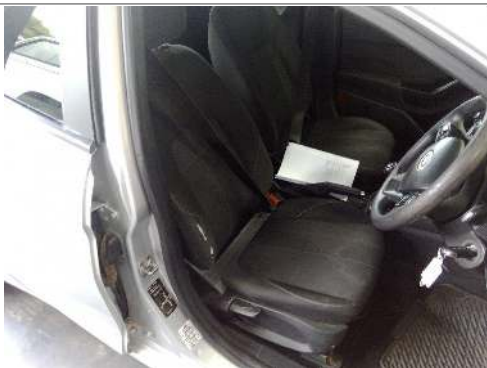
| Damage | Repair Way |
|---|---|
| Seat Front Right Damaged | Repair |

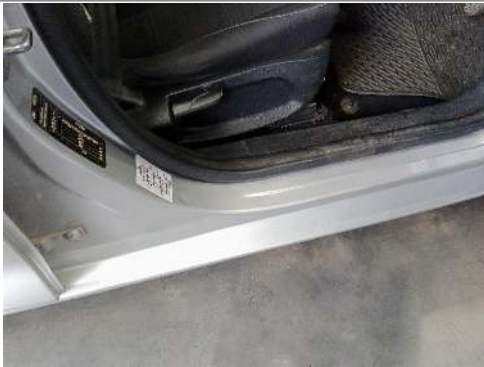
| Damage | Repair Way |
|---|---|
| Sill Panel Right Dented | Repair |

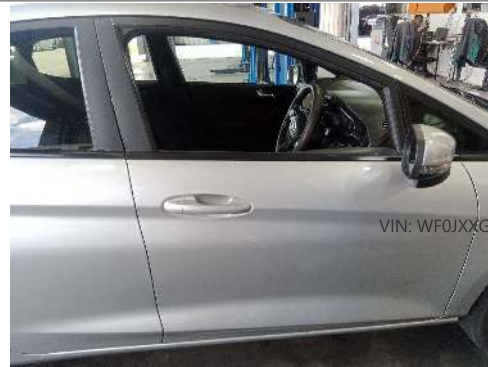
| Damage | Repair Way |
|---|---|
| Door Front Right Paintwork • Scratched | Repair |

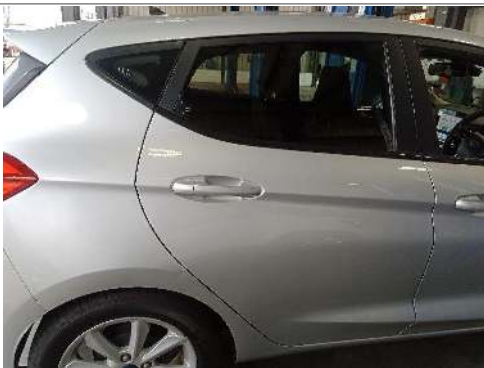
| Damage | Repair Way |
|---|---|
| Door Rear Right Paintwork • Scratched | Repair |

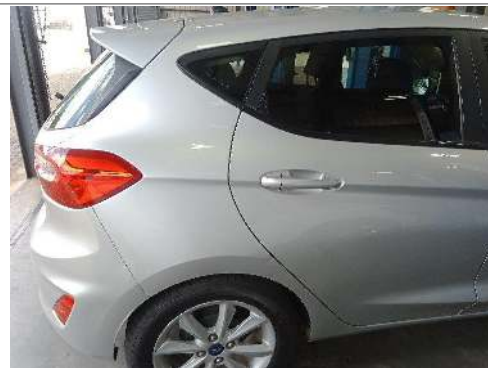
| Damage | Repair Way |
|---|---|
| Rear Fender Right Dented | Repair |

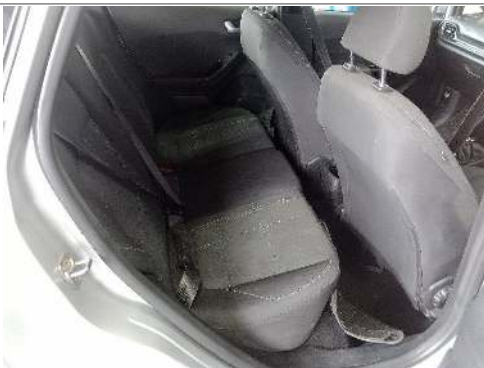
| Damage | Repair Way |
|---|---|
| Seat Rear Defective | Repair |

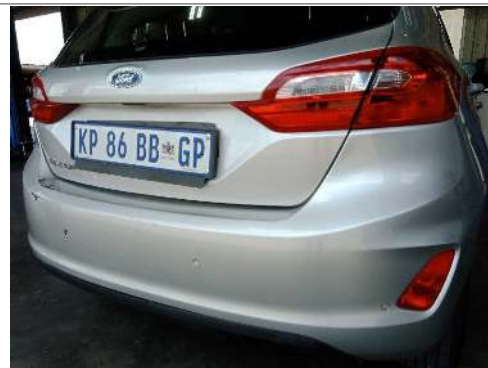
| Damage | Repair Way |
|---|---|
| Rear bumper Damaged | Repair |

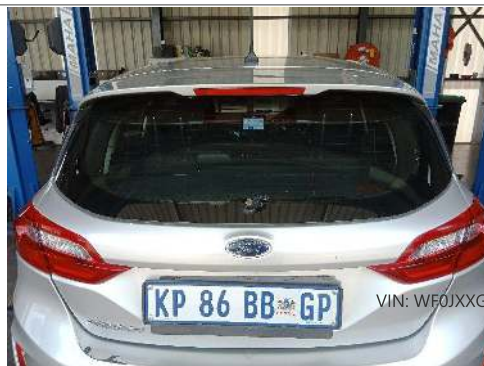
| Damage | Repair Way |
|---|---|
| Boot Lid / Hatch door Paintwork • Scratched | Repair |

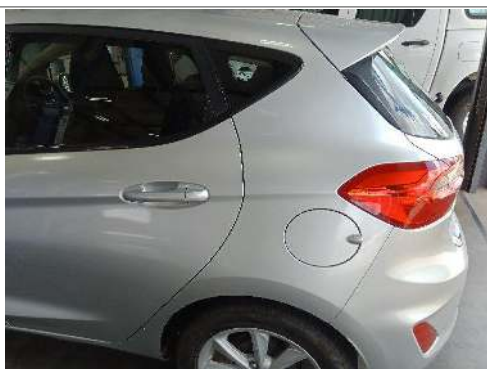
| Damage | Repair Way |
|---|---|
| Rear Fender Left Residual Traces of Repair | Repair |

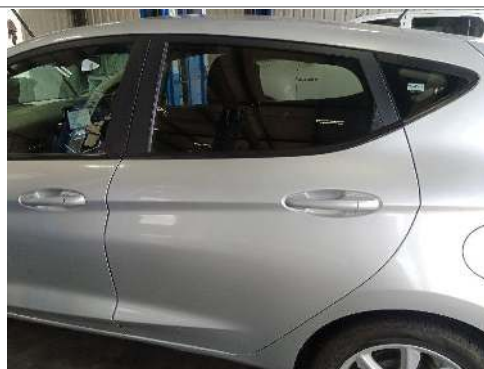
| Damage | Repair Way |
|---|---|
| Door Rear Left Residual Traces of Repair | Repair |

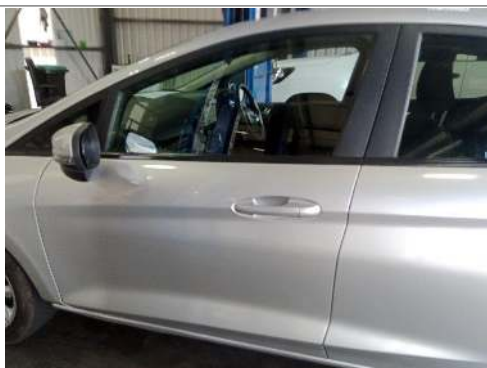
| Damage | Repair Way |
|---|---|
| Door Front Left Residual Traces of Repair | Repair |

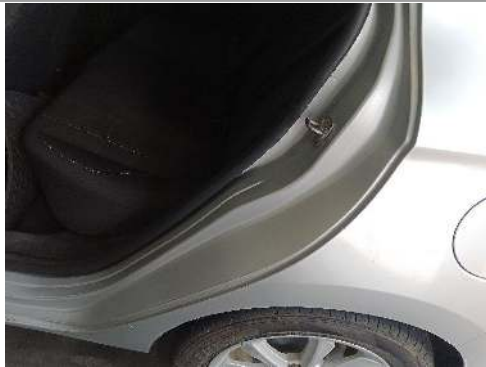
| Damage | Repair Way |
|---|---|
| C • Pillar Left Residual Traces of Repair | Repair |

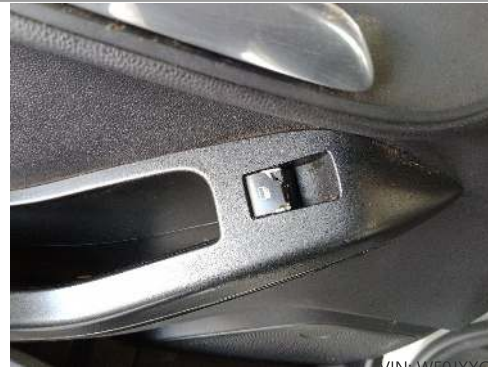
| Damage | Repair Way |
|---|---|
| Switch Electrical Window Winder front left Broken | Replace |

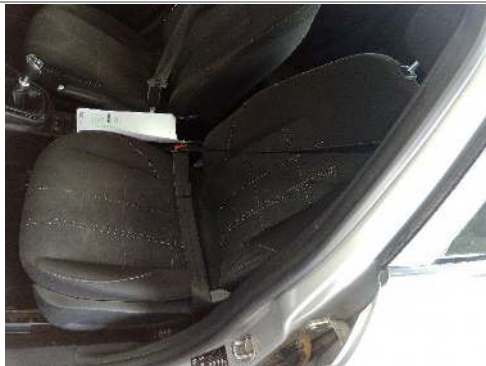
| Damage | Repair Way |
|---|---|
| Seat Front Left Dirty | Repair |

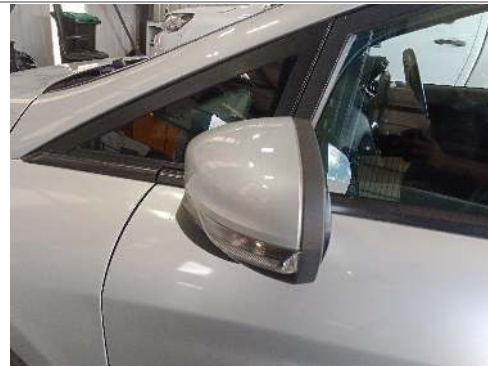
| Damage | Repair Way |
|---|---|
| Side Mirror Left Paintwork • Scratched | Repair |

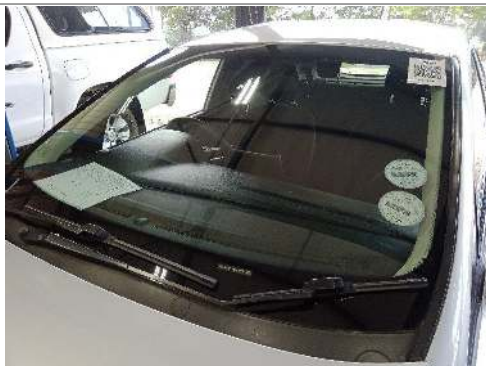
| Damage | Repair Way |
|---|---|
| Windscreen Chipped | Repair |

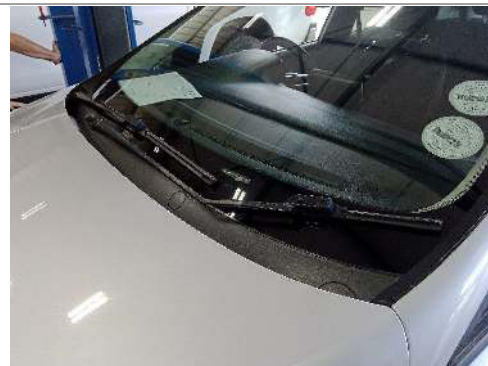
| Damage | Repair Way |
|---|---|
| Windscreen Wiper Defective | Replace |

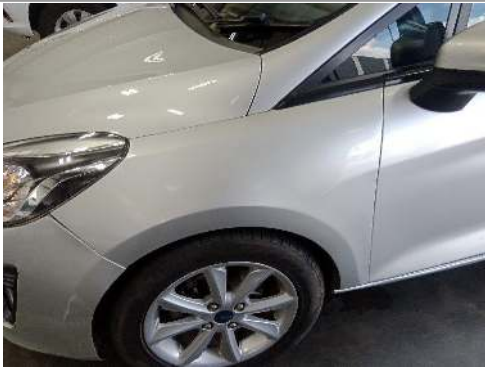
| Damage | Repair Way |
|---|---|
| Front Fender Left Residual Traces of Repair | Repair |

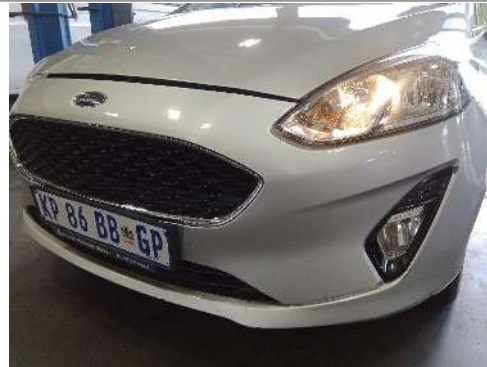
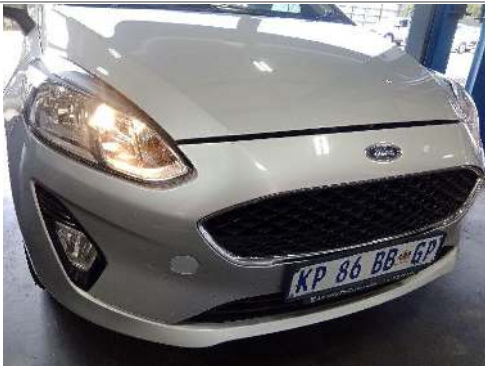
| Damage | Repair Way |
|---|---|
| Front Bumper Damaged | Repair |

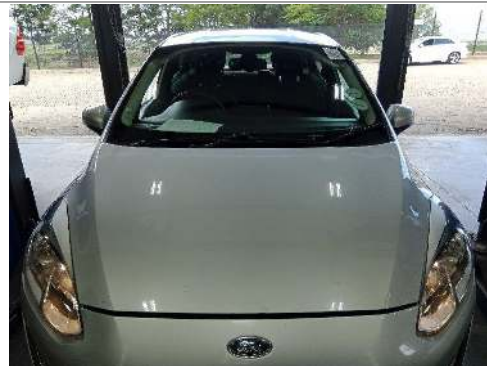
| Damage | Repair Way |
|---|---|
| Bonnet Paintwork • Chipmarks | Repair |

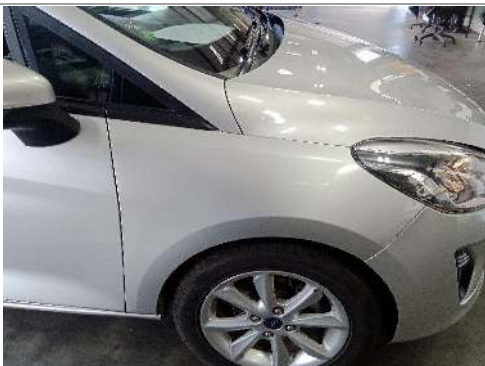
| Damage | Repair Way |
|---|---|
| Front Fender Right Paintwork • Scratched | Repair |

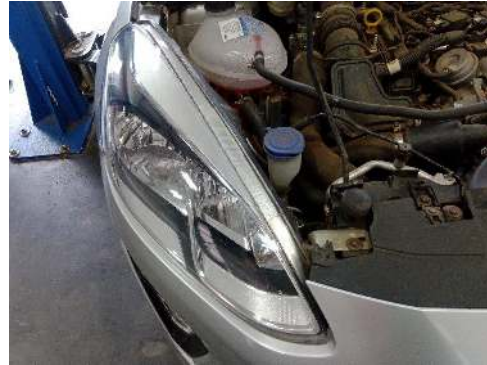
| Damage | Repair Way |
|---|---|
| Headlight Right Damaged | Replace |

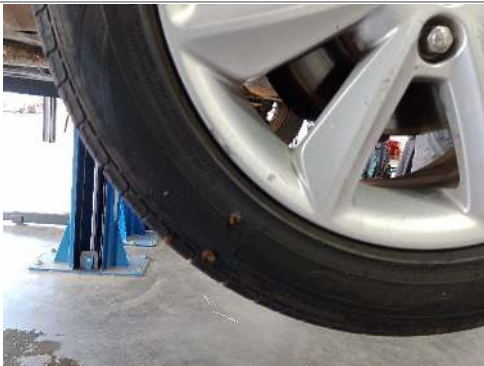
| Damage | Repair Way |
|---|---|
| Tyre Front Right Damaged | Replace |

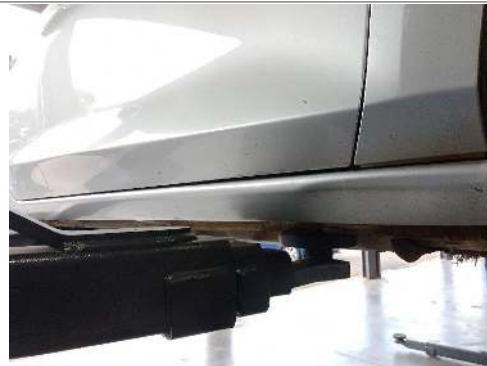
| Damage | Repair Way |
|---|---|
| Rocker Panel Right Dented | Repair |

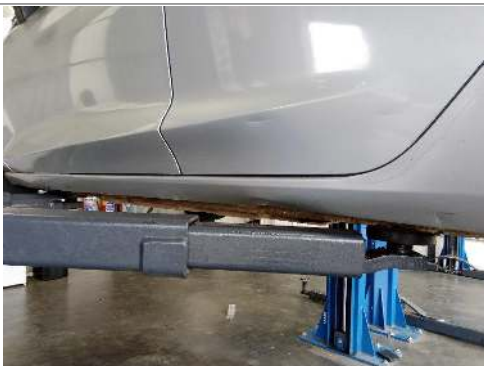
| Damage | Repair Way |
|---|---|
| Rocker Panel Left Damaged | Repair |

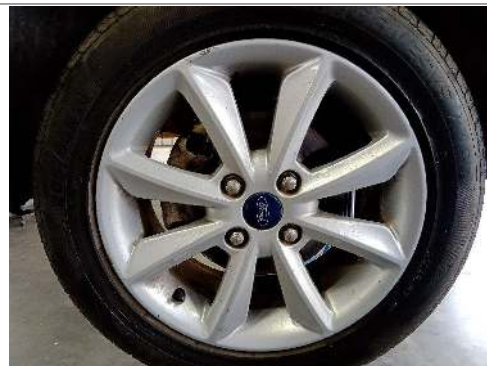
| Damage | Repair Way |
|---|---|
| Wheel bearing Front Left Loose / Excessive Play | Replace |

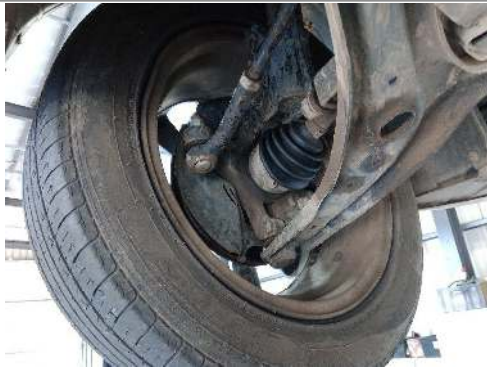
| Damage | Repair Way |
|---|---|
| Rim Front Left Dented | Repair |

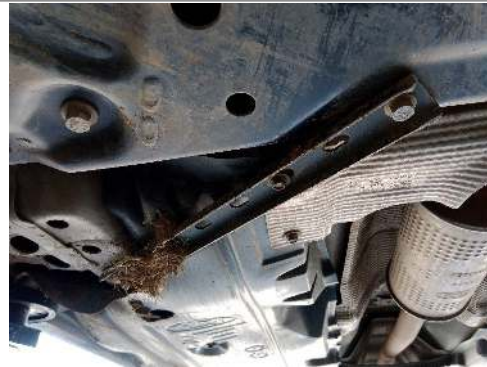
| Damage | Repair Way |
|---|---|
| Cross Member Front Right Damaged | Repair |

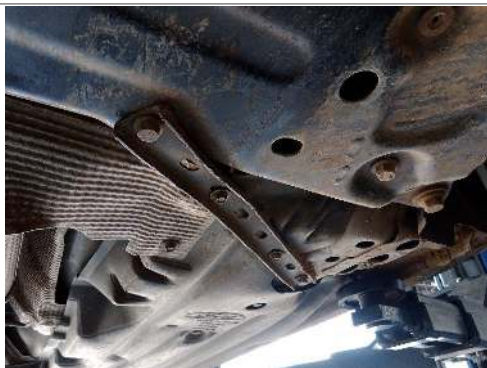
| Damage | Repair Way |
|---|---|
| Cross Member Front Left Dented | Repair |

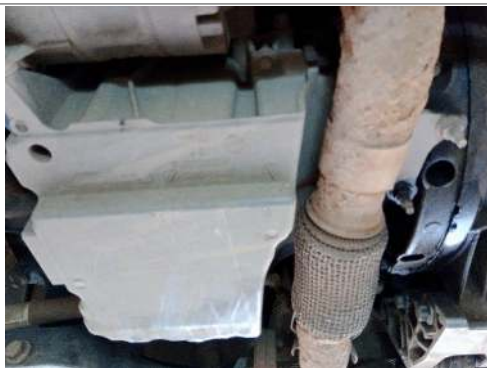
| Damage | Repair Way |
|---|---|
| Engine Oil Leak | Repair |

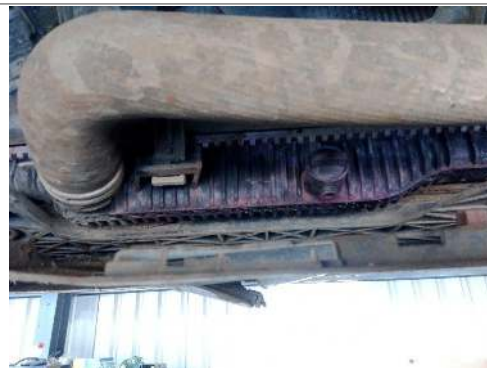
| Damage | Repair Way |
|---|---|
| Radiator Water Leak | Replace |

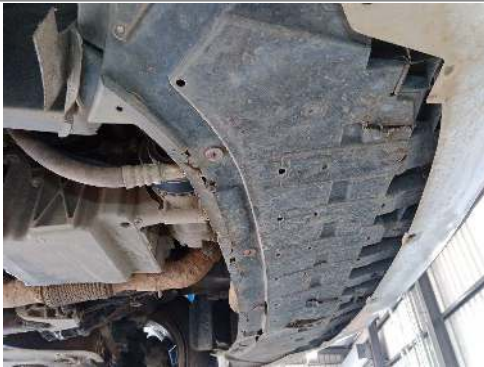
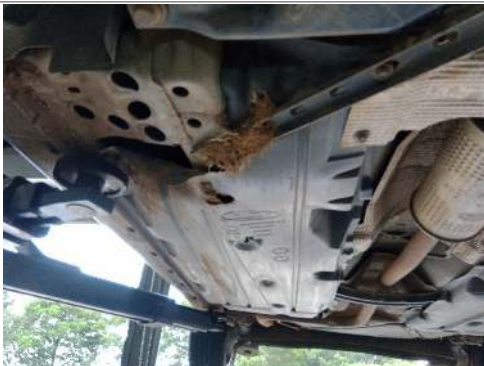
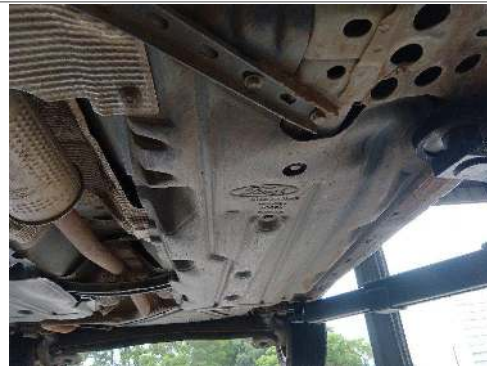
| Damage | Repair Way |
|---|---|
| Belly plates Damaged | Replace |

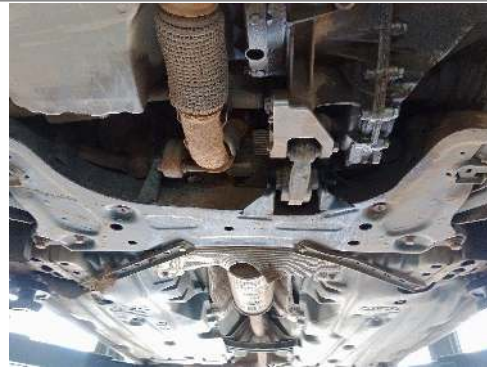
| Damage | Repair Way |
|---|---|
| Sub Frame Damaged | Repair |

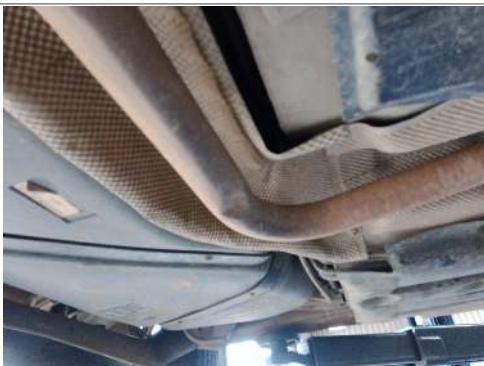
| Damage | Repair Way |
|---|---|
| Engine to silencer pipe Damaged | Repair |

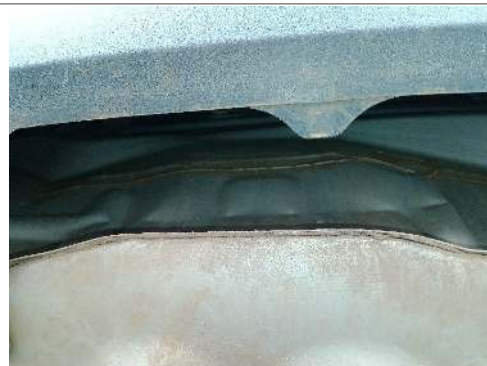
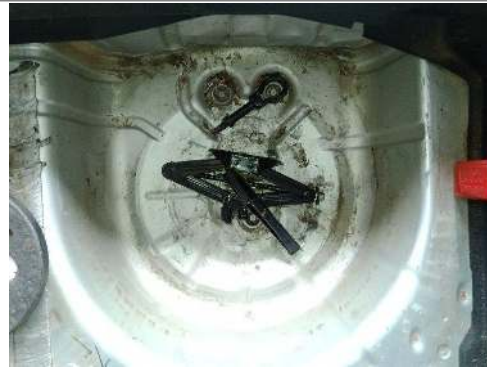
| Damage | Repair Way |
|---|---|
| Inner Boot Floor Pan and Spare Wheel Well Damaged | Repair |

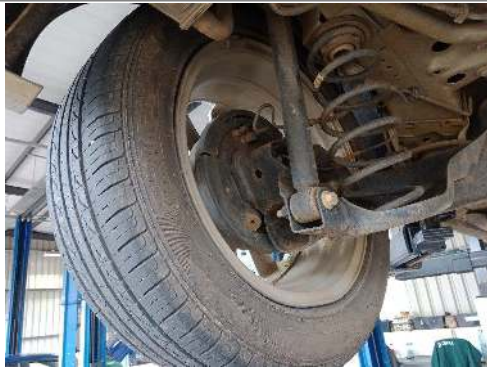
| Damage | Repair Way |
|---|---|
| Rim Rear Left Dented | Repair |

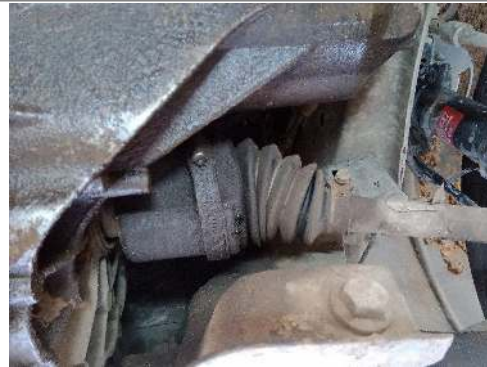
| Damage | Repair Way |
|---|---|
| CV Joint(s) Boot(s) Front Left (inner/outer) Damaged | Replace |

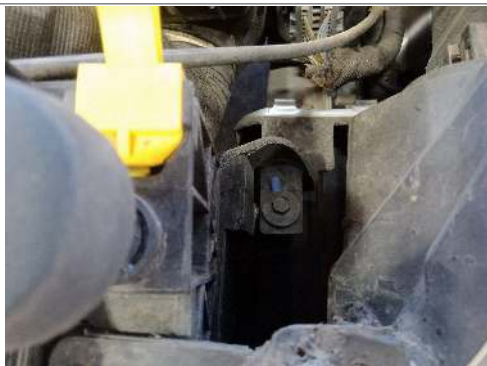
| Damage | Repair Way |
|---|---|
| Radiator Cradle Defective | Replace |

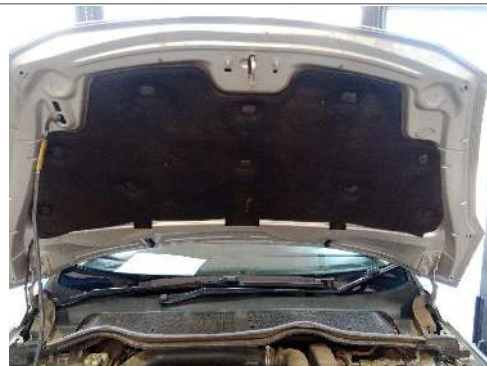
| Damage | Repair Way |
|---|---|
| Under bonnet insulation cover Defective | Repair |

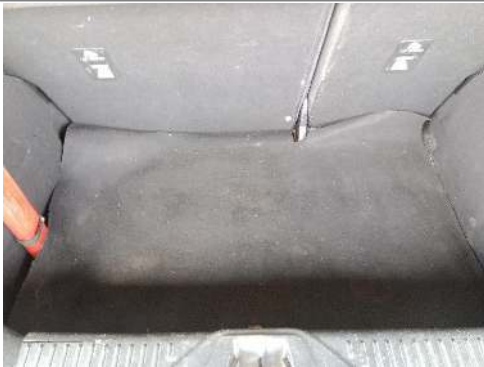
| Damage | Repair Way |
|---|---|
| Boot Carpet Damaged | Repair |
