CONDITION REPORT

Report No: 2016230376

MFC Auction House
M57 Pretoria Rd, Glenmarais, KEMPTON PARK
Gauteng

Vehicle Type	LIGHT LOAD VEHICLE	Registered Owner	MFC AUCTION HOUSE
Manufacturer	VOLKSWAGEN	Registration Number	KT27WXGP
Model	AMAROK	Register Number	
VIN	WV1ZZZ2HZDH011794	Date Of First Licensing	
Engine Number		Last COR	
Doors	4	License Expiry Date	16/01/2024
Color	WHITE	Power / Displacement	
Year Model		Paint Finish	TWO COAT UNI
Km Reading	271,691 KM	Fuel	DIESEL
Cab / Body Type	DOUBLE CAB	Transmission	MANUAL

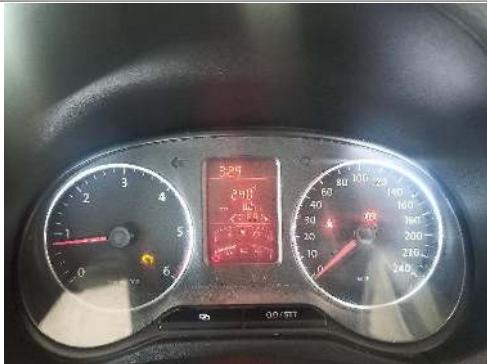
DASHBOARD (W/ ENGINE RUNNING)

General Comments: ENGINE MANAGEMENT LIGHTS ILLUMINATED ON CLUSTER.Electrical Components and Instruments: Heater is disconnected.

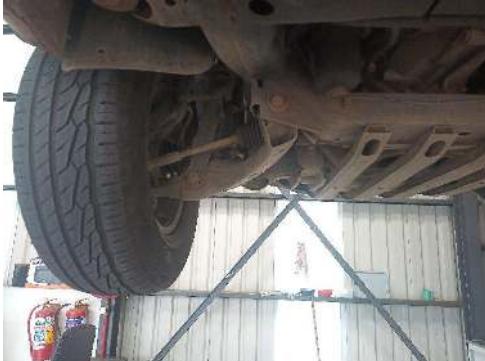
LF TYRE TREAD

Size	Load/Speed Index	Manufacture	Model	Type*	Production Date	Tread Depth (mm)
Front Left	265/70R16	112H	General	Radial	V	1722	3 mm
Front Right	265/70R16	112H	General	Radial	V	1722	4 mm
Rear Left	265/70R16	112H	General	Radial	V	1622	3 mm
Rear Right	265/70R16	112H	General	Radial	V	1822	3 mm

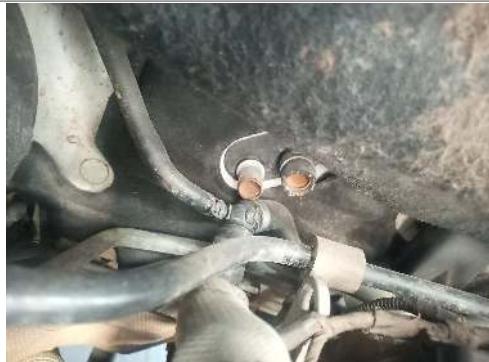
Damage	Repair Way
Engine Wiring Damaged	Repair
Hoses Defective	Repair
Central Air Vent Damaged	Replace
Center Console / Cubbyhole + Lid Damaged	Repair
Heater operation Insufficient	Replace
Seat Front Left Damaged	Repair
Seat Front Right Damaged	Repair
Sun Visor Right Damaged	Repair
Side Mirror Left Damaged	Replace
Side Mirror Right Damaged	Replace
Front Bumper Damaged	Repair
Bonnet Damaged	Repair
Front Fender Left Damaged	Repair
Front Fender Right Damaged	Repair
Rear Fender Left Damaged	Repair
Rear Fender Right Damaged	Repair
Door Front Left Damaged	Repair
Door Front Right Damaged	Repair
Door Rear Left Damaged	Repair
Door Rear Right Damaged	Repair
Tailgate Damaged	Repair
Rear bumper Damaged	Repair
Roof Damaged	Replace

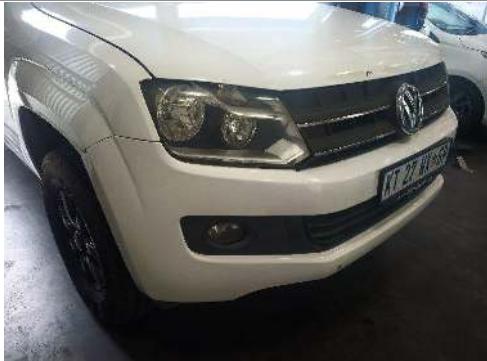
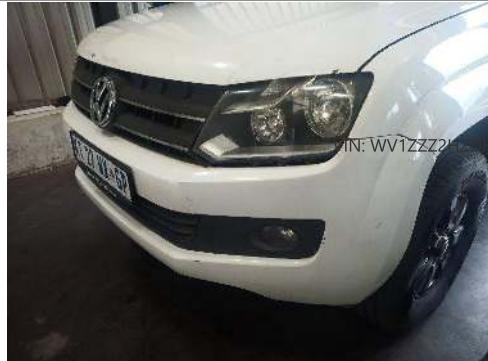
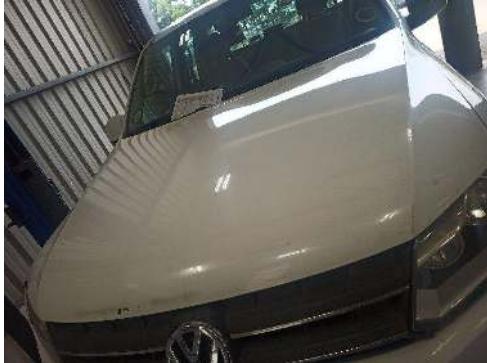
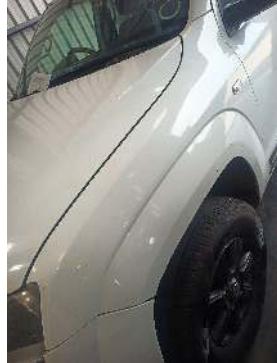
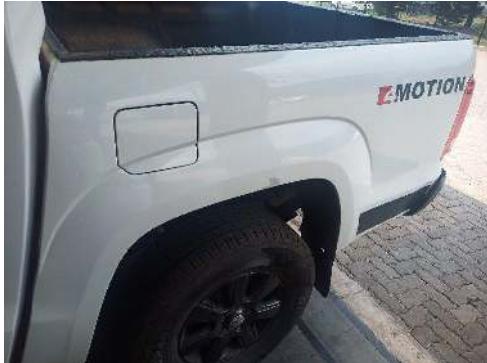
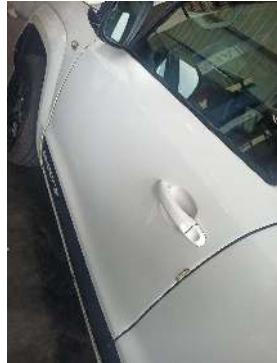
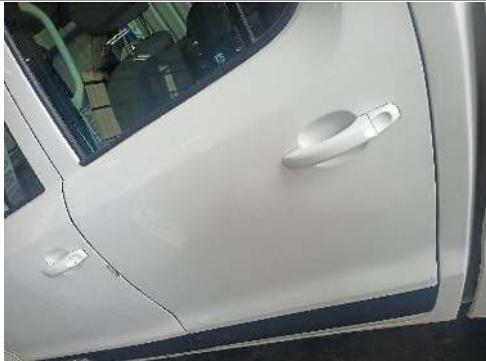
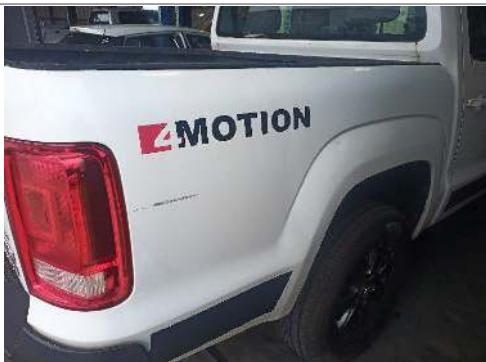
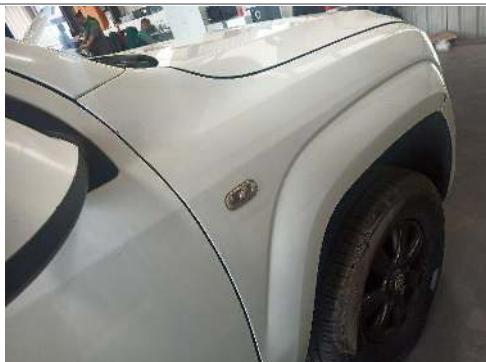
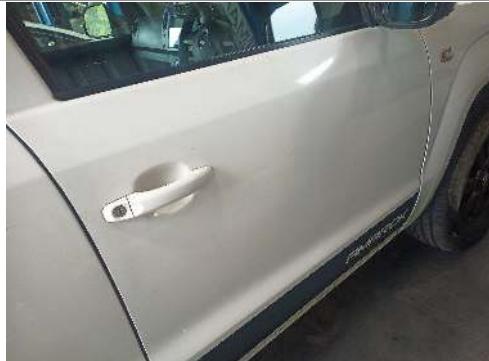
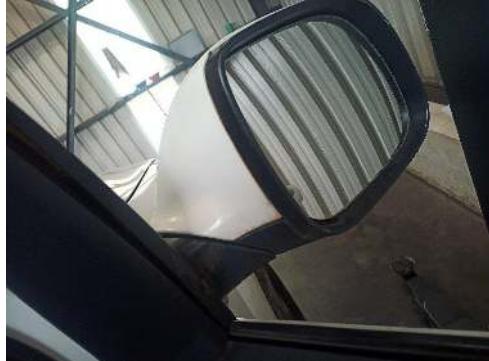
Body • Exterior: Minor dents and scratches and stone chips to some body panels. Signs of
