## CONDITION REPORT

Report No: 2016403039

| Manufacturer | VOLKSWAGEN | Registration Number | KHX312NW |
| Model | GOLF TSI | Register Number | |

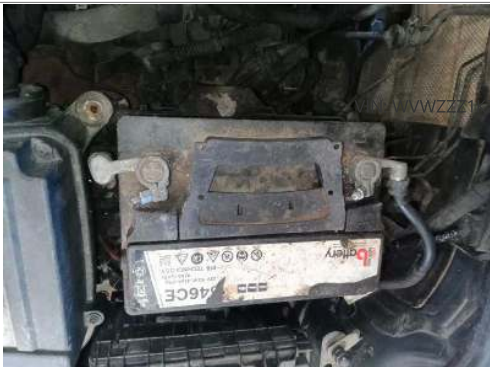
Radiator Cradle Damaged  
Engine Performance Idling / Hunting  
Engine Noise Excessive  
Engine Smoke Excessive  
Battery loose  
Engine management lights illuminated  
Aircon not working  
Both front fog lights malfunction  
No license disc

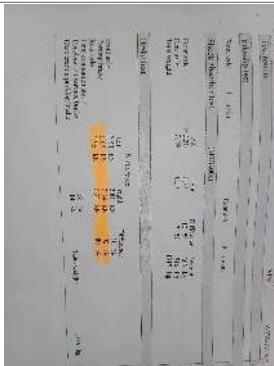
| Damage | Repair Way |
|---|---|
| Parking Brake Performance Left / Right Difference out of legal range | Repair |

| | Left | Right | | |
|---|---|---|---|---|
| Emergency / Parking | 1.6 | 0.1 | - | |

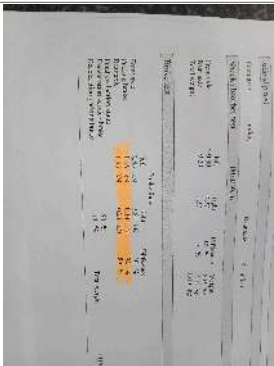
| Damage | Repair Way |
|---|---|
| Service Brake Performance Rear Axle Left / Right | Repair |
| Difference out of legal range | |

| | Left | Right | | |
|---|---|---|---|---|
| Rear | 1.9 | 0.2 | - | |

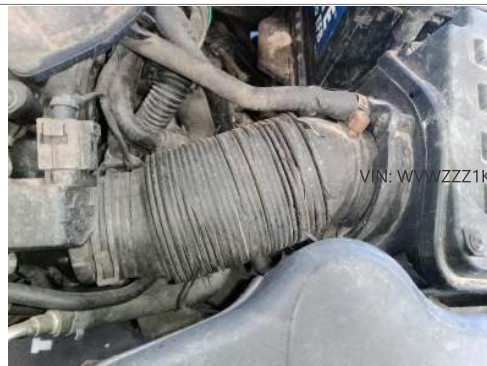
| Damage | Repair Way |
|---|---|
| Air cleaner Damaged | Replace |

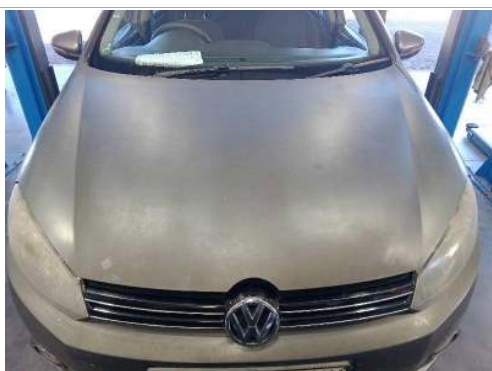
| Damage | Repair Way |
|---|---|
| Bonnet Paintwork • Discoloured | Repair |

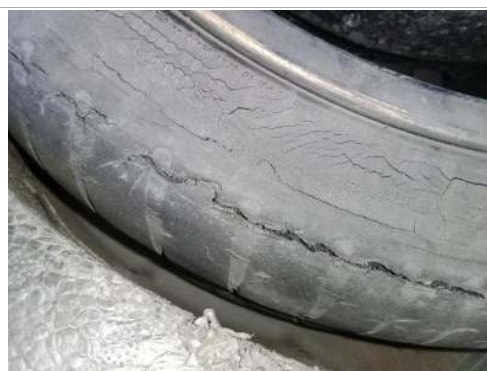
| Damage | Repair Way |
|---|---|
| Spare Tyre Damaged | Replace |

| | Size | Load/Speed Index | Manufacture | Model | Type* | Production Date | Tread Depth (mm) |
|---|---|---|---|---|---|---|---|
| Spare | 225/40R18 | 92Y | Michelin | Pilot sport | V | 1111 | 0 mm |

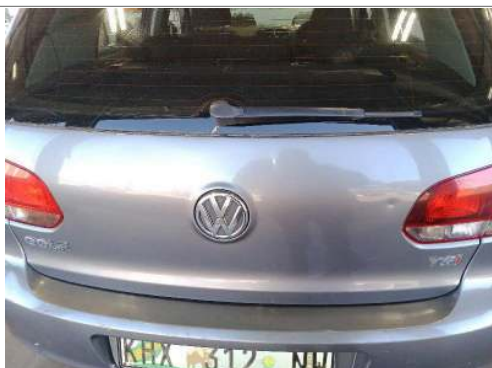
| Damage | Repair Way |
|---|---|
| Boot Lid / Hatch door Dented | Repair |

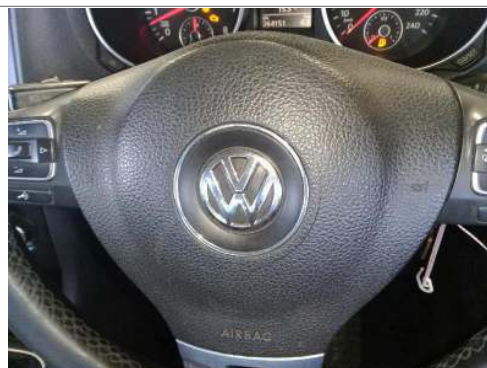
| Damage | Repair Way |
|---|---|
| Hooter Defective | Repair |

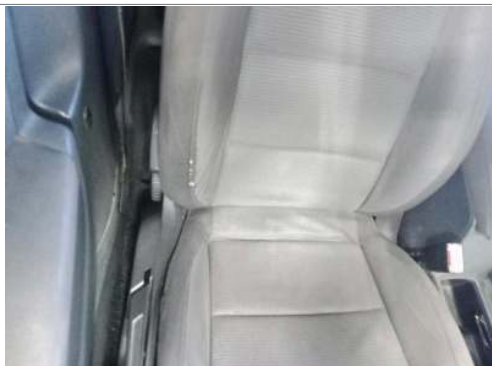
| Damage | Repair Way |
|---|---|
| Seat Front Right Torn / Cut | Repair |

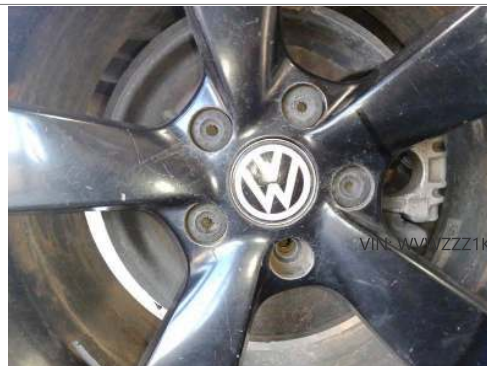
| Damage | Repair Way |
|---|---|
| Bolt(s) / Nut(s) Rear Wheel Right Missing | Replace |

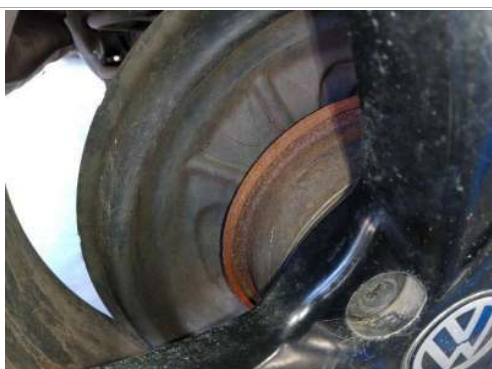
| Damage | Repair Way |
|---|---|
| Brake disc 2. Axle right Damaged | Replace |

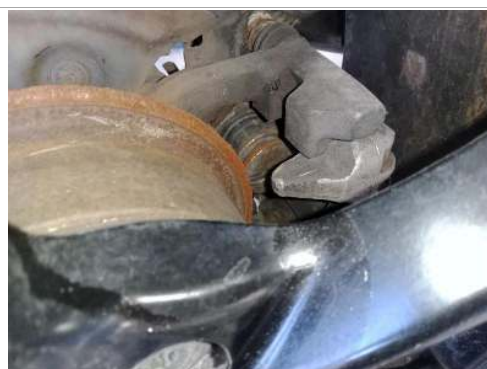
| Damage | Repair Way |
|---|---|
| Brake Pad/Shoe 2. Axle right Damaged | Replace |

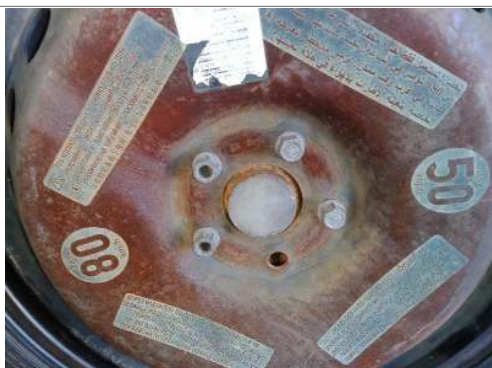
| Damage | Repair Way |
|---|---|
| Bolt(s) / Nut(s) Rear Wheel Left Missing | Replace |

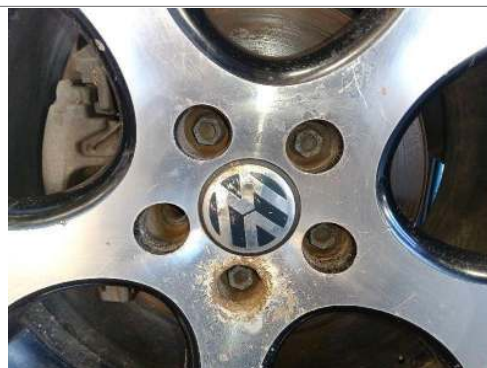
| Damage | Repair Way |
|---|---|
| Bolt(s) / Nut(s) Front Wheel Left Missing | Replace |

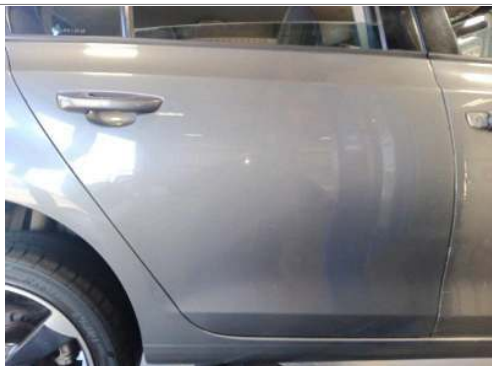
| Damage | Repair Way |
|---|---|
| Door Rear Right Paintwork • Scratched | Repair |

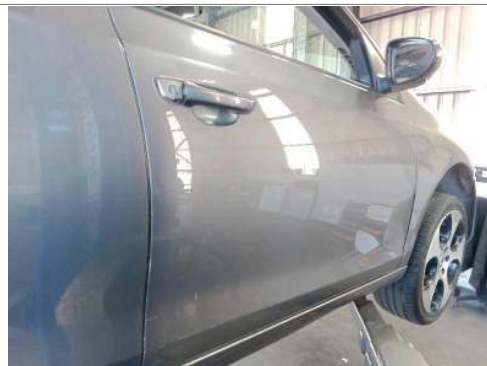
| Damage | Repair Way |
|---|---|
| Door Front Right Paintwork • Scratched | Repair |

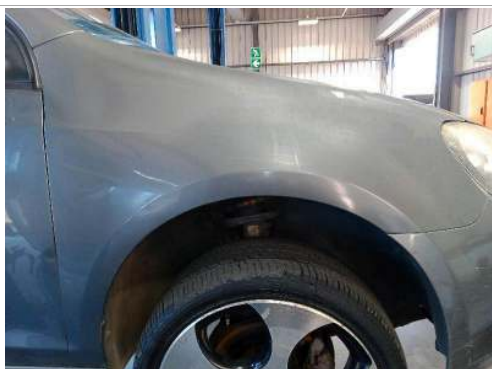
| Damage | Repair Way |
|---|---|
| Front Fender Right Paintwork • Discoloured | Repair |

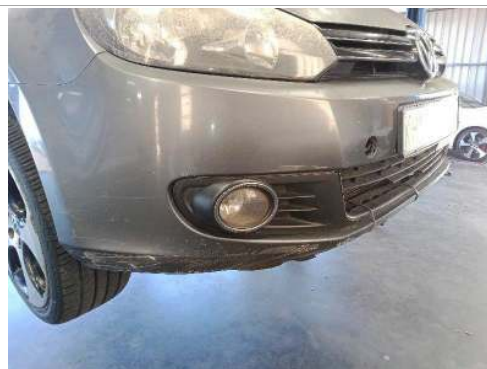
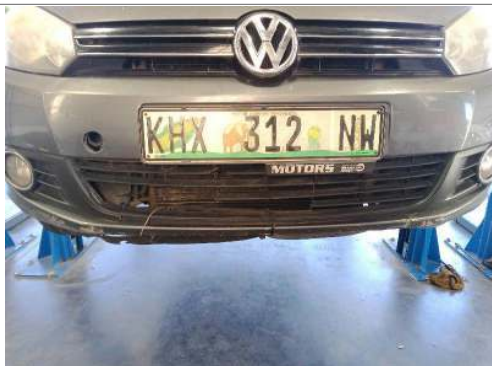
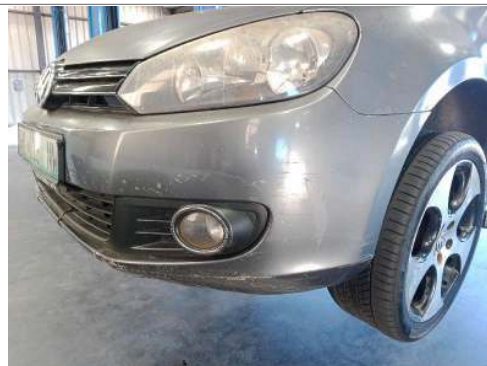
| Damage | Repair Way |
|---|---|
| Front Bumper Damaged | Repair |

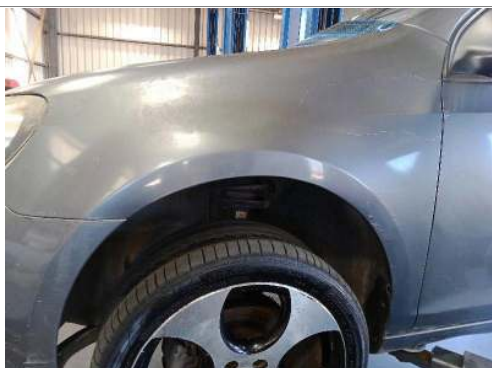
| Damage | Repair Way |
|---|---|
| Front Fender Left Paintwork • Discoloured | Repair |

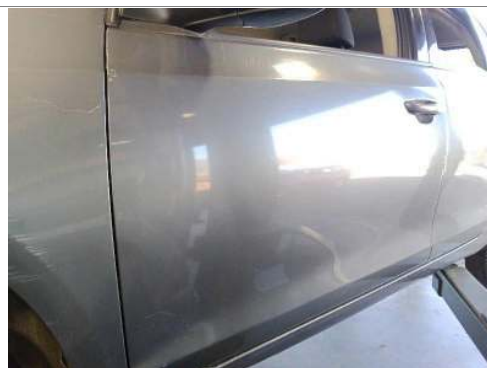
| Damage | Repair Way |
|---|---|
| Door Front Left Paintwork • Scratched | Repair |

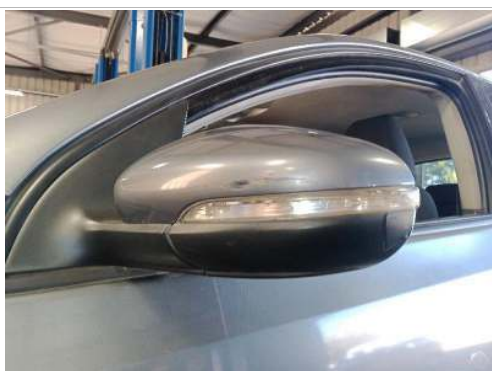
| Damage | Repair Way |
|---|---|
| Side Mirror Left Paintwork • Scratched | Repair |

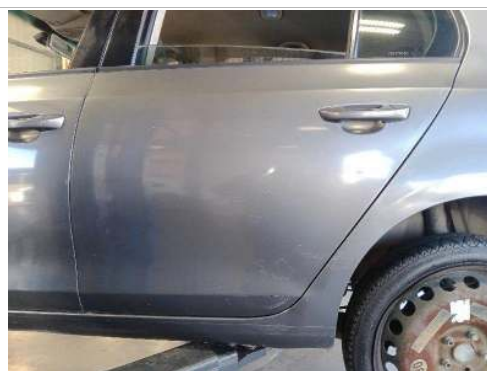
| Damage | Repair Way |
|---|---|
| Door Rear Left Paintwork • Scratched | Repair |

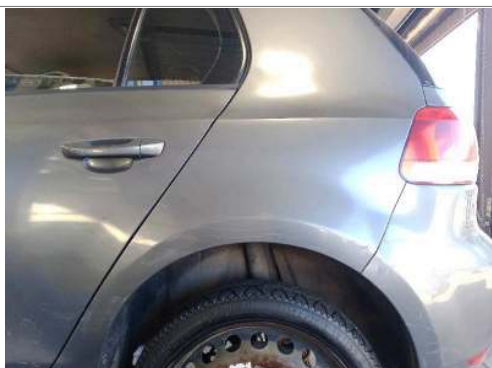
| Damage | Repair Way |
|---|---|
| Rear Fender Left Paintwork • Scratched | Repair |

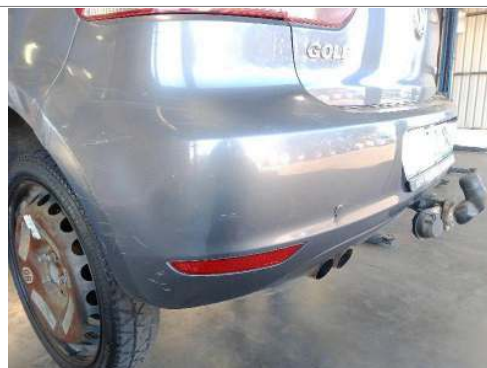
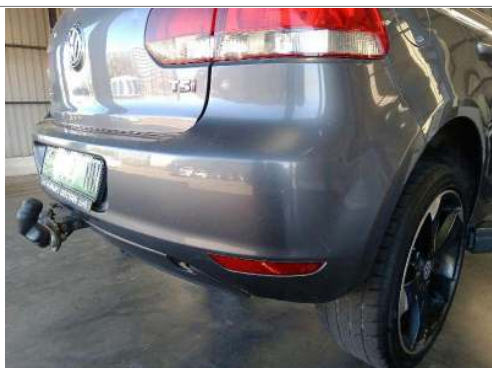
| Damage | Repair Way |
|---|---|
| Rear bumper Damaged | Repair |

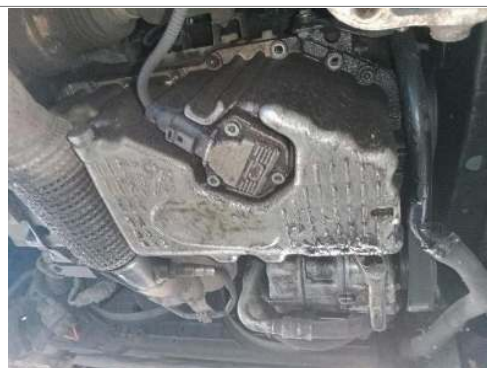
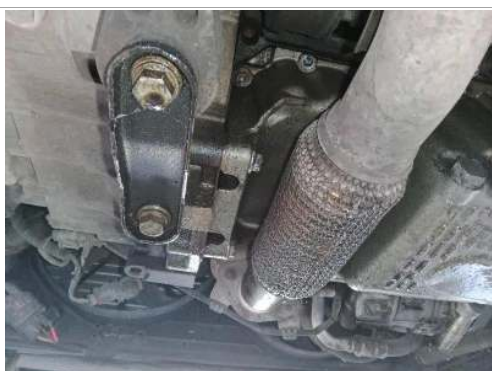
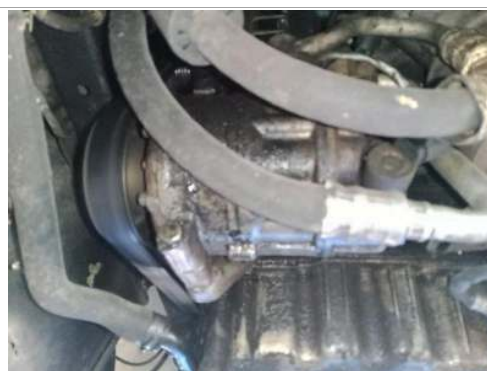
| Damage | Repair Way |
|---|---|
| Engine Oil Leak | Repair |

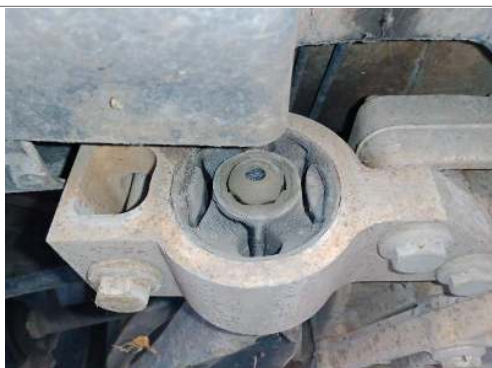
| Damage | Repair Way |
|---|---|
| Control Arm Bush(es) Front Axle Left Cracked | Replace |

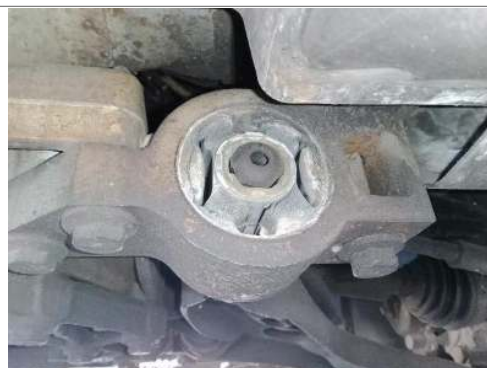
| Damage | Repair Way |
|---|---|
| Control Arm Bush(es) Front Axle Right Cracked | Replace |

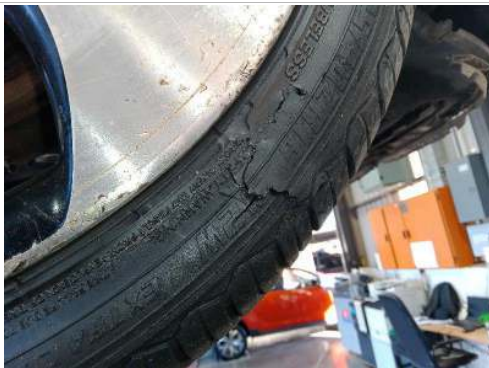
| Damage | Repair Way |
|---|---|
| Tyre Front Right Damaged | Replace |

| | Size | Load/Speed Index | Manufacture | Model | Type* | Production Date | Tread Depth (mm) |
|---|---|---|---|---|---|---|---|
| Front Right | 225/40R18 | 92W | Frun-two | Full run | V | 3919 | 3 mm |
