CONDITION REPORT

Report No: 2016218352

Vehicle Type	PASSENGER VEHICLE	Registered Owner	MFC
Manufacturer	VOLKSWAGEN	Registration Number	KBH184MP
Model	POLO GTI	Register Number	
VIN	WVWZZZ6RZDY087210	Date Of First Licensing	
Engine Number		Last COR	
Doors	5	License Expiry Date	31/10/2023
Color	WHITE	Power / Displacement	
Year Model		Paint Finish	TWO COAT UNI
Km Reading	146,855 KM	Fuel	PETROL
Cab / Body Type	HATCHBACK	Transmission	AUTOMATIC

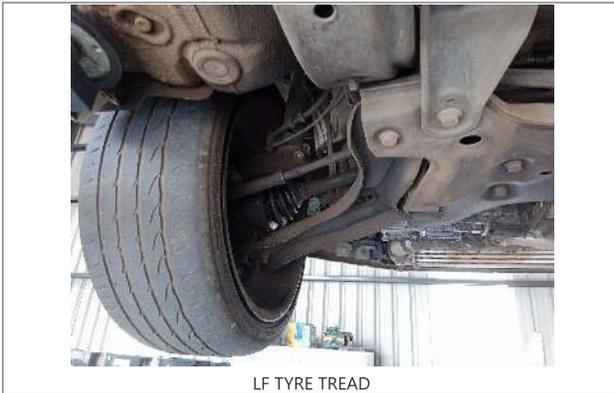
LF TYRE TREAD

Size	Load/Speed Index	Manufacture	Model	Type*	Production Date	Tread Depth (mm)
Front Left	215/40Z R17	87W	Farroad	FR26	V	0521	0 mm
Front Right	215/40 R17	87W	Hifly	HF805	V	2221	2 mm
Rear Left	175/65 R14	82T	Goodyear	GT2	V	4010	4 mm
Rear Right	205/40 R17	84W	Velocity	Speedmax	V	3016	0 mm
Spare	215/40Z R17	87W	Farroad	FRD26	V	0521	0 mm

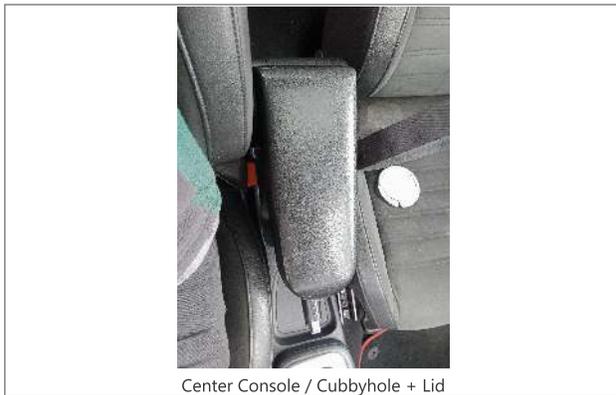
Damage	Repair Way
Engine Oil Leak	Repair
Engine Wiring Defective	Repair
Under bonnet insulation cover Damaged	Replace
Center Console / Cubbyhole + Lid Broken	Repair
Tail Light Left Cracked	Replace
Headlight Left Cracked	Replace
Headlight Right Damaged	Replace
Seat Front Right Torn / Cut	Repair
Door Handle Rear Right Defective	Repair
Door Sealing Rubber Front Right Damaged	Replace
Parcel Tray Missing	Replace
Side Mirror Left Paintwork • Scratched	Repair
Side Mirror Right Paintwork • Scratched	Repair
Front Bumper Damaged	Repair
Bonnet Paintwork • Chipmarks	Repair
Front Fender Left Dented	Repair
Front Fender Right Dented	Repair
Rear Fender Left Residual Traces of Repair	Repair
Rear Fender Right Paintwork • Scratched	Repair
Door Front Left Paintwork • Scratched	Repair
Door Front Right Paintwork • Scratched	Repair
Door Rear Left Dented	Repair
Door Rear Right Paintwork • Scratched	Repair
Boot Lid / Hatch door Dented	Repair

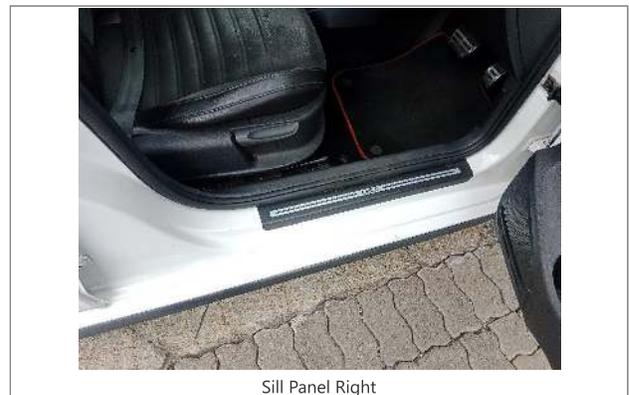
Rear bumper Paintwork • Scratched	Repair
Sill Panel Right Paintwork • Scratched	Repair
Rocker Panel Left Damaged	Repair
Rocker Panel Right Damaged	Repair
Roof Dented	Repair

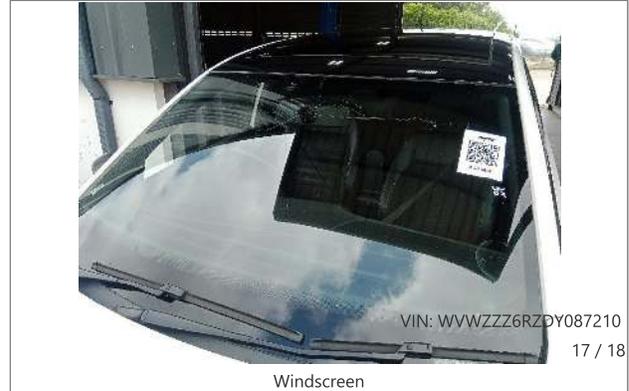
Damage	Repair Way
Windscreen Cracked	Replace
Stabilizer Mounting Front Left Damaged	Replace
Control Arm Bush(es) Front Axle Left Cracked	Replace
Control Arm Bush(es) Front Axle Right Cracked	Replace
Tyre Front Left Damaged	Replace
Tyre Rear Right Worn	Replace
Spare Tyre Damaged	Replace
Rim Front Left Dented	Repair
Rim Front Right Dented	Repair
Rim Rear Right Dented	Repair
Rim Spare Wheel Cracked	Repair
Main Beam Right Dented	Repair
Engine to silencer pipe Defective	Replace
Catalytic converter Missing	Replace
Belly plates Damaged	Replace
Gearbox Oil Leak	Repair
CV Joint(s) Front Left (inner/outer) Defective	Repair
CV Joint(s) Boot(s) Front Left (inner/outer) Damaged	Replace
Radiator Cradle Damaged	Replace
Warning lights illuminated on dashboard	Repair

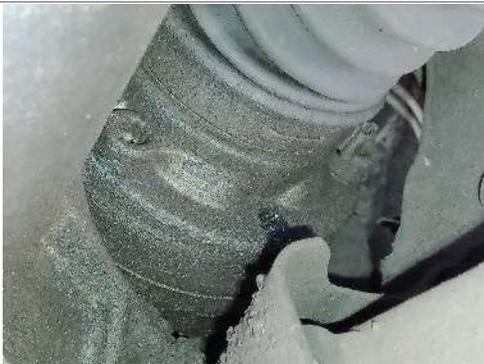
CV Joint(s) Front Left (inner/outer)

Undercarriage: Vehicle undercarriage dirty. Engine splash plate missing. Non standard exhaust fitted to vehicle. Bolt missing on front left inner CV joint.
