CONDITION REPORT

Report No:
2016931041
DATE
01/07/2025

MFC Auction House
M57 Pretoria Rd, Glenmarais, KEMPTON PARK
Gauteng

Vehicle Type	PASSENGER VEHICLE	Registered Owner	MFC
Manufacturer	VOLKSWAGEN	Registration Number	LGG289MP
Model	POLO GP 1.8 TSI GTI 141KW 5-DR DSG [2016-2018]	Register Number	
VIN	WVWZZZ6RZHY071232	Date Of First Licensing	
Engine Number		Last COR	
Doors	5	License Expiry Date	31/01/2026
Color	RED	Power / Displacement	
Year Model	2016	Paint Finish	C - COMMON
Km Reading	203,062 KM	Fuel	PETROL
Cab / Body Type	HATCHBACK	Transmission	AUTOMATIC

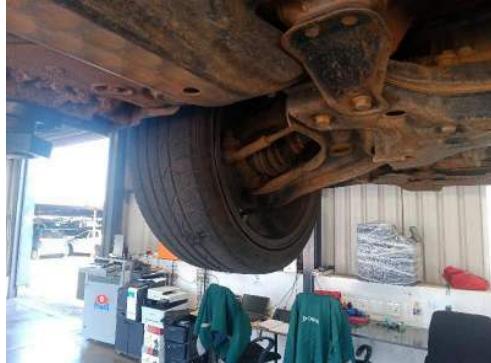
LF TYRE TREAD

Size	Load/Speed Index	Manufacture	Model	Type*	Production Date	Tread Depth (mm)
Front Left	215/40R17	87V	Continental	Contact	V	1418	3 mm
Front Right	215/40R17	87V	Continental	Contact	V	1418	3 mm
Rear Left	215/40R17	87V	Continental	Contact	V	1418	2 mm
Rear Right	215/40R17	87W	Hilo	Vantage xu1	V	1621	3 mm
Spare	T125/60R18	94M	Continental	Temporary	V	2518	3 mm
