## CONDITION REPORT

Report No: 2016337113

| Manufacturer | VOLKSWAGEN | Registration Number | NONE |
| Model | GOLF GTI | Register Number | |

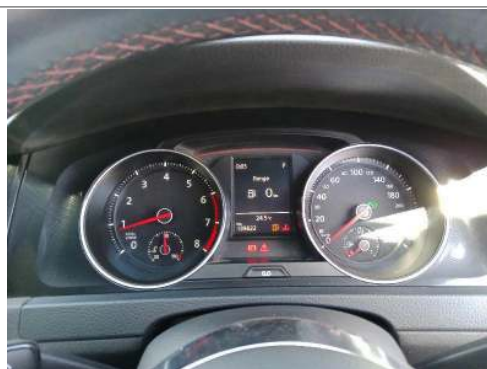
| Damage | Repair Way |
|---|---|
| Warning lights illuminated on dashboard | Repair |

DASHBOARD (W/ ENGINE RUNNING)

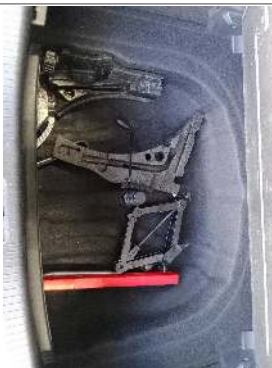
Spare wheel Accessories

| Damage | Repair Way |
|---|---|
| Tyres and rims | Spare wheel missing |

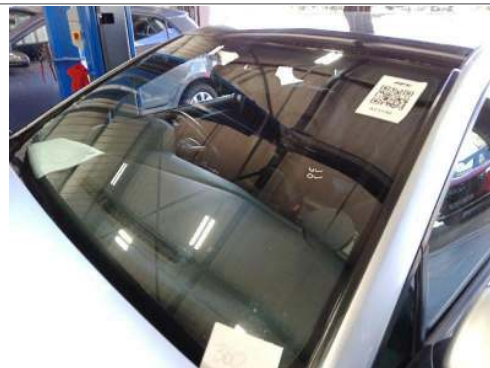
LICENSE DISC

| Damage | Repair Way |
|---|---|
| Vehicle | Vehicle license has no license disc |

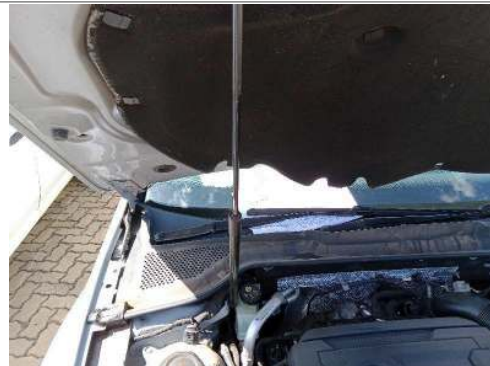
| Damage | Repair Way |
|---|---|
| Bonnet stay and shocks Damaged | Replace |

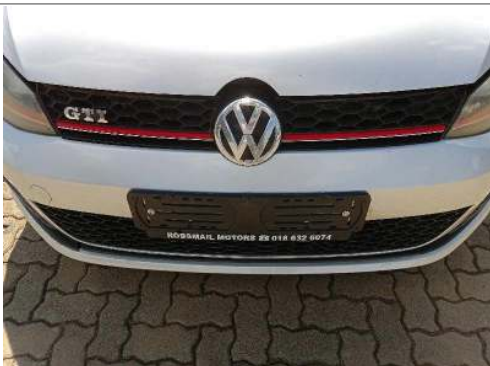
| Damage | Repair Way |
|---|---|
| Number Plate Front Missing | Replace |

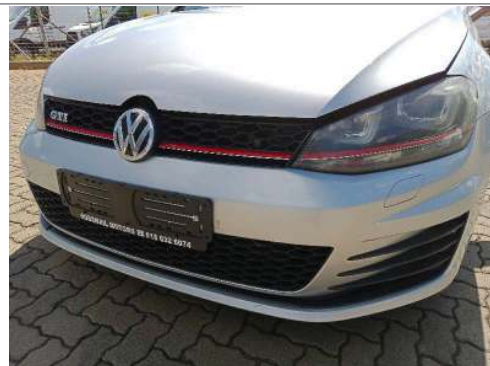
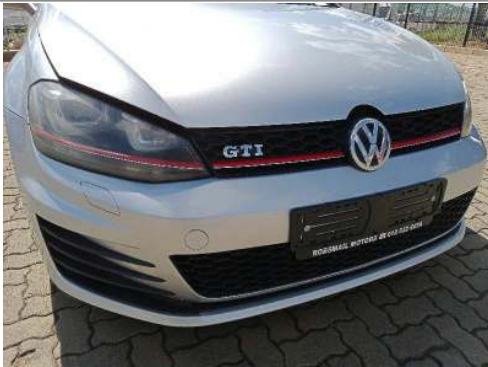
| Damage | Repair Way |
|---|---|
| Front Bumper Residual Traces of Repair | Repair |

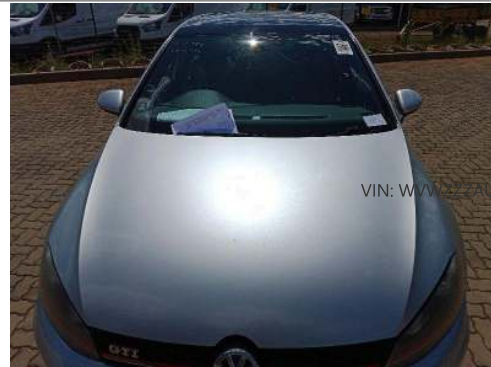
| Damage | Repair Way |
|---|---|
| Bonnet Residual Traces of Repair | Repair |

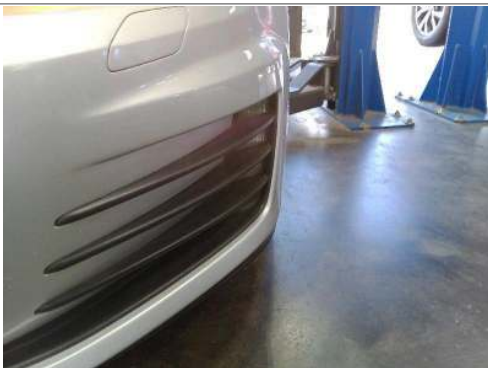
| Damage | Repair Way |
|---|---|
| Park Light Front Left Defective | Replace |

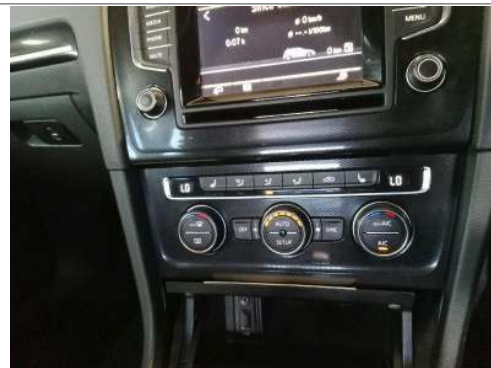
| Damage | Repair Way |
|---|---|
| Air Conditioner Insufficient | Replace |

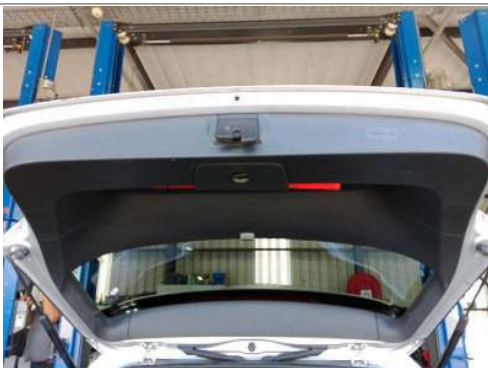
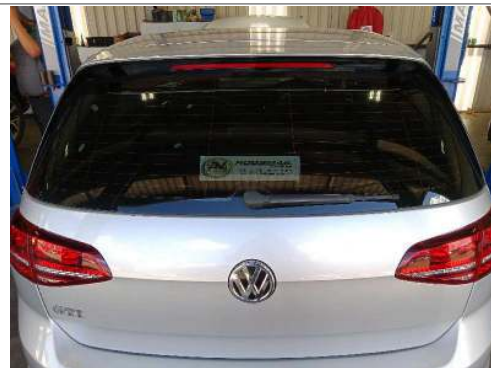
| Damage | Repair Way |
|---|---|
| Boot Lid / Hatch door Paintwork • Scratched | Repair |

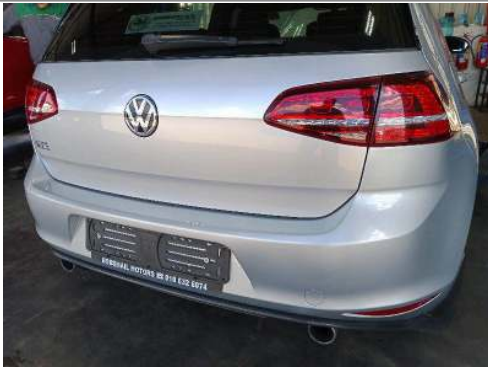
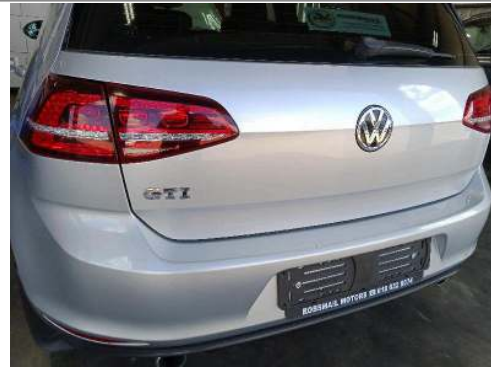
| Damage | Repair Way |
|---|---|
| Rear bumper Paintwork • Scratched | Repair |

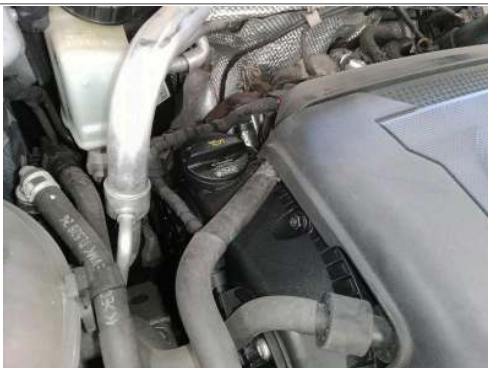
| Damage | Repair Way |
|---|---|
| Engine Oil Leak | Repair |
| Engine Noise Excessive | Repair |

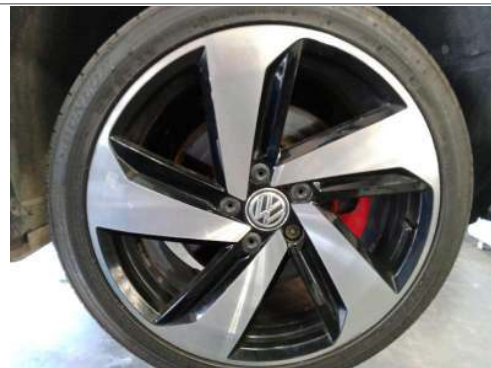
| Damage | Repair Way |
|---|---|
| Rim Front Right Scratched | Repair |

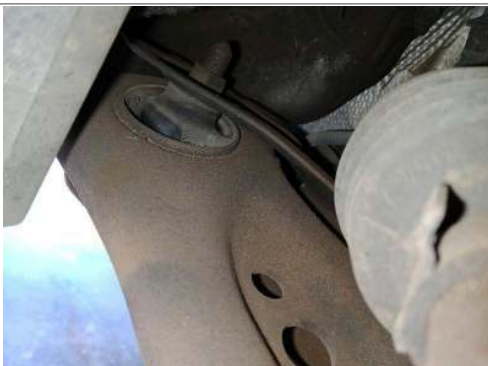
| Damage | Repair Way |
|---|---|
| Control Arm Bush(es) Front Axle Right Cracked | Replace |

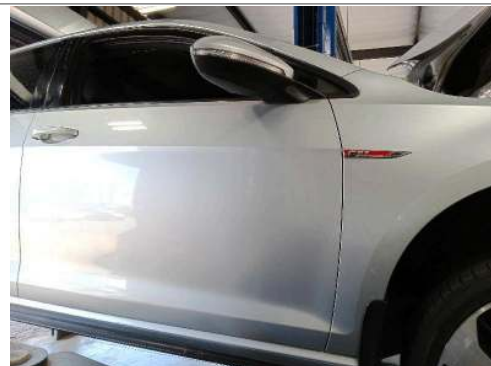
| Damage | Repair Way |
|---|---|
| Door Front Right Paintwork • Scratched | Repair |

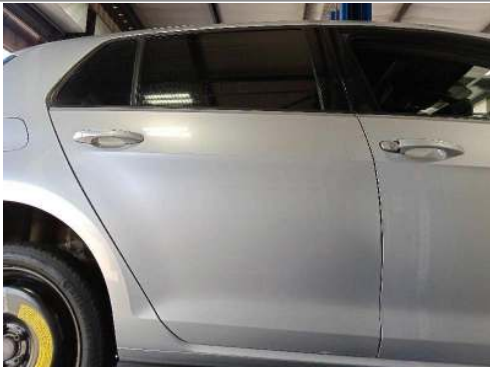
| Damage | Repair Way |
|---|---|
| Door Rear Right Paintwork • Scratched | Repair |

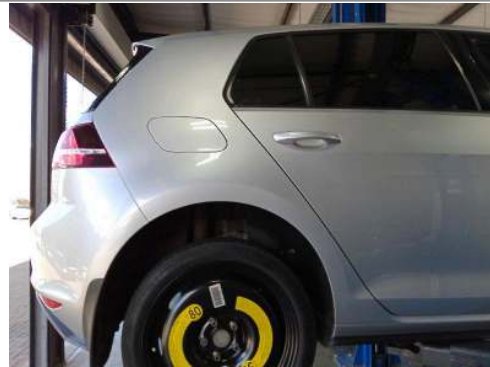
| Damage | Repair Way |
|---|---|
| Rear Fender Right Paintwork • Scratched | Repair |

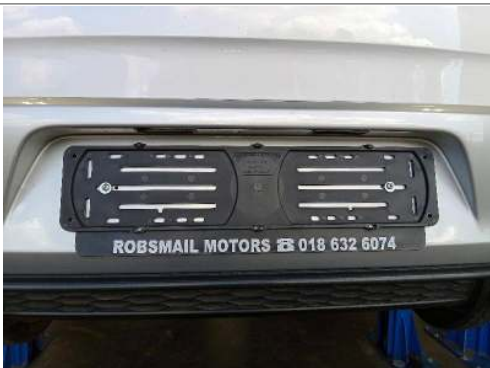
| Damage | Repair Way |
|---|---|
| Number Plate Rear Missing | Replace |

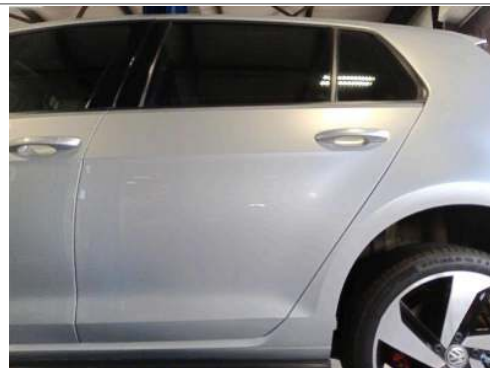
| Damage | Repair Way |
|---|---|
| Door Rear Left Residual Traces of Repair | Repair |

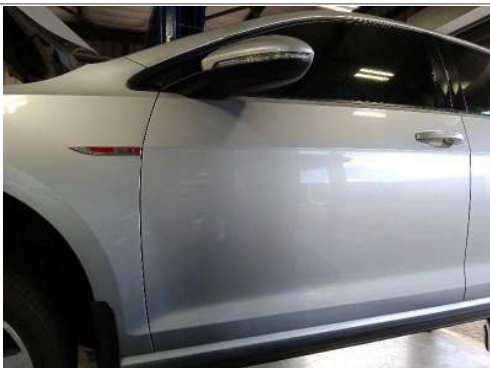
| Damage | Repair Way |
|---|---|
| Door Front Left Residual Traces of Repair | Repair |

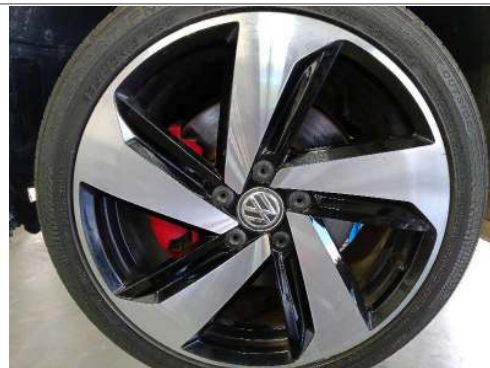
| Damage | Repair Way |
|---|---|
| Rim Front Left Scratched | Repair |

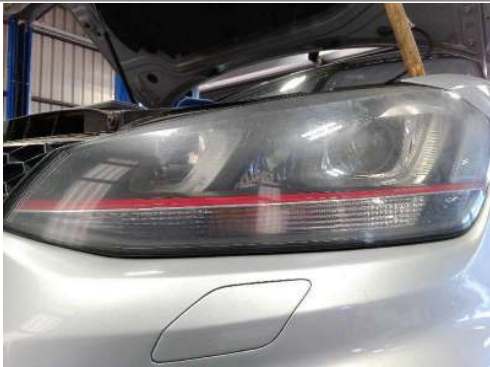
| Damage | Repair Way |
|---|---|
| Headlight Left Defective | Replace |

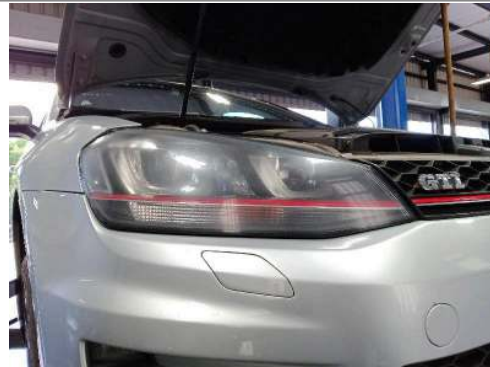
| Damage | Repair Way |
|---|---|
| Headlight Right Defective | Replace |

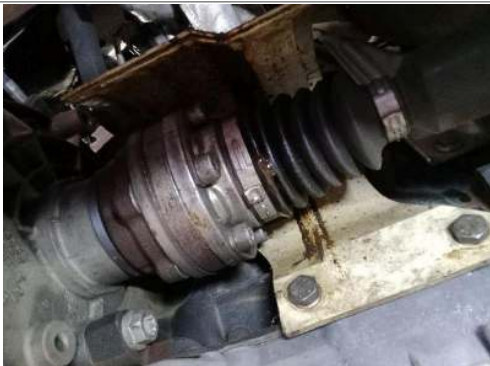
| Damage | Repair Way |
|---|---|
| CV Joint(s) Boot(s) Front Right (inner/outer) Damaged | Replace |

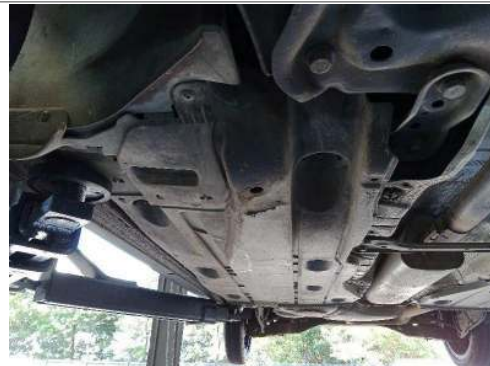
| Damage | Repair Way |
|---|---|
| Belly plates Damaged | Repair |

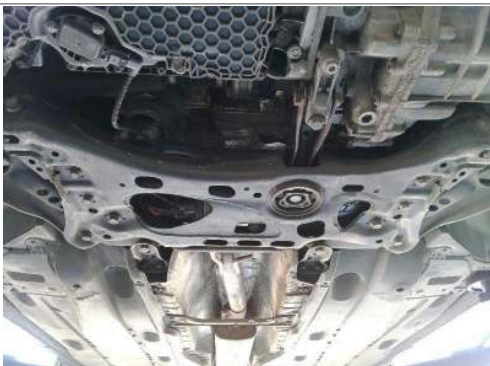
| Damage | Repair Way |
|---|---|
| Sub Frame Dented | Repair |

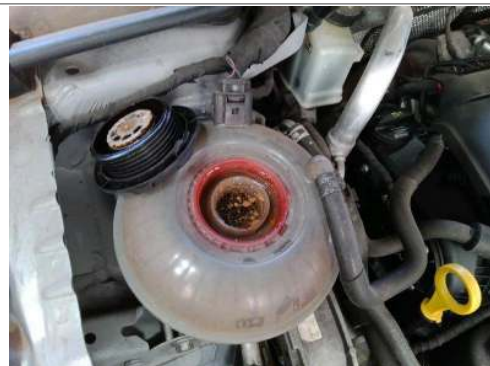
| Damage | Repair Way |
|---|---|
| Expansion Bottle Defective | Repair |

General Comments: ACCORDING TO THE AGE AND MILEAGE OF THE VEHICLE, NORMAL WEAR AND TEAR MARKS ARE VISIBLE ON THE INTERIOR, EXTERIOR, ELECTRICAL AND MECHANICAL PARTS. FOREIGN SUBSTANCE IN EXPANSION BOTTLE.

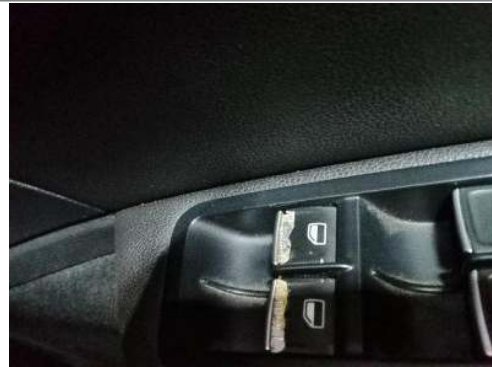
| Damage | Repair Way |
|---|---|
| Switch Electrical Window Winder front left Defective | Replace |

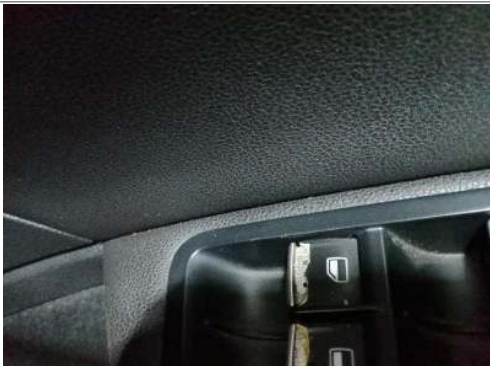
| Damage | Repair Way |
|---|---|
| Switch Electrical Window Winder front right Defective | Replace |

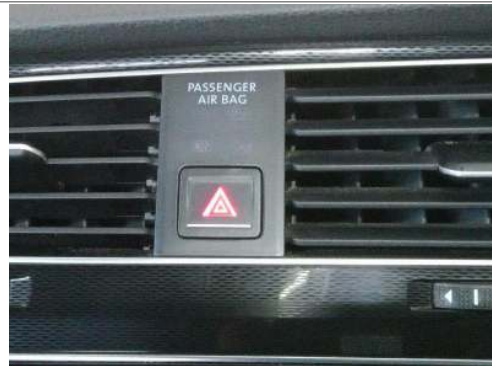
| Damage | Repair Way |
|---|---|
| Hazard Lights Defective | Replace |
