CONDITION REPORT

Report No: 2016220515

MFC Auction House
M57 Pretoria Rd, Glenmarais, KEMPTON PARK
Gauteng

Vehicle Type	PASSENGER VEHICLE	Registered Owner	MFC
Manufacturer	VOLKSWAGEN	Registration Number	NDE22350
Model	GOLF	Register Number	
VIN	WVWZZZAUZHW188096	Date Of First Licensing	
Engine Number		Last COR	
Doors	5	License Expiry Date	30/09/2023
Color	RED	Power / Displacement	
Year Model		Paint Finish	M - METALLIC
Km Reading	136,724 KM	Fuel	PETROL
Cab / Body Type	HATCHBACK	Transmission	AUTOMATIC

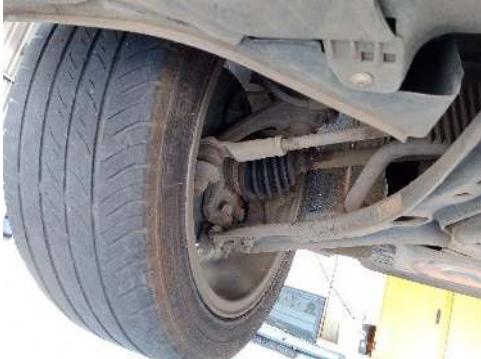
LF TYRE TREAD

Size	Load/Speed Index	Manufacture	Model	Type*	Production Date	Tread Depth (mm)
Front Left	225/45R17	94W	Hilo	Green plus	V	0119	1 mm
Front Right	225/45R17	94W	Goodyear	Goodyear	V	0921	5 mm
Rear Left	225/45R17	94W	Goodyear	Goodyear	V	0000	6 mm
Rear Right	225/45R17	94W	Goodyear	Goodyear	V	0821	5 mm
Spare	205/50R17	93W	Tracmak	Radial	V	////	1 mm

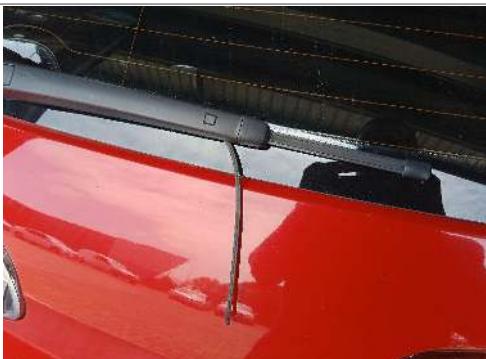
Damage	Repair Way
Switch Electrical Window Winder rear right Damaged	Repair
Windscreen Wiper Worn	Replace
Seat Front Right Torn / Cut	Repair
Front Fender Right Damaged	Repair
Rear Fender Left Paintwork • Flaking	Repair
Rear Fender Right Paintwork • Scratched	Repair
Door Rear Left Paintwork • Scratched	Repair
Rear bumper Paintwork • Flaking	Repair
Tyre Front Right Damaged	Replace
