CONDITION REPORT

Report No: 2016204986

MFC Auction House
M57 Pretoria Rd, Glenmarais, KEMPTON PARK
Gauteng

| Manufacturer | VOLKSWAGEN | Registration Number | HK41BWGP |

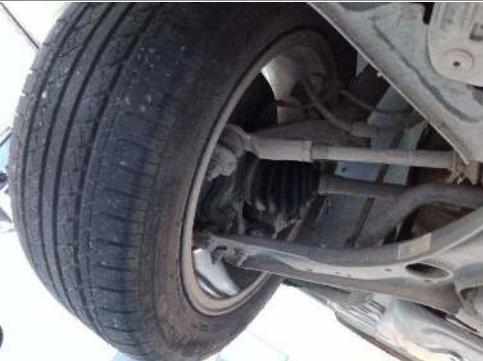
LF TYRE TREAD

| | Size | Load/Speed Index | Manufacture | Model | Type* | Production Date | Tread Depth (mm) |
|---|---|---|---|---|---|---|---|
| Front Left | 205/55R16 | 91V | GT radial | Champro | V | 1221 | 2 mm |

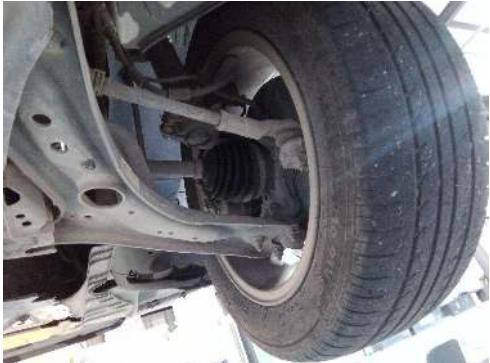
RF TYRE TREAD

| | Size | Load/Speed Index | Manufacture | Model | Type* | Production Date | Tread Depth (mm) |
|---|---|---|---|---|---|---|---|
| Front Right | 205/55R16 | 91V | GT radial | Champro | V | 1221 | 3 mm |

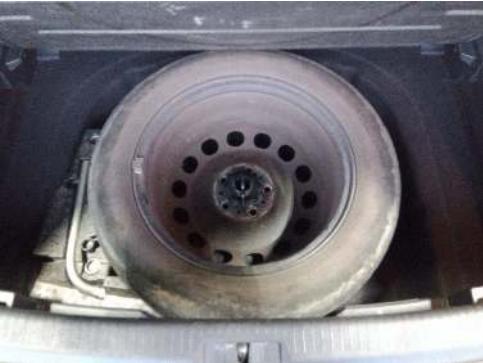
Sparewheel

| | Size | Load/Speed Index | Manufacture | Model | Type* | Production Date | Tread Depth (mm) |
|---|---|---|---|---|---|---|---|
| Spare | 205/55R15 | 91V | Continental | Contact | V | ////// | 0 mm |

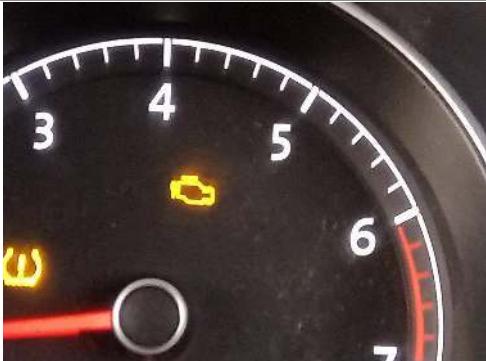
Engine warning light illuminat

| Damage | Repair Way |
|--|---|
| Engine warning light illuminated. | Repair. |

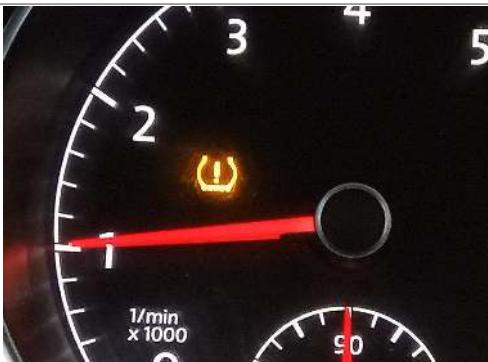
Tyre pressure warning light il

| Damage | Repair Way |
|--|---|
| Tyre pressure warning light illuminated. | Repair. |

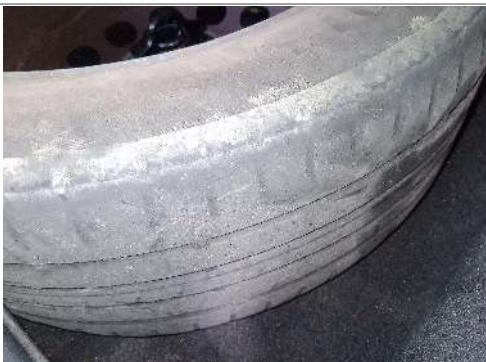
| Damage | Repair Way |
|--|---|
| Spare Tyre Smooth | Replace |

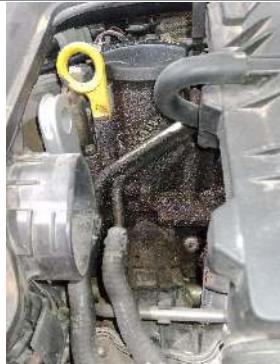
| Damage | Repair Way |
|--|---|
| Engine Oil Leak | Repair |

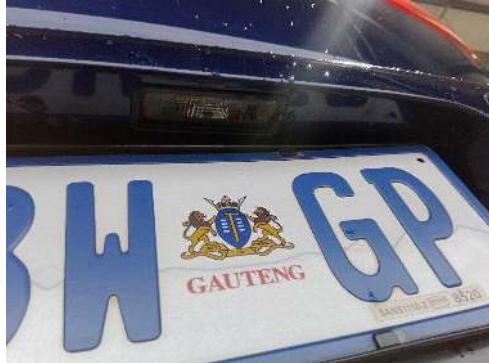
| Damage | Repair Way |
|--|---|
| Number Plate Light Right Defective | Repair |

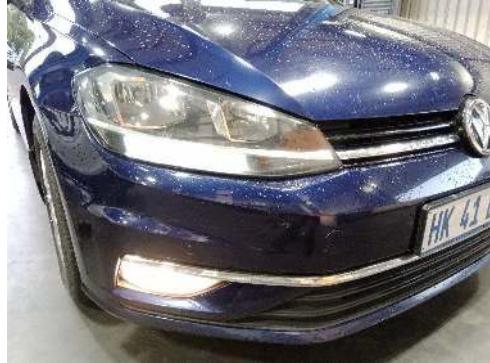
| Damage | Repair Way |
|--|---|
| Dim Light Right Defective | Repair |
