MFC Auction House  
M57 Pretoria Rd, Glenmarais, KEMPTON PARK  
Gauteng

Vehicle Type	PASSENGER VEHICLE	Registered Owner	MFC AUCTION HOUSE
Manufacturer	TOYOTA	Registration Number	KG64KXGP
Model	QUANTUM	Register Number	
VIN	AHTSX22PX07036993	Date Of First Licensing	
Engine Number		Last COR	
Doors	4	License Expiry Date	31/03/2024
Color	WHITE	Power / Displacement	
Year Model		Paint Finish	C - COMMON
Km Reading	307,724 KM	Fuel	PETROL
Cab / Body Type	OTHERS	Transmission	MANUAL

## CONDITION REPORT

Report No: 2016355293

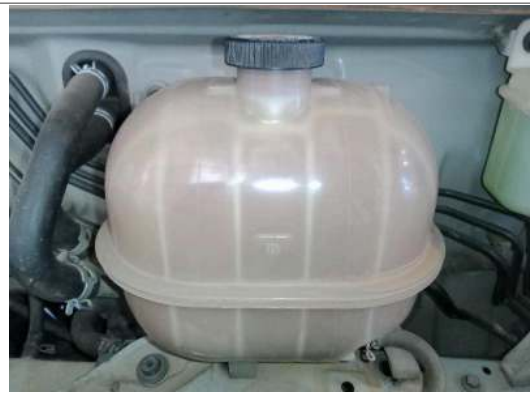
Coolant bottle

Damage	Repair Way
Engine Oil Leak	Repair
Engine Wiring Defective	Repair
Expansion Bottle Defective	Repair
Fan Damaged	Replace
Tail Light Left Damaged	Replace
Tail Light Right Damaged	Replace
Headlight Left Damaged	Replace
Headlight Right Damaged	Replace
Seat Front Left Damaged	Repair
Seat Rear Damaged	Repair
Seat Rear ( 2. Row) Damaged	Repair
Front Lower Valance Dented	Repair
Front Bumper Damaged	Repair
Bonnet Dented	Repair
B • Pillar Left Welded	Repair
C • Pillar Left Residual Traces of Repair	Repair
Rear Fender Left Dented	Repair
Front Fender Left / Inner Tray Residual Traces of Repair	Repair
Front Fender Right / Inner Tray Damaged	Repair
Door Front Left Paintwork • Scratched	Repair
Door Front Right Dented	Repair
Door Rear Right Paintwork • Scratched	Repair
Boot Lid / Hatch door Dented	Repair
Rear bumper Paintwork • Scratched	Repair
Sill Panel Left Welded	Repair
Sill Panel Right Dented	Repair
Sliding Door Paintwork • Scratched	Repair

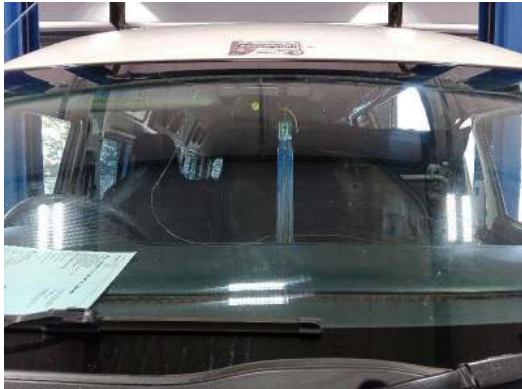
Windscreen Cracked	Replace

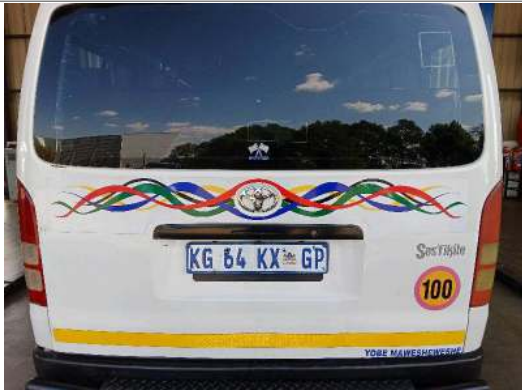
Boot Lid / Hatch door

Damage	Repair Way
Service Brake Performance Rear Axle Left / Right	Repair
Difference out of legal range	
Parking Brake Performance Malfunction	Repair
Tyre Rear Right Smooth	Replace
Spare Tyre Torn / Cut	Replace
Fuel Tank Dented	Replace
Radiator Cradle Welded	Repair
Boot not opening	Repair
Vehicle is cut and join on l/F maine beam	Repair
Airbag light on	Repair
