## CONDITION REPORT

Report No: 2016442290

Vehicle Type	PASSENGER VEHICLE	Registered Owner	MFC AUCTION HOUSE
Manufacturer	VOLKSWAGEN	Registration Number	NP72991
Model	POLO	Register Number	
VIN	AAVZZZ6RZDU031748	Date Of First Licensing	
Engine Number		Last COR	
Doors	5	License Expiry Date	04/07/2024
Color	RED	Power / Displacement	
Year Model		Paint Finish	TWO COAT METALLIC
Km Reading	255,693 KM	Fuel	PETROL
Cab / Body Type	HATCHBACK	Transmission	MANUAL

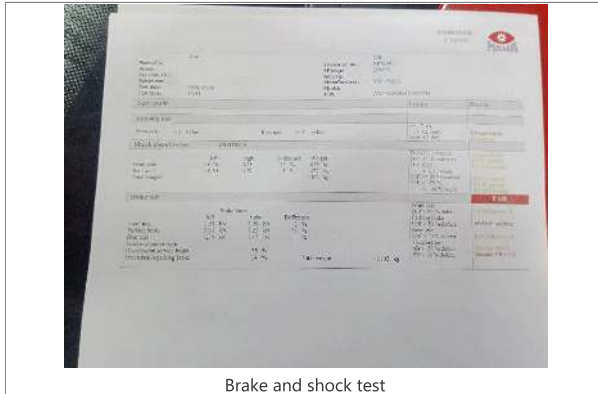
Brake and shock test

Left	Right	Axle Weight [KG]	Deceleration [m/s <sup>2</sup> ]
	Braking Force [KN]	Braking Force [KN]		
Front	2.51	2.58	-	
Rear	1.54	1.47	-	
Emergency / Parking	0.33	1.23	-

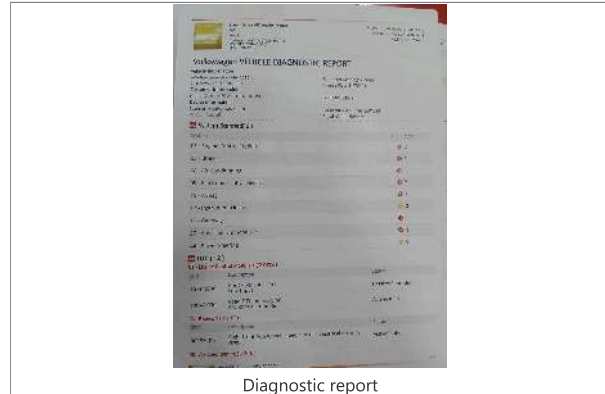
Diagnostic report

During the diagnostic the following error messages were detected: (See also attached Diagnostic Report. For more information regarding the Fault Codes (DTC) and the recommended rectifications please contact the workshops of the vehicle manufacture).

No	System	Code	Description	Status
1	GATEWAY	01304:004	RADIO- NO SIGNAL/ COMMUNICATION

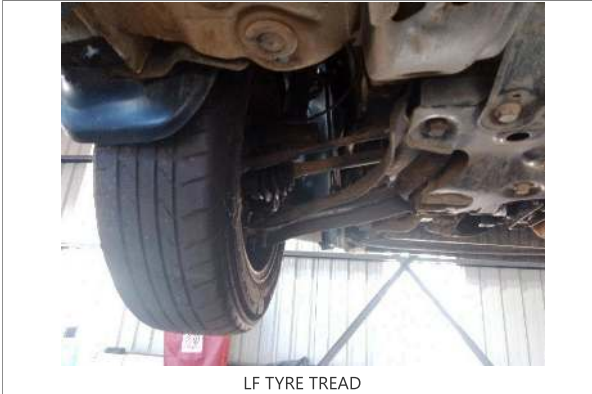
LF TYRE TREAD

Size	Load/Speed Index	Manufacture	Model	Type*	Production Date	Tread Depth (mm)
Front Left	185/60R15	84H	Maxtrek	Radial	V	1622	2 mm
Front Right	185/60R15	84H	Hilo	Radial	V	1921	0 mm
Rear Left	195/60R15	88H	Continental	Contieco	V	2803	2 mm
Rear Right	185/60R15	84H	Hilo	Radial	V	3822	3 mm

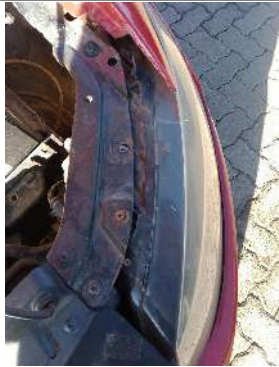
Damage	Repair Way
Engine Oil Leak	Replace
Central Air Vent Damaged	Replace
Radio/CD/USB Missing	Replace
Engine Management Lights Set	Replace
Headlight Left Damaged	Replace
Headlight Right Damaged	Replace
Seat Front Right Damaged	Repair
Seat Rear Damaged	Repair
Front Bumper Damaged	Repair
Bonnet Damaged	Repair
Front Fender Left Damaged	Repair
Front Fender Right Damaged	Repair
Rear Fender Left Damaged	Repair
Rear Fender Right Damaged	Repair
Door Front Left Damaged	Repair
Door Rear Left Damaged	Repair
Rear bumper Damaged	Repair
Roof Damaged	Repair
Tie Rod End left Worn	Replace
Wheel bearing Rear Right Excessive Wear & Tear	Replace
Tyre Front Right Worn	Replace
Gearbox Oil Leak	Replace
Radiator Cradle Damaged	Replace
Steering Insufficient	Repair
Engine	Battery loose
interior	ignition damage starter button fitted to vehicle
interior	vehicle interior in poor condition
interior	some interior panels missing
Body and exterior	Signs of stone chips to some body panels.

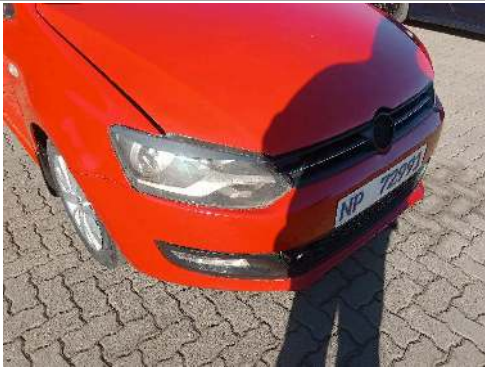
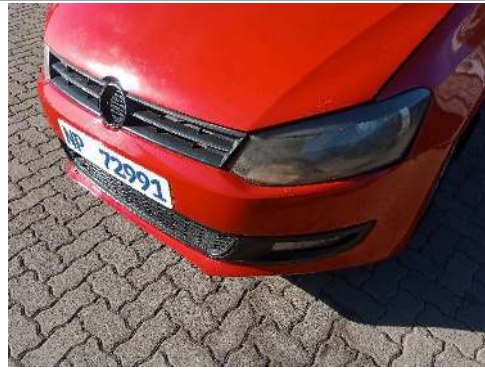
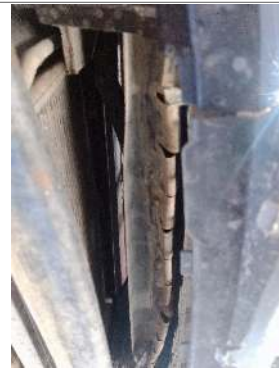
Front Bumper

Damage	Repair Way
Body and exterior	Signs of repair work done to somebody panels.
Body and exterior	Poor alignment to somebody panels.
Body and exterior	Repair work done to vehicle below standard.
Body and exterior	Vehicle body in poor condition.
Body and exterior	Signs of impact damage to front of vehicle
axle and suspension	excessive noise from front and rear suspension
