MFC Auction House  
M57 Pretoria Rd, Glenmarais, KEMPTON PARK  
Gauteng

DEKRA MFC  
M57 Pretoria Rd - 1619  
KEMPTON PARK - GT  
08610 33572

## CONDITION REPORT

Report No: 2016210205

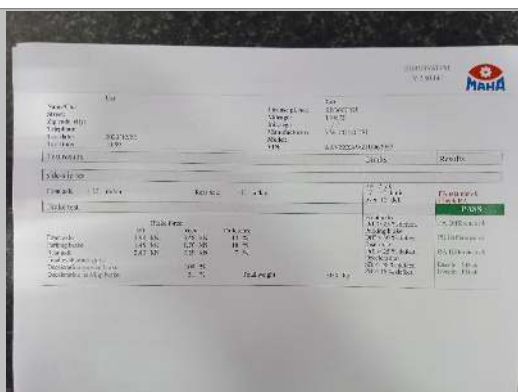
Shock and brake report

| | Left | Right | | |
|---|---|---|---|---|
| Front | 2.9 | 3.4 | - | |
| Rear | 2.4 | 2.5 | - | |
| Emergency / Parking | 1.4 | 1.7 | - | |

General Comments: ACCORDING TO AGE AND MILEAGE OF VEHICLE NORMAL WEAR AND TEAR ON INTERIOR, EXTERIOR, ELECTRICAL AND MECHANICAL PARTS. SHOCK TEST NOT PERFORMED DUE TO SHOCK MACHINE NOT WORKING.

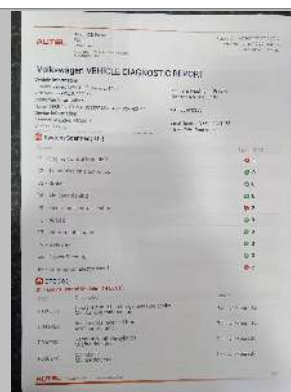
Diagnostic test

During the diagnostic no active error messages were detected. (See also attached Diagnostic Report. For more information regarding the Fault Codes (DTC) and the recommended rectifications please contact the workshops of the vehicle manufacture).

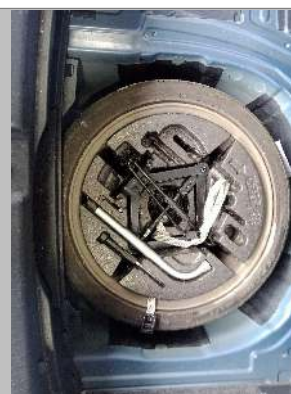
Sparewheel

| | Size | Load/Speed Index | Manufacture | Model | Type* | Production Date | Tread Depth (mm) |
|---|---|---|---|---|---|---|---|
| Spare | 215/40R17 | 87W | Nexen | Nfera | V | 0000 | 3 mm |

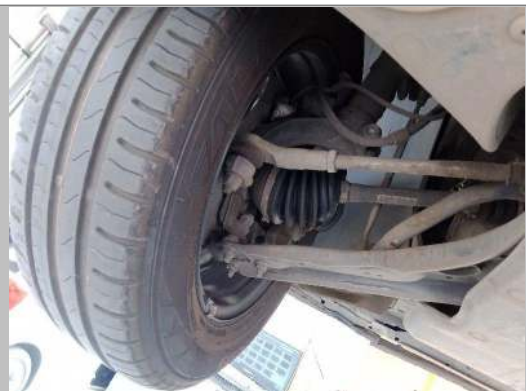
LF TYRE TREAD

| | Size | Load/Speed Index | Manufacture | Model | Type* | Production Date | Tread Depth (mm) |
|---|---|---|---|---|---|---|---|
| Front Left | 185/65R15 | 88H | Falken | Sincera | V | 1818 | 6 mm |

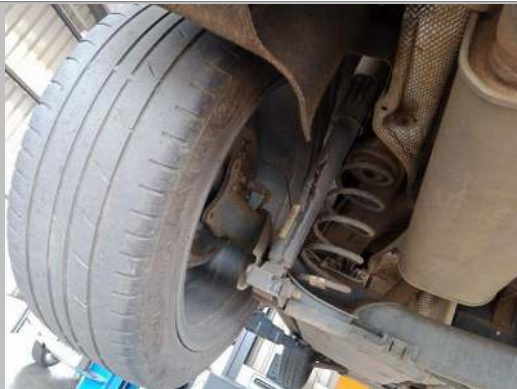
LR TYRE TREAD

| | Size | Load/Speed Index | Manufacture | Model | Type* | Production Date | Tread Depth (mm) |
|---|---|---|---|---|---|---|---|
| Rear Left | 215/45R17 | 91W | Royal Black | Royal perfor | V | 0421 | 1 mm |

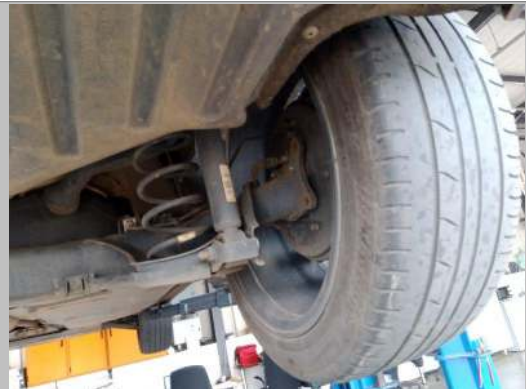
RR TYRE TREAD

| | Size | Load/Speed Index | Manufacture | Model | Type* | Production Date | Tread Depth (mm) |
|---|---|---|---|---|---|---|---|
| Rear Right | 215/45R17 | 91W | Royal Black | Royal perfor | V | 0121 | 1 mm |

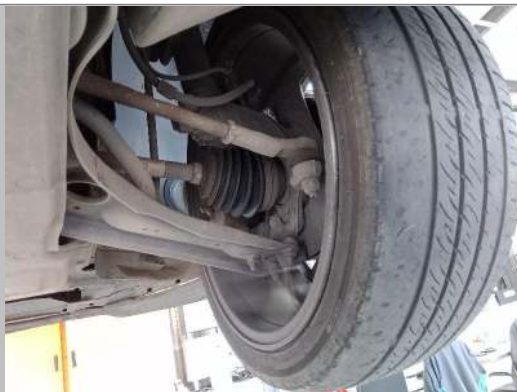
RF TYRE TREAD

| Damage | Repair Way |
|---|---|
| Front tyre size differs. | Replace |

| | Size | Load/Speed Index | Manufacture | Model | Type* | Production Date | Tread Depth (mm) |
|---|---|---|---|---|---|---|---|
| Front Right | 215/40R17 | 87W | Autogrip | P308 | V | 3421 | 0 mm |

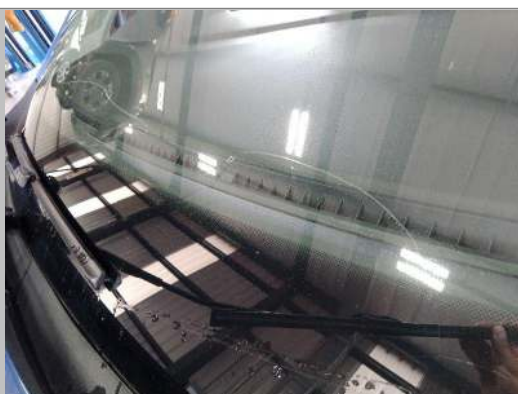
| Damage | Repair Way |
|---|---|
| Windscreen Cracked | Replace |

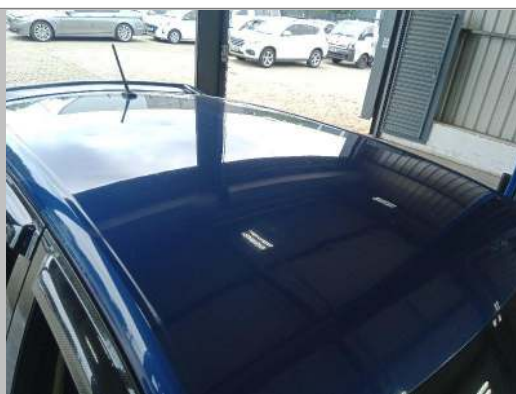
| Damage | Repair Way |
|---|---|
| Roof Dented | Repair |

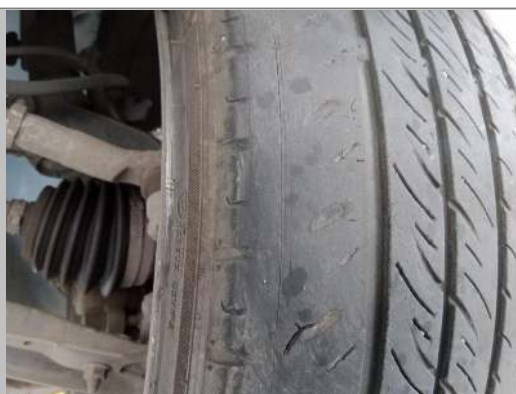
| Damage | Repair Way |
|---|---|
| Tyre Front Right Smooth | Replace |
