CONDITION REPORT

Report No: 2016292128

Vehicle Type	PASSENGER VEHICLE	Registered Owner	MFC AUCTION HOUSE
Manufacturer	FORD	Registration Number	JR77LSGP
Model	EVEREST	Register Number	
VIN	AFAJXXMJWJHB72867	Date Of First Licensing	
Engine Number		Last COR	
Doors	5	License Expiry Date	31/03/2024
Color	BLACK	Power / Displacement	
Year Model		Paint Finish	TWO COAT METALLIC
Km Reading	133,580 KM	Fuel	DIESEL
Cab / Body Type	SUV	Transmission	AUTOMATIC

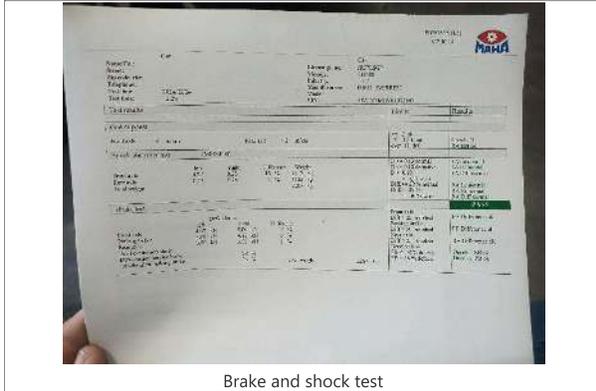
Brake and shock test

Left	Right	Axle Weight [KG]	Deceleration [m/s ²]
	Braking Force [KN]	Braking Force [KN]		
Front	4.67	5.0	-	
Rear	3.9	3.87	-	
Emergency / Parking	3.9	4.13	-

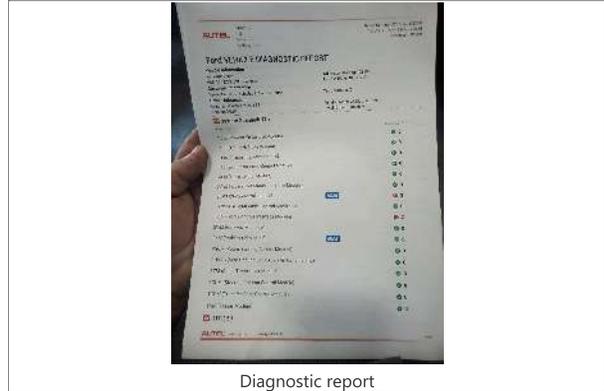
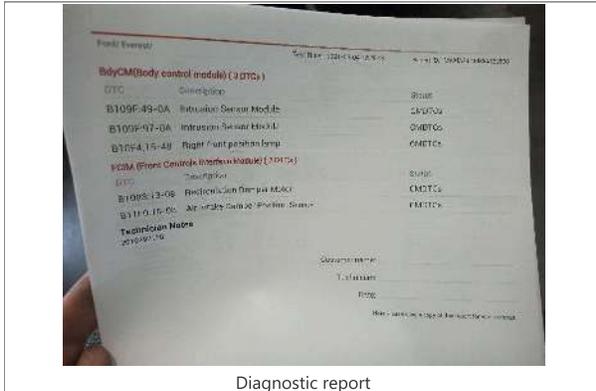
Diagnostic report

During the diagnostic no active error messages were detected. (See also attached Diagnostic Report. For more information regarding the Fault Codes (DTC) and the recommended rectifications please contact the workshops of the vehicle manufacture).

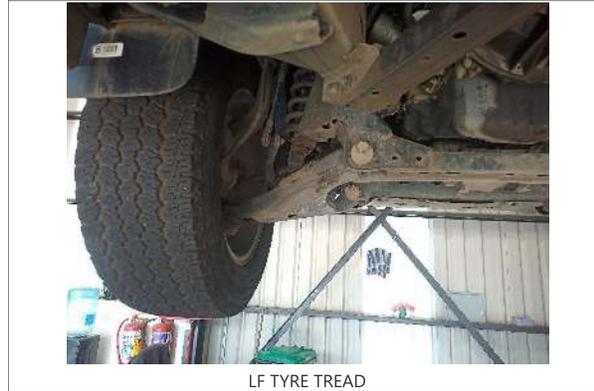
LF TYRE TREAD

Size	Load/Speed Index	Manufacture	Model	Type*	Production Date	Tread Depth (mm)
Front Left	265/60R18	110H	Goodyear	Wrangler	V	0522	2 mm
Front Right	265/60R18	110H	Goodyear	Wrangler	V	0922	3 mm
Rear Left	265/60R18	110H	Goodyear	Wrangler	V	0522	3 mm
Rear Right	265/60R18	110H	Goodyear	Wrangler	V	0522	3 mm

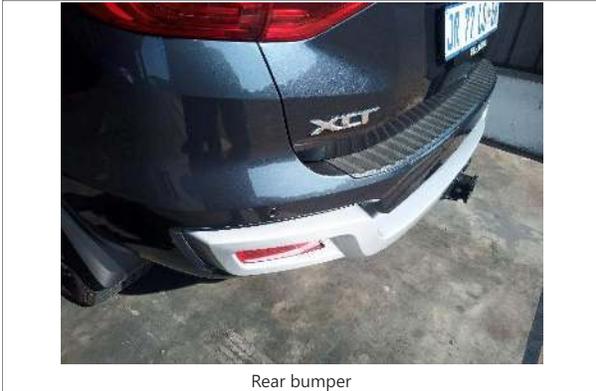
Damage	Repair Way
Engine Oil Leak	Repair
Front Bumper Damaged	Repair
Bonnet Damaged	Repair
Front Fender Left Damaged	Repair
Front Fender Right Damaged	Repair
Rear Fender Right Damaged	Repair
Door Front Left Damaged	Repair
Door Front Right Damaged	Repair
Door Rear Left Damaged	Repair
Door Rear Right Damaged	Repair
Rear bumper Damaged	Repair
Gearbox Oil Sweat	Repair
Body and exterior	Signs of repair work done to somebody panels.
Body and exterior	Poor alignment to some body panels.
