MFC Auction House  
M57 Pretoria Rd, Glenmarais, KEMPTON PARK  
Gauteng

| Manufacturer | FORD | Registration Number | JPY079MP |

## CONDITION REPORT

Report No: 2016343347

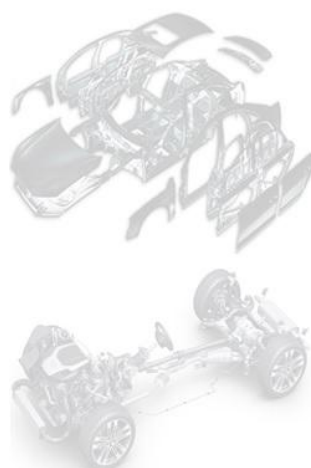
Front Bumper Paintwork • Scratched  
Front Fender Left Dented  
Front Fender Right Dented  
Rear Fender Left Paintwork • Scratched  
Door Front Left Dented  
Tailgate Dented

Repair  
Repair  
Repair  
Repair  
Repair  
Repair

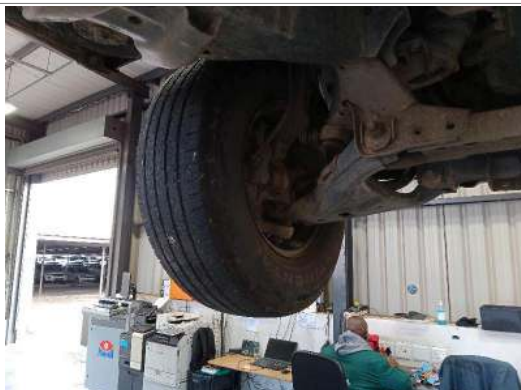
LF TYRE TREAD

| | Size | Load/Speed Index | Manufacture | Model | Type* | Production Date | Tread Depth (mm) |
|---|---|---|---|---|---|---|---|
| Front Left | 255/70R16 | 111T | Continental | Contact | V | 2921 | 3 mm |

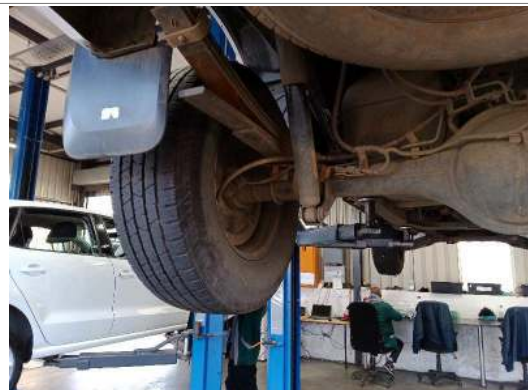
LR TYRE TREAD

| | Size | Load/Speed Index | Manufacture | Model | Type* | Production Date | Tread Depth (mm) |
|---|---|---|---|---|---|---|---|
| Rear Left | 255/70R16 | 111T | Continental | Contact | V | 2921 | 3 mm |

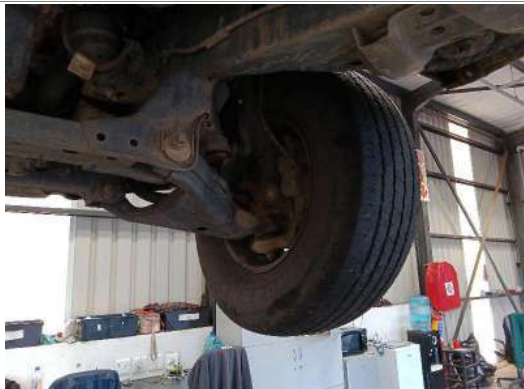
RF TYRE TREAD

| | Size | Load/Speed Index | Manufacture | Model | Type* | Production Date | Tread Depth (mm) |
|---|---|---|---|---|---|---|---|
| Front Right | 255/70R16 | 111T | Continental | Contact | V | 2921 | 3 mm |

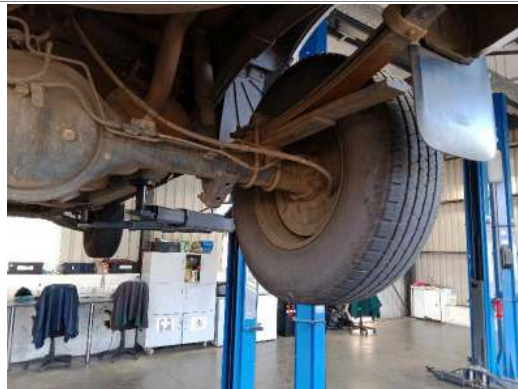
RR TYRE TREAD

| | Size | Load/Speed Index | Manufacture | Model | Type* | Production Date | Tread Depth (mm) |
|---|---|---|---|---|---|---|---|
| Rear Right | 255/70R16 | 111T | Continental | Contact | V | 2921 | 3 mm |

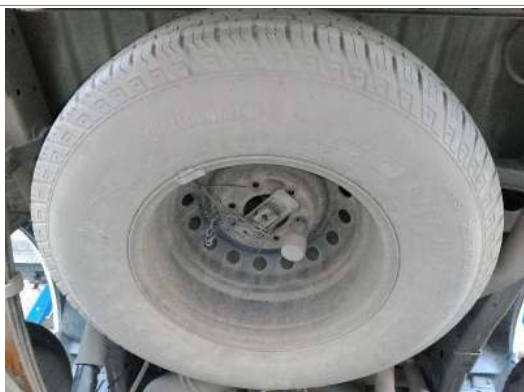
Spare wheel

| | Size | Load/Speed Index | Manufacture | Model | Type* | Production Date | Tread Depth (mm) |
|---|---|---|---|---|---|---|---|
| Spare | 255/70R16 | 111T | Continental | Contact | V | //// | 5 mm |

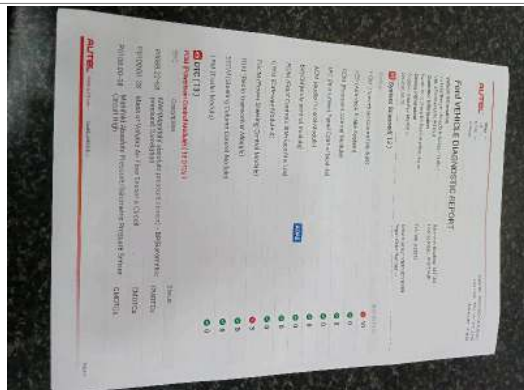
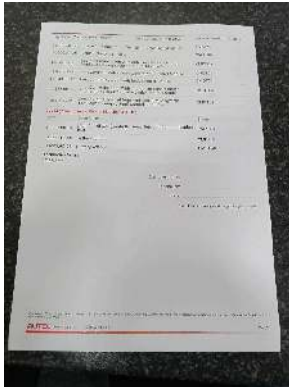
DIAGNOSTIC REPORT PAGE 1

During the diagnostic no active error messages were detected. (See also attached Diagnostic Report. For more information regarding the Fault Codes (DTC) and the recommended rectifications please contact the workshops of the vehicle manufacture).
