CONDITION REPORT

Report No: 2016391814

Vehicle Type	PASSENGER VEHICLE	Registered Owner	MFC AUCTION HOUSE
Manufacturer	TOYOTA	Registration Number	FXC710L
Model	QUANTUM	Register Number	
VIN	AHTSS22P007138270	Date Of First Licensing	
Engine Number		Last COR	
Doors	4	License Expiry Date	31/10/2023
Color	WHITE	Power / Displacement	
Year Model		Paint Finish	TWO COAT UNI
Km Reading	35,349 KM	Fuel	DIESEL
Cab / Body Type	STATION WAGON	Transmission	MANUAL

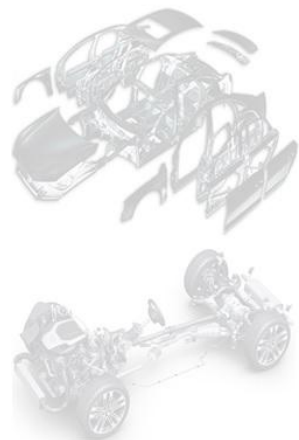
Damage	Repair Way
Front Bumper Damaged	Repair
Rear Fender Left Damaged	Repair
Rear Fender Right Damaged	Repair
Windscreen Damaged	Repair

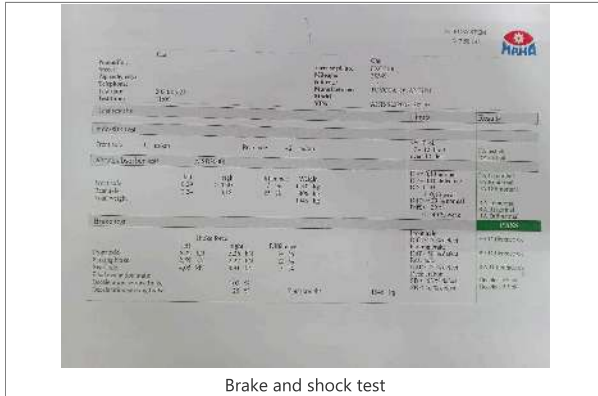
Brake and shock test

Left	Right	Axle Weight [KG]	Deceleration [m/s ²]
	Braking Force [KN]	Braking Force [KN]		
Front	6.22	5.36	-	
Rear	4.05	3.91	-	
Emergency / Parking	2.59	2.27	-

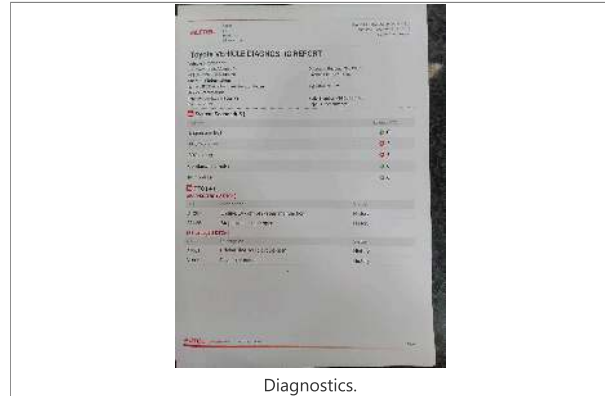
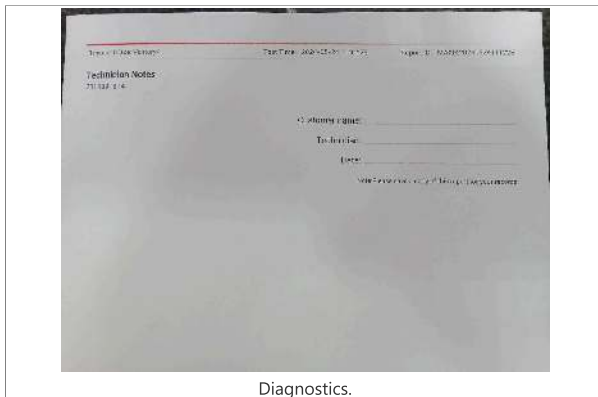
Diagnostics.

During the diagnostic no active error messages were detected. (See also attached Diagnostic Report. For more information regarding the Fault Codes (DTC) and the recommended rectifications please contact the workshops of the vehicle manufacture).

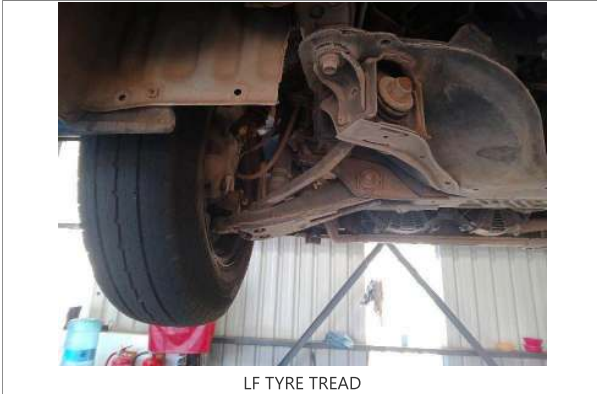
LF TYRE TREAD

Size	Load/Speed Index	Manufacture	Model	Type*	Production Date	Tread Depth (mm)
Front Left	195R15C	104S	Toyo	Radial	V	1222	2 mm
Front Right	195R15C	104S	Toyo	Radial	V	1222	2 mm
Rear Left	195R15C	104S	Toyo	Radial	V	1222	2 mm
Rear Right	195R15C	104S	Toyo	Radial	V	1222	2 mm
