MFC Auction House  
M57 Pretoria Rd, Glenmarais, KEMPTON PARK  
Gauteng

Vehicle Type	MINI BUS	Registered Owner	MFC
Manufacturer	TOYOTA	Registration Number	DCH510NC
Model	QUANTUM	Register Number	
VIN	AHTSS22P907150062	Date Of First Licensing	
Engine Number		Last COR	
Doors	5	License Expiry Date	30/09/2024
Color	WHITE	Power / Displacement	
Year Model		Paint Finish	C - COMMON
Km Reading	25,419 KM	Fuel	DIESEL
Cab / Body Type	OTHERS	Transmission	MANUAL

## CONDITION REPORT

Report No: 2016209474

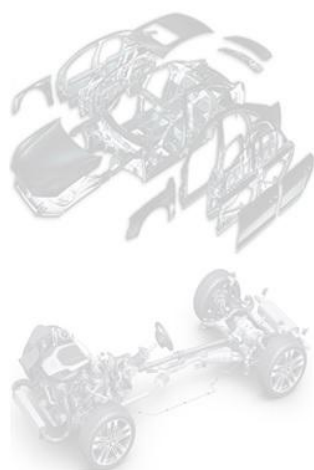
Damage	Repair Way
Load Body Paintwork • Scratched	Repair
Service Brake Performance Front Axle Left / Right	Repair
Difference out of legal range

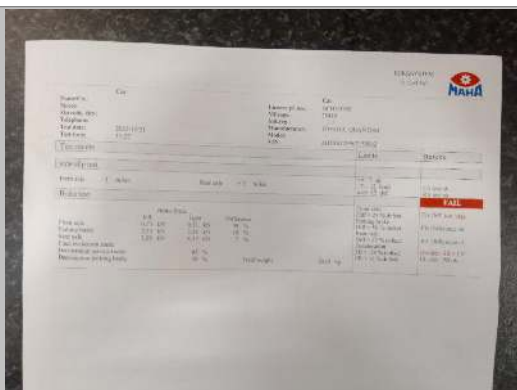
Shock and brake report

Left	Right		
	Braking Force [KN]	Braking Force [KN]	Axle Weight [KG]	Deceleration [m/s <sup>2</sup> ]
Front	0.7	0.3	-	
Rear	3.8	4.1	-	
Emergency / Parking	2.7	3.3	-

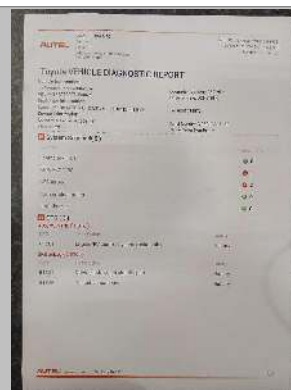
Diagnostic test

During the diagnostic no active error messages were detected. (See also attached Diagnostic Report. For more information regarding the Fault Codes (DTC) and the recommended rectifications please contact the workshops of the vehicle manufacture).

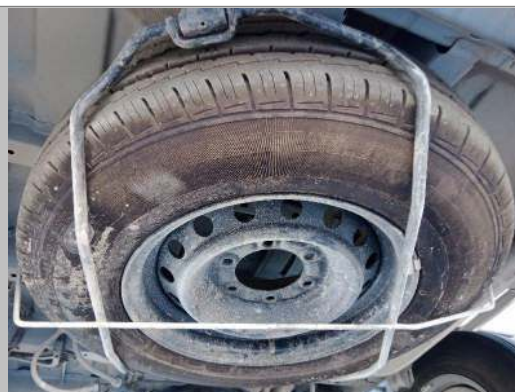
Sparewheel

Size	Load/Speed Index	Manufacture	Model	Type*	Production Date	Tread Depth (mm)
Front Left	195R15	106/104S	Toyo	H07	V	1523	5 mm
Front Right	195R15	106/104S	Toyo	H07	V	1323	5 mm
Rear Left	195R15	106/104S	Toyo	H07	V	1323	2 mm
Rear Right	195R15	106/104S	Toyo	H07	V	1323	3 mm
Spare	195R15	106/104S	Toyo	H07	V	0000	6 mm

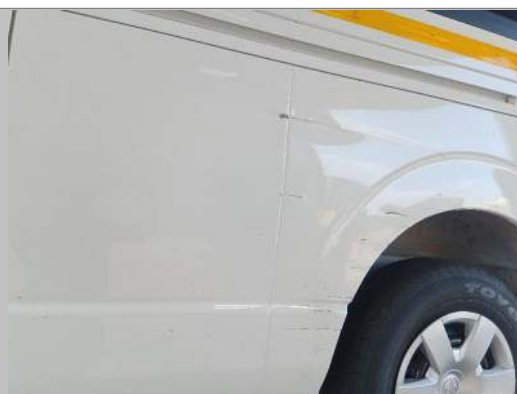
Load Body

General Comments: ACCORDING TO AGE AND MILEAGE OF VEHICLE NORMAL WEAR AND TEAR ON INTERIOR, EXTERIOR, ELECTRICAL AND MECHANICAL PARTS. SHOCK TEST NOT PERFORMED DUE TO SHOCK MACHINE NOT WORKING.  
Body • Exterior: Minor dents scratches and stone chips on some body panels. Signs of spray work done on some body panels.  
Axle and Suspension: Shock test not performed.
