CONDITION REPORT

Report No:
2016946643
DATE
15/07/2025

Vehicle Type	PASSENGER VEHICLE	Registered Owner	
Manufacturer	MAZDA	Registration Number	FD14WBG
Model	MAZDA3 2.0 ASTINA AT [2014-2017]	Register Number	
VIN	JM6BM4278G0321501	Date Of First Licensing	
Engine Number		Last COR	
Doors	5	License Expiry Date	
Color	WHITE	Power / Displacement	
Year Model	2016	Paint Finish	M - METALLIC
Km Reading	283,085 KM	Fuel	PETROL
Cab / Body Type	SEDAN	Transmission	AUTOMATIC

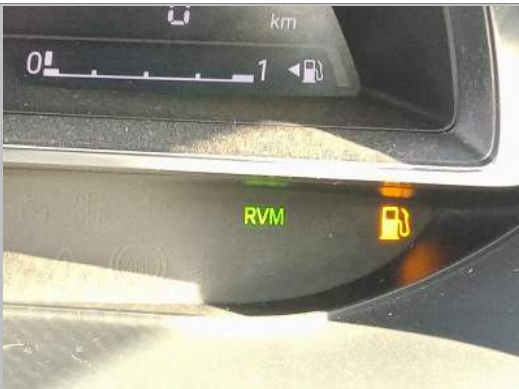
No	System	Code	Description	Status
1	ABS	C0072:68-60	BRAKE TEMPORARY TOO HIGH

Warning lights illuminated

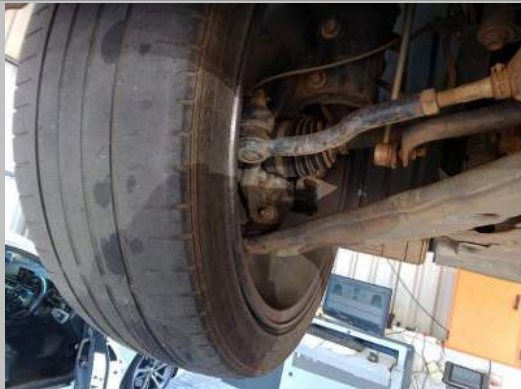
LF TYRE TREAD

Size	Load/Speed Index	Manufacture	Model	Type*	Production Date	Tread Depth (mm)
Front Left	215/45R18	93W	Winrun	R330	V	4623	0 mm
Front Right	215/45R18	93W	Anchee	AC818	V	4523	1 mm
Rear Left	215/45R18	93W	Winrun	R330	V	4623	3 mm
Rear Right	215/45R18	93W	Anchee	AC818	V	4523	3 mm
Spare	T125/70D16	96M	Dunlop	Temporary	V	0000	3 mm

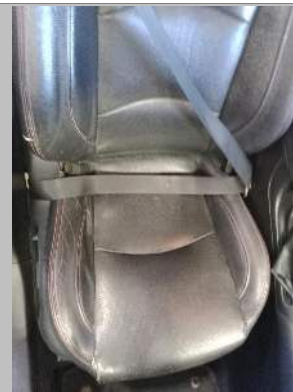
Damage	Repair Way
Switch Electrical Window Winder front right Defective	Repair
Seat Front Left Torn / Cut	Repair
Seat Front Right Torn / Cut	Repair
Seat Rear Torn / Cut	Repair
Front Bumper Paintwork • Chipmarks	Repair
Bonnet Residual Traces of Repair	Repair
Front Fender Right Residual Traces of Repair	Repair
Rear bumper Paintwork • Scratched	Repair
Sunroof Damaged	Repair
Windscreen Cracked	Replace
Stabilizer Mounting Front Left Damaged	Replace
Stabilizer Mounting Front Right Damaged	Replace
Control Arm Bush(es) Front Axle Left Cracked	Replace
Control Arm Bush(es) Front Axle Right Cracked	Replace
Ball Joint(s) Front Axle Right Cracked	Replace
Tyre Front Left Smooth	Replace
Electric sunroof damage	Repair
Body exterior	Residual traces of repair work done on some body p
Body exterior	Minor dents scratches stone chips on some body pan
Body exterior	Signs of spray work done on some body panels
Engine	Bottom of engine is fully covered
