MFC Auction House  
M57 Pretoria Rd, Glenmarais, KEMPTON PARK  
Gauteng

## Vehicle Data

## VEHICLE INSPECTION

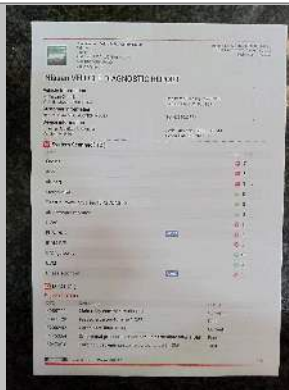
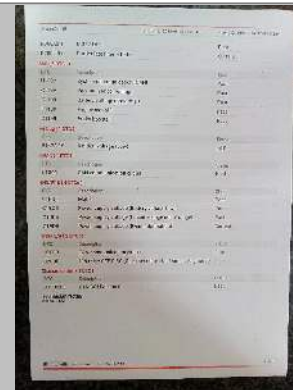
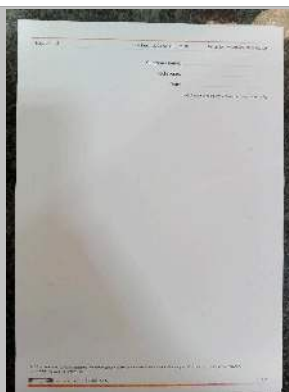
Diagnostic test

No	System	Code	Description	Status
1	ENGINE	P0657:11	MAIN RELAY CONTROL CIRCUIT CC.O

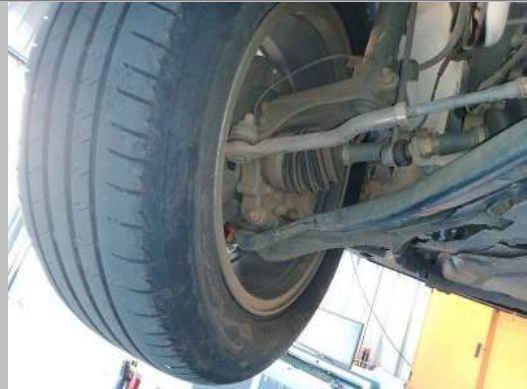
LF TYRE TREAD

Size	Load/Speed Index	Manufacture	Model	Type*	Production Date	Tread Depth (mm)
Front Left	225/60R18	104W	Bridgestone	Alenza	V	4723	1 mm
Front Right	225/60R18	104W	Bridgestone	Alenza	V	2416	0 mm
Rear Left	225/60R18	99H	GT radial	Champiro	V	1319	1 mm
Rear Right	225/60R18	99H	GT radial	Champiro	V	1319	1 mm
Spare	T155/90D17	101M	Dunlop	Temporary	V	0000	6 mm

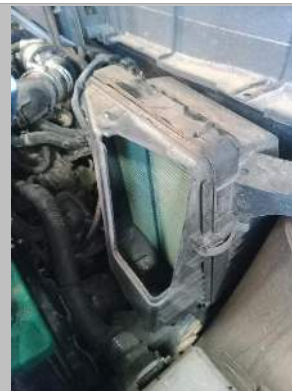
Damage	Repair Way
Air cleaner Damaged	Replace
Rear bumper Damaged	Repair
Tie Rod End left Cracked	Replace
Tie Rod End right Cracked	Replace
Control Arm Bush(es) Front Axle Left Cracked	Replace
Control Arm Bush(es) Front Axle Right Cracked	Replace
Ball Joint(s) Front Axle Left Cracked	Replace
Ball Joint(s) Front Axle Right Cracked	Replace
Tyre Front Right Excessive Wear & Tear	Replace
Bolt(s) / Nut(s) Front Wheel Right Missing	Replace
non runner vehicle	Repair
electronics malfunctions	Repair
Body exterior	Signs of spray work done on some body panels
vehicle towed to Dekra workshop	Repair
Engine	Bottom of engine is fully covered
Engine light illuminated	Repair
