CONDITION REPORT

Report No: 2016518859

DATE  
04/09/2024

Vehicle Type	PASSENGER VEHICLE	Registered Owner	
Manufacturer	TOYOTA	Registration Number	LP83CTGP
Model	STARLET	Register Number	
VIN	JTDJWCA3S00309721	Date Of First Licensing	
Engine Number		Last COR	
Doors	5	License Expiry Date	31/01/2025
Color	WHITE	Power / Displacement	
Year Model		Paint Finish	M - METALLIC
Km Reading	26,327 KM	Fuel	PETROL
Cab / Body Type	HATCHBACK	Transmission	MANUAL

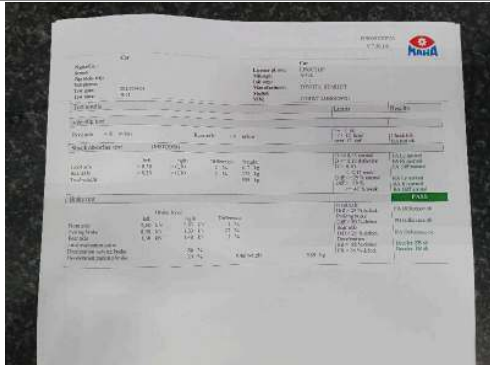
Shock and brake report

Left	Right	Axle Weight [KG]	Deceleration [m/s <sup>2</sup> ]
	Braking Force [KN]	Braking Force [KN]		
Front	2.8	2.8	-	
Rear	1.3	1.4	-	
Emergency / Parking	0.9	1.3	-

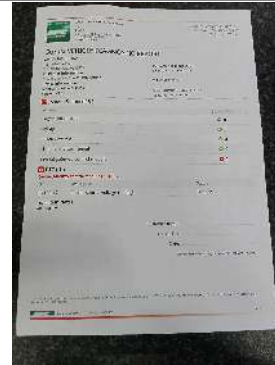
Diagnostic report

No	System	Code	Description	Status
1	HISTORY	B1150-17	POWER SOURCE VOLTAGE TOO HIGH

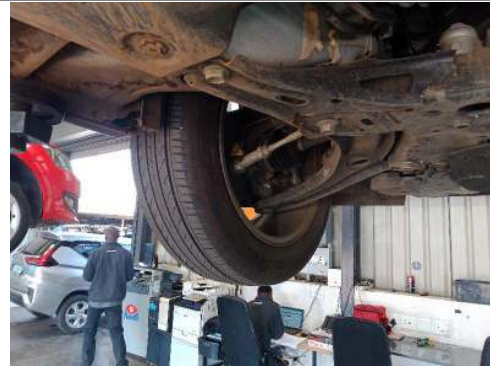
LF TYRE TREAD

Size	Load/Speed Index	Manufacture	Model	Type*	Production Date	Tread Depth (mm)
Front Left	195/55R16	87H	Goodyear	Assurance	V	4122	3 mm
Front Right	195/55R16	87H	Goodyear	Assurance	V	4122	3 mm
Rear Left	195/55R16	87H	Goodyear	Assurance	V	4122	4 mm
Rear Right	195/55R16	87H	Goodyear	Assurance	V	4122	4 mm

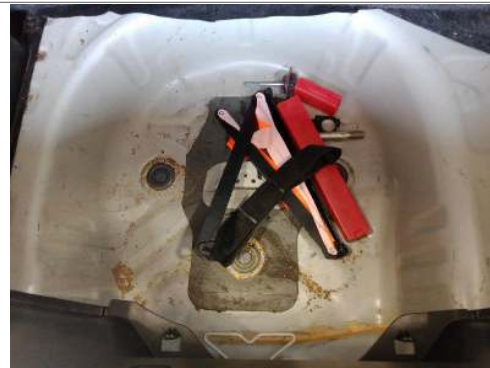
No spare wheel

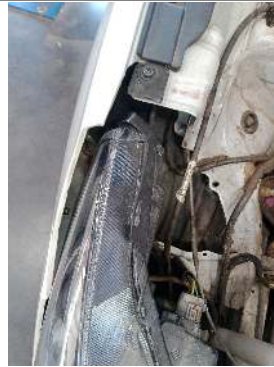
Damage	Repair Way
Headlight Right Damaged	Replace
Seat Front Right Defective	Repair
Front Bumper Paintwork • Scratched	Repair
Front Fender Right Dented	Repair
Rear Fender Right Paintwork • Scratched	Repair
Door Front Right Paintwork • Scratched	Repair
Door Rear Left Dented	Repair
Door Rear Right Paintwork • Scratched	Repair
Boot Lid / Hatch door Dented	Repair
Rear bumper Dented	Repair
Shock Absorber Rear Left Leak	Replace
Shock Absorber Rear Right Leak	Replace
Rim Rear Right Scratched	Repair
Bolt(s) / Nut(s) Front Wheel Right Missing	Replace
