CONDITION REPORT

Report No: 2016362918

MFC Auction House
M57 Pretoria Rd, Glenmarais, KEMPTON PARK
Gauteng

Vehicle Type	PASSENGER VEHICLE	Registered Owner	MFC
Manufacturer	CHEVROLET	Registration Number	FJ41XJGP
Model	CAPTIVA	Register Number	
VIN	KL1FC2EU9FB045788	Date Of First Licensing	
Engine Number		Last COR	
Doors	5	License Expiry Date	30/11/2024
Color	WHITE	Power / Displacement	
Year Model		Paint Finish	TWO COAT UNI
Km Reading	212,575 KM	Fuel	PETROL
Cab / Body Type	STATION WAGON	Transmission	MANUAL

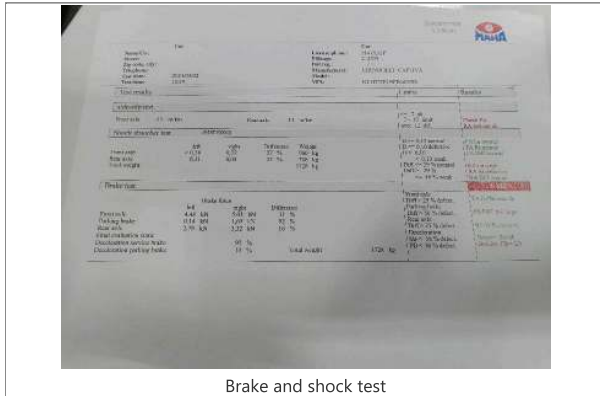
Brake and shock test

Left	Right	Axle Weight [KG]	Deceleration [m/s ²]
	Braking Force [KN]	Braking Force [KN]		
Front	4.48	5.03	-	
Rear	2.79	3.32	-	
Emergency / Parking	0.14	1.65	-

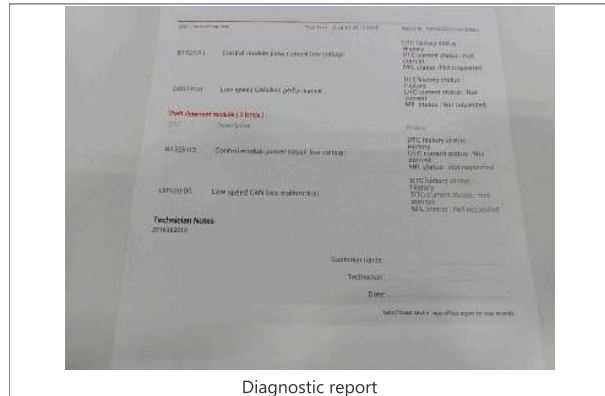
Diagnostic report

During the diagnostic no active error messages were detected. (See also attached Diagnostic Report. For more information regarding the Fault Codes (DTC) and the recommended rectifications please contact the workshops of the vehicle manufacture).

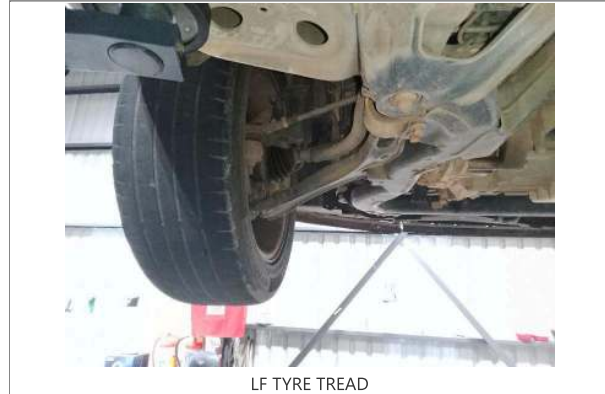
LF TYRE TREAD

Size	Load/Speed Index	Manufacture	Model	Type*	Production Date	Tread Depth (mm)
Front Left	225/55R18	102W	Autogrip	Radial	V	2620	0 mm
Front Right	225/55R18	102W	Autogrip	Radial	V	2620	0 mm
Rear Left	215/70R16	100T	Hankook	Radial	V	0215	2 mm
Rear Right	235/60R18	107V	Hankook	Radial	V	2913	1 mm

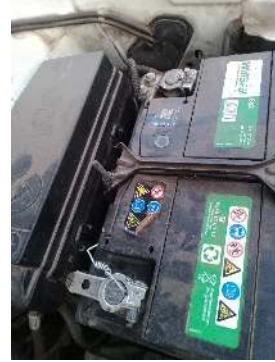
Damage	Repair Way
Battery clamps Defective	Repair
Engine Management Lights Set	Repair
Seat Front Right Worn	Repair
Side Mirror Left Damaged	Repair
Front Bumper Damaged	Repair
Bonnet Damaged	Repair
Front Fender Right Damaged	Repair
Door Front Left Damaged	Repair
Door Front Right Damaged	Repair
Door Rear Left Damaged	Repair
Door Rear Right Damaged	Repair
Rear bumper Damaged	Repair
Shock Absorber Rear Left Worn	Replace
Shock Absorber Rear Right Worn	Replace
Tyre Front Left Worn	Replace
Tyre Front Right Worn	Replace
Gearbox Oil Leak	Repair
Brake's	Electronic handbrake not working
Vehicle	Vehicle electronics malfunctioning
Body and exterior	Signs of repair work done to somebody panels.
Body and exterior	Poor alignment to somebody panels.
Engine	power steering noisy
