CONDITION REPORT

Report No:
2017219023
DATE
15/04/2026

Vehicle Type	LIGHT LOAD VEHICLE	Registered Owner	MFC
Manufacturer	HYUNDAI	Registration Number	FYS419L
Model	H-100 BAKKIE 2.6 EURO II DECK AC DSL PU [2020-ON]	Register Number	
VIN	KMFZBX7BLPU019805	Date Of First Licensing	
Engine Number		Last COR	
Doors	2	License Expiry Date	31/10/2026
Color	WHITE	Power / Displacement	
Year Model	2023	Paint Finish	C - COMMON
Km Reading	118,383 KM	Fuel	DIESEL
Cab / Body Type	SINGLE CAB	Transmission	MANUAL

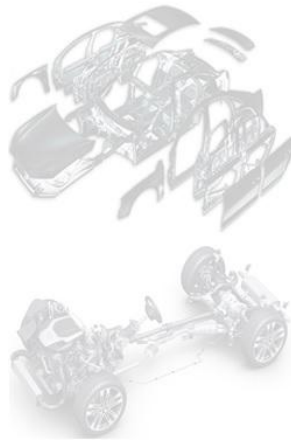
Damage	Repair Way
Seat Front Right Torn / Cut	Repair
Bonnet Paintwork • Chipmarks	Repair
Front Fender Left Dented	Repair
Door Front Right Dented	Repair
Rear bumper Paintwork • Scratched	Repair
Windscreen Cracked	Replace
Parking Brake Performance Left / Right Difference out of legal range	Repair

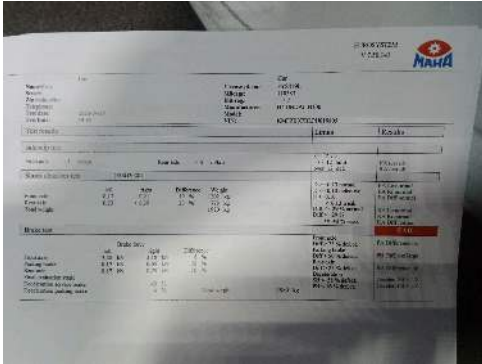
Shock and brake report

Left	Right	Axle Weight [KG]	Deceleration [m/s ²]
	Braking Force [KN]	Braking Force [KN]		
Front	3.4	3.1	-	
Rear	0.8	0.7	-	
Emergency / Parking	0.1	0.6	-

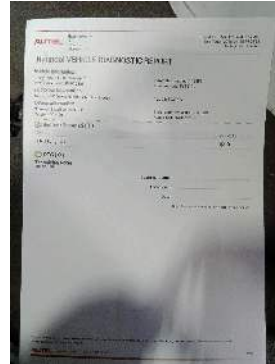
Diagnostic report

During the diagnostic no active error messages were detected. (See also attached Diagnostic Report. For more information regarding the Fault Codes (DTC) and the recommended rectifications please contact the workshops of the vehicle manufacture).

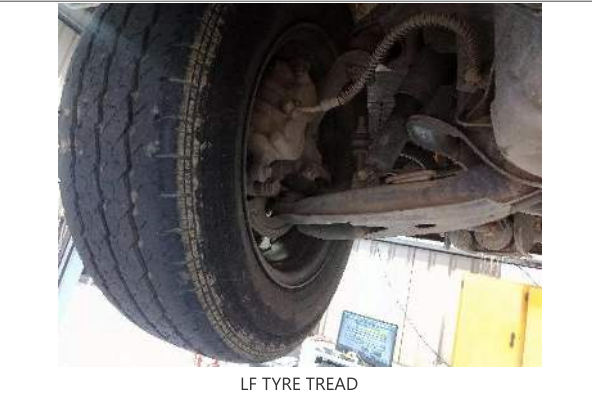
LF TYRE TREAD

Size	Load/Speed Index	Manufacture	Model	Type*	Production Date	Tread Depth (mm)
Front Left	195/70R15	104/102R	Autogrip	Vanax	V	3224	1 mm
Front Right	195/70R15	104/102S	Nexen	CP321	V	4722	1 mm
Rear Left	195/70R15	104/102R	Autogrip	Vanmax	V	4324	2 mm
Rear Right	195/70R15	104/102R	Autogrip	Vanmax	V	3224	2 mm

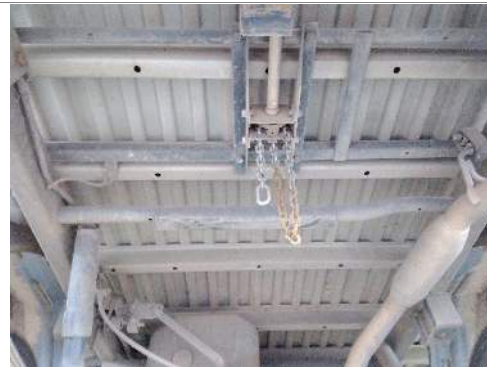
No sparewheel
