## CONDITION REPORT

Report No: 2016866320

Vehicle Type	PASSENGER VEHICLE	Registered Owner	
Manufacturer	HYUNDAI	Registration Number	KYB411NW
Model	VELOSTER 1.6 GDI 3-DR EXECUTIVE DCT [2011-2017]	Register Number	
VIN	KMHTC61DLDU143015	Date Of First Licensing	
Engine Number		Last COR	
Doors	4	License Expiry Date	30/09/2025
Color	GREY	Power / Displacement	
Year Model	2013	Paint Finish	M - METALLIC
Km Reading	150,842 KM	Fuel	PETROL
Cab / Body Type	HATCHBACK	Transmission	MANUAL

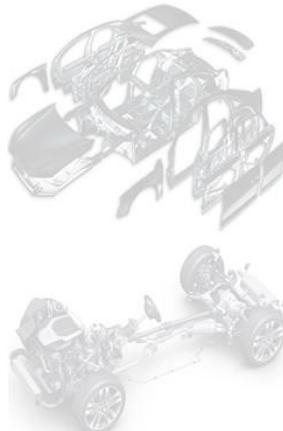
Damage	Repair Way
Seat Rear Defective	Repair
Side Mirror Right Paintwork • Scratched	Repair
Front Bumper Paintwork • Scratched	Repair
Bonnet Dented	Repair
Front Fender Right Paintwork • Scratched	Repair
Rear Fender Right Paintwork • Scratched	Repair
Door Front Right Dented	Repair
Door Rear Left Dented	Repair
Rear bumper Damaged	Repair
Windscreen Cracked	Replace
Tyre Front Right Damaged	Replace
Tyre Rear Right Damaged	Replace
Spare Tyre Smooth	Replace
Body exterior	Vehicle has minor scratches, stone chips and dents

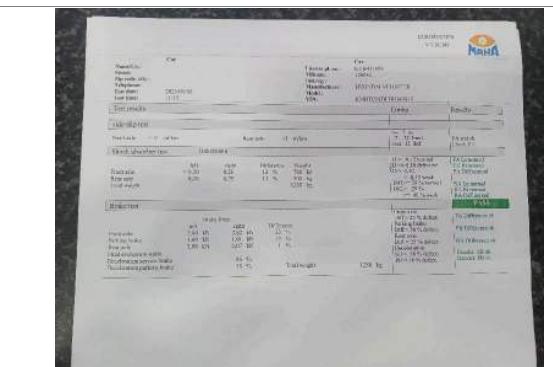
Shock and brake report

Left	Right	Axle Weight [KG]	Deceleration [m/s <sup>2</sup> ]
	Braking Force [kN]	Braking Force [kN]		
Front	2.9	3.8	-	-
Rear	2.0	2.0	-	-
Emergency / Parking	1.6	1.9	-	-

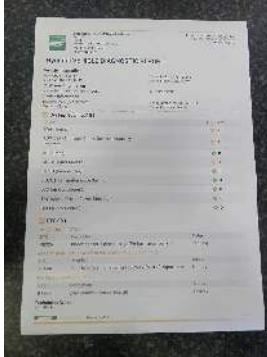
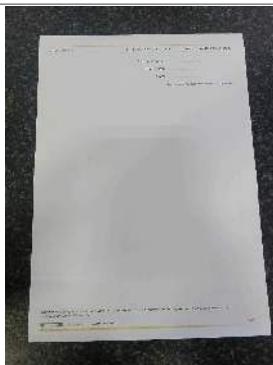
Diagnostic report

No	System	Code	Description	Status
1	PENDING	P0326	KNOCK SENSOR 1 CIRCUIT RANGE/ PERFORMANCE (BANK 1)

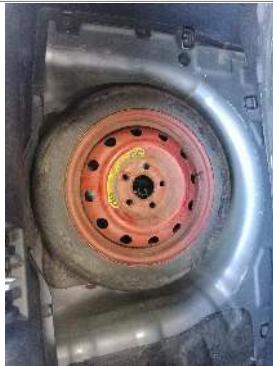
Spare wheel

Size	Load/Speed Index	Manufacture	Model	Type*	Production Date	Tread Depth (mm)
Front Left	225/45R18	95W	Dunlop	Lemans	V	1617	2 mm
Front Right	225/40R18	92Y	Dunlop	Sp sport	V	1421	0 mm
Rear Left	225/40R18	92W	Three-A	P606	V	3920	3 mm
Rear Right	235/40R18	95Y	Continental	Contact	V	4422	0 mm
Spare	T125/80D15	95M	Hankook	S400	V	0313	0 mm
