## CONDITION REPORT

Report No:  
2016903345  
DATE  
05/06/2025

| Manufacturer | KIA | Registration Number | JP32ZSGP |
| Model | PICANTO | Register Number | |

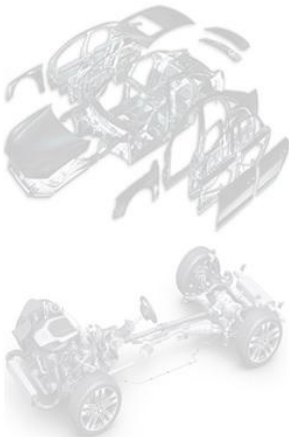
| | Damage | Repair Way |
| | Tail Light Right Damaged | Replace |
| | Front Bumper Damaged | Repair |
| | Bonnet Damaged | Repair |
| | Front Fender Left Damaged | Repair |
| | Front Fender Right Damaged | Repair |
| | Rear Fender Left Damaged | Repair |
| | Rear Fender Right Damaged | Repair |
| | Door Front Left Damaged | Repair |
| | Door Front Right Damaged | Repair |
| | Door Rear Left Damaged | Repair |
| | Door Rear Right Damaged | Repair |
| | Boot Lid / Hatch door Damaged | Repair |
| | Rear bumper Damaged | Repair |
| | Radiator Cradle Damaged | Replace |

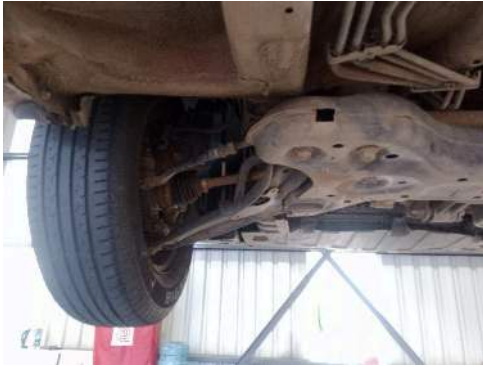
LF TYRE TREAD

| | Size | Load/Speed Index | Manufacture | Model | Type* | Production Date | Tread Depth (mm) |
|---|---|---|---|---|---|---|---|
| Front Left | 175/70R13 | 82T | Durun | Radial | | 4723 | 2 mm |

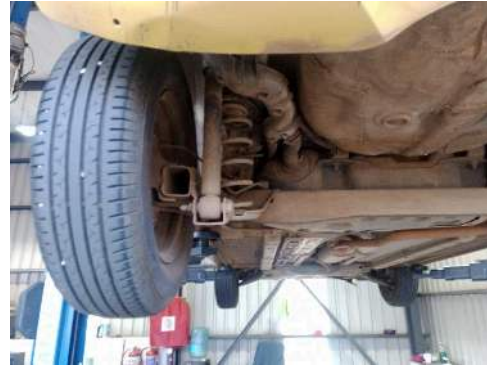
LR TYRE TREAD

| | Size | Load/Speed Index | Manufacture | Model | Type* | Production Date | Tread Depth (mm) |
|---|---|---|---|---|---|---|---|
| Rear Left | 175/70R13 | 82T | Durun | Radial | V | 4323 | 2 mm |

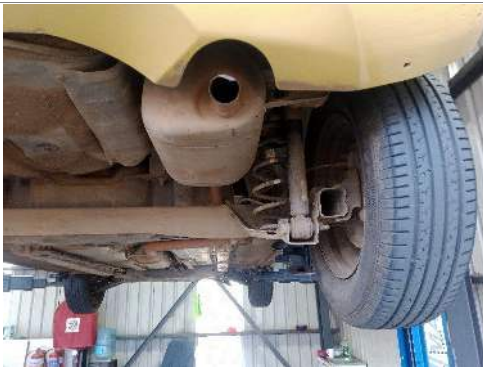
RR TYRE TREAD

| | Size | Load/Speed Index | Manufacture | Model | Type* | Production Date | Tread Depth (mm) |
|---|---|---|---|---|---|---|---|
| Rear Right | 175/70R13 | 82T | Durun | Radial | V | 4723 | 2 mm |

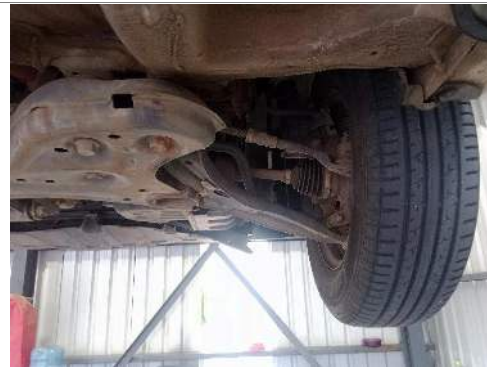
RF TYRE TREAD

| | Size | Load/Speed Index | Manufacture | Model | Type* | Production Date | Tread Depth (mm) |
|---|---|---|---|---|---|---|---|
| Front Right | 175/70R13 | 82T | Durun | Rad | V | 4723 | 2 mm |
