## CONDITION REPORT

Report No:  
2016999204  
DATE  
02/09/2025

| Manufacturer | KIA | Registration Number | KD72PSGP |
| Model | PEGAS | Register Number | |

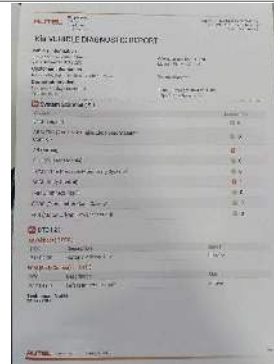
Diagnostic.

| No | System | Code | Description | Status |
|---|---|---|---|---|
| 1 | BCM | B1214:00 | LEFT REAR SENSOR FAULT | |

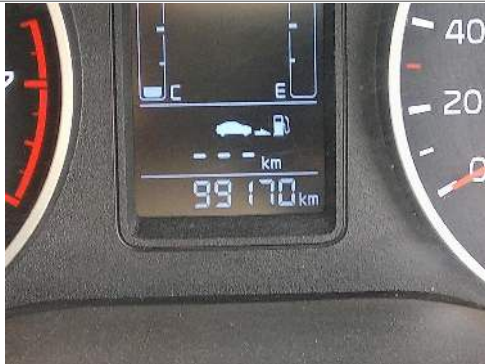
ODOMETER

| Km Reading | 99,170 KM | Fuel | PETROL |

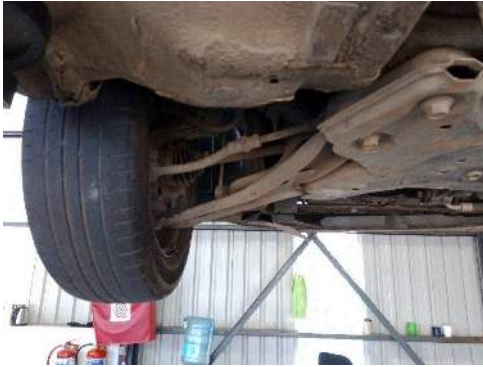
LF TYRE TREAD

| | Size | Load/Speed Index | Manufacture | Model | Type* | Production Date | Tread Depth (mm) |
|---|---|---|---|---|---|---|---|
| Front Left | 185/60R14 | 82V | Symmetry | Radial | V | 1224 | 0 mm |

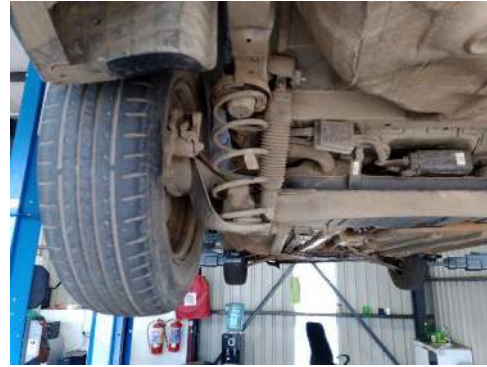
LR TYRE TREAD

| | Size | Load/Speed Index | Manufacture | Model | Type* | Production Date | Tread Depth (mm) |
|---|---|---|---|---|---|---|---|
| Rear Left | 175/70R14 | 84T | Autogrip | Radial | V | 3216 | 0 mm |

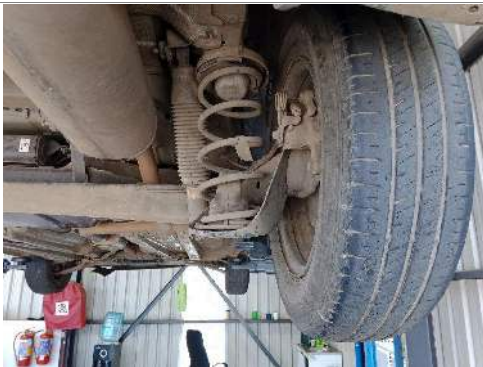
RR TYRE TREAD

| | Size | Load/Speed Index | Manufacture | Model | Type* | Production Date | Tread Depth (mm) |
|---|---|---|---|---|---|---|---|
| Rear Right | 175/70R14 | 84T | Tracmax | Radial | V | 4922 | 0 mm |

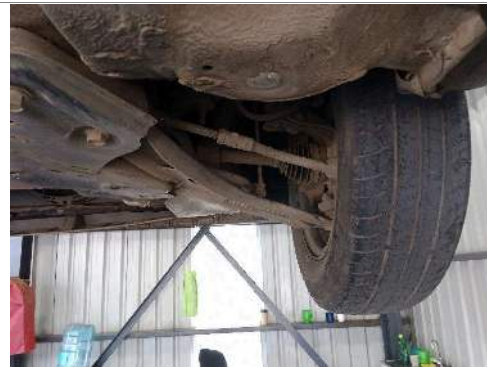
RF TYRE TREAD

| | Size | Load/Speed Index | Manufacture | Model | Type* | Production Date | Tread Depth (mm) |
|---|---|---|---|---|---|---|---|
| Front Right | 175/70R14 | 84T | Nexen | Radial | V | 2221 | 0 mm |

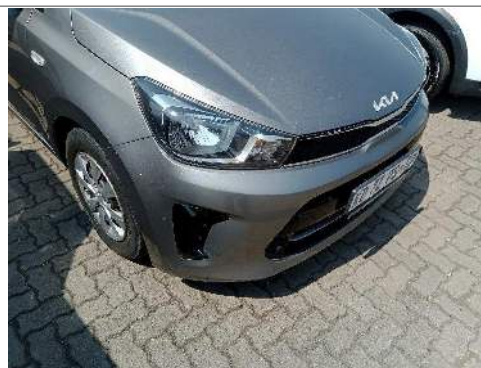
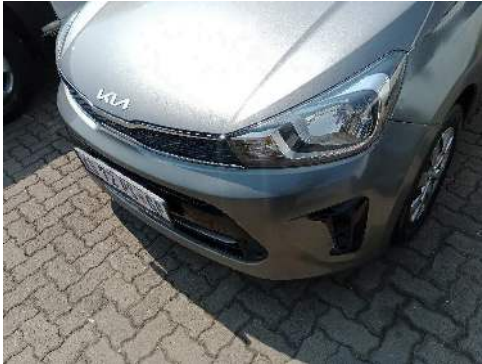
Front Bumper

| | Damage | Repair Way |
|---|---|---|
| | Tail Light Left Damaged<br>Tail Light Right Damaged<br>Front Bumper Damaged<br>Bonnet Damaged<br>C • Pillar Left Damaged<br>C • Pillar Right Damaged<br>Front Fender Left Damaged<br>Front Fender Right Damaged<br>Rear Fender Left Damaged<br>Rear Fender Right Damaged<br>Door Front Left Damaged<br>Door Front Right Damaged<br>Door Rear Left Damaged<br>Door Rear Right Damaged<br>Boot Lid / Hatch door Damaged<br>Rear bumper Damaged<br>Roof Damaged<br>Tyre Front Left Worn<br>Tyre Front Right Worn<br>Tyre Rear Left Worn<br>Tyre Rear Right Worn | Replace<br>Replace<br>Repair<br>Repair<br>Repair<br>Repair<br>Repair<br>Repair<br>Repair<br>Repair<br>Repair<br>Repair<br>Repair<br>Repair<br>Repair<br>Repair<br>Replace<br>Replace<br>Replace<br>Replace |

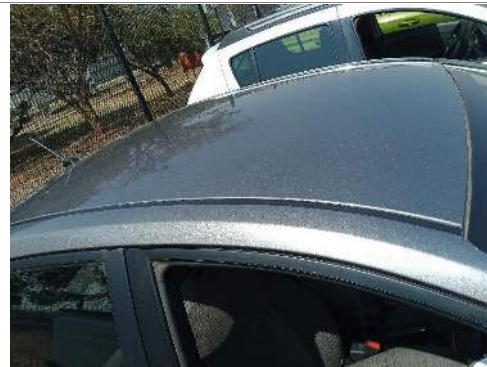
Roof

General Comments: ACCORDING TO THE AGE AND MILEAGE OF THE VEHICLE, NORMAL WEAR AND TEAR MARKS ARE VISIBLE ON THE INTERIOR, EXTERIOR, ELECTRICAL AND MECHANICAL PARTS. Body • Exterior: Minor dents and scratches and stone chips to some body panels. Signs of repair work done to somebody panels. Poor alignment to somebody panels. Vehicle body in poor condition. Signs of hail damage to some body panels.
