CONDITION REPORT

Report No: 2016218356

Vehicle Type	PASSENGER VEHICLE	Registered Owner	MFC
Manufacturer	FORD	Registration Number	KSV095MP
Model	FIGO	Register Number	
VIN	MAJGXXMTKGG25410	Date Of First Licensing	
Engine Number		Last COR	
Doors	5	License Expiry Date	30/11/2023
Color	WHITE	Power / Displacement	
Year Model		Paint Finish	C - COMMON
Km Reading	176,651 KM	Fuel	PETROL
Cab / Body Type	HATCHBACK	Transmission	MANUAL

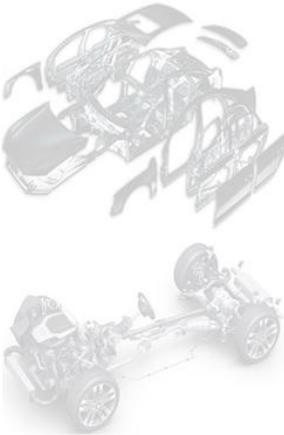
Damage	Repair Way
Tail Light Right Damaged	Replace
Seat Front Right Damaged	Repair
Front Bumper Paintwork • Scratched	Repair
Front Fender Left Dented	Repair
Front Fender Right Paintwork • Chipmarks	Repair
Rear Fender Left Dented	Repair
Rear Fender Right Dented	Repair
Door Rear Left Dented	Repair
Door Rear Right Paintwork • Scratched	Repair
Boot Lid / Hatch door Paintwork • Chipmarks	Repair
Windscreen Cracked	Replace
R/R hup cap missing	Replace
Bonnet release handle damage	Repair

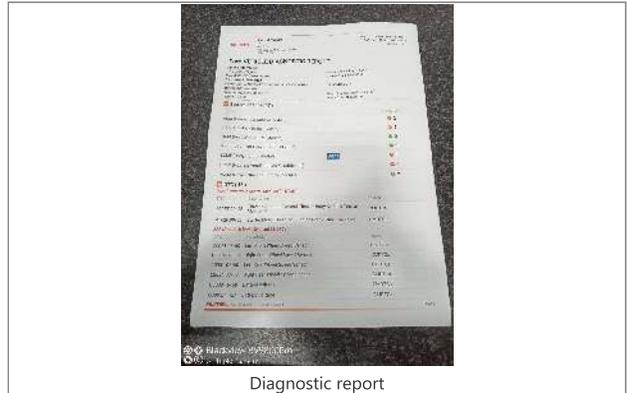
Diagnostic report

During the diagnostic no active error messages were detected. (See also attached Diagnostic Report. For more information regarding the Fault Codes (DTC) and the recommended rectifications please contact the workshops of the vehicle manufacture).

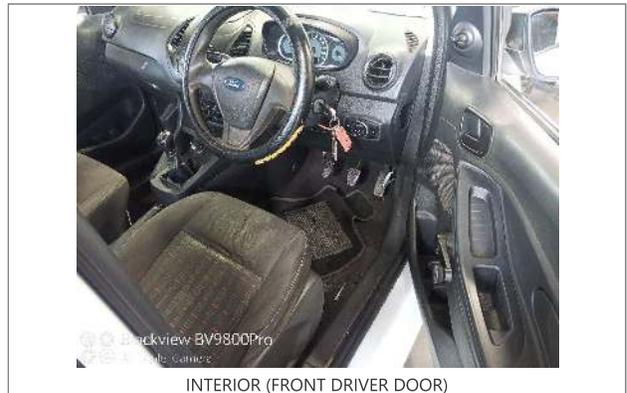
INTERIOR (FRONT DRIVER DOOR)

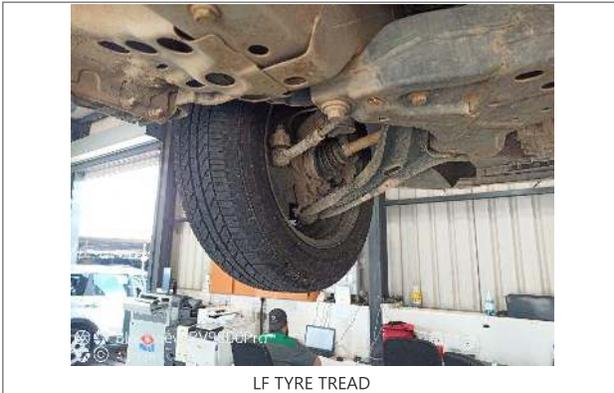
LF TYRE TREAD

Size	Load/Speed Index	Manufacture	Model	Type*	Production Date	Tread Depth (mm)
Front Left	175/65R14	82T	Sumitomo	Htr	V	2728	4 mm
Front Right	175/65R14	82T	Sumitomo	Htr	V	2728	4 mm
Rear Left	175/65R14	82T	Sumitomo	Htr	V	2728	4 mm
Rear Right	175/65R14	82T	Sumitomo	Htr	V	2723	4 mm
Spare	175/65R14	82H	Apollo	Alnac	V	3516	1 mm
