CONDITION REPORT

Report No:  
2016991004  
DATE  
26/08/2025

| Manufacturer | HYUNDAI | Registration Number | LS22HGGP |
| Model | GRAND CRETA | Register Number | |

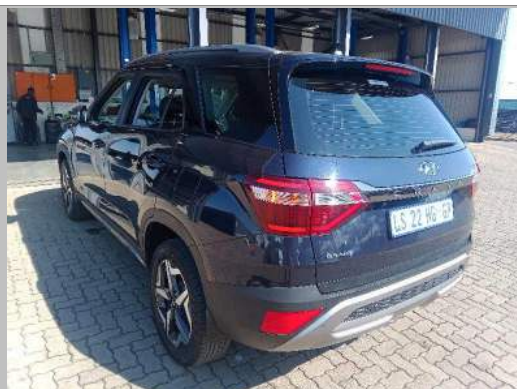
REAR LEFT CORNER

| Damage | Repair Way |
|---|---|
| Door Rear Left Dented | Repair |

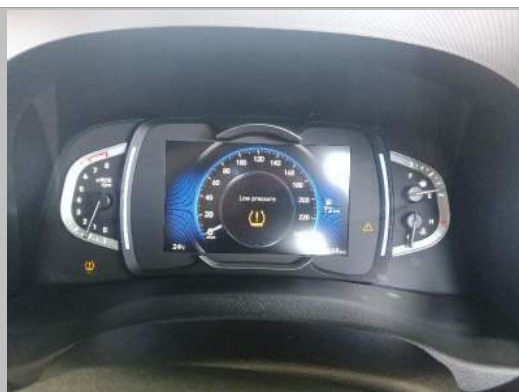
DASHBOARD (W/ ENGINE RUNNING)

| Damage | Repair Way |
|---|---|
| Warning lights illuminated | Repair |

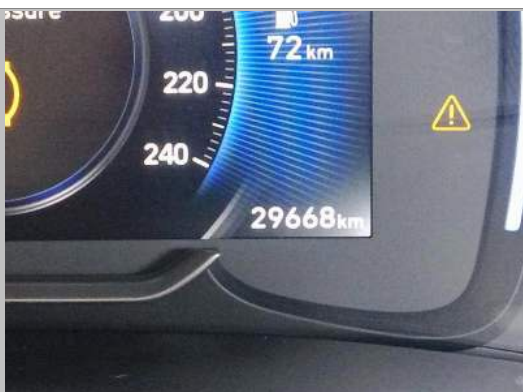
| Km Reading | 29,668 KM | Fuel | PETROL |

ODOMETER

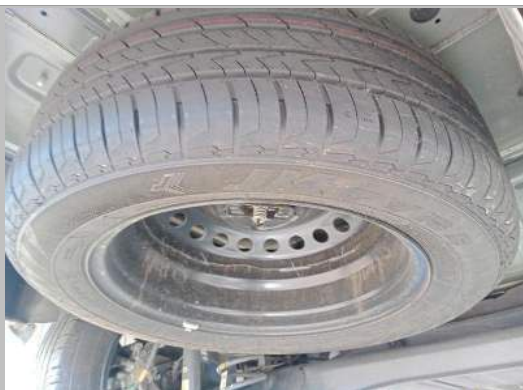
Sparewheel

| | Size | Load/Speed Index | Manufacture | Model | Type* | Production Date | Tread Depth (mm) |
|---|---|---|---|---|---|---|---|
| Spare | 215/60R17 | 96H | Jk tyre | Royale | V | /////// | 6 mm |

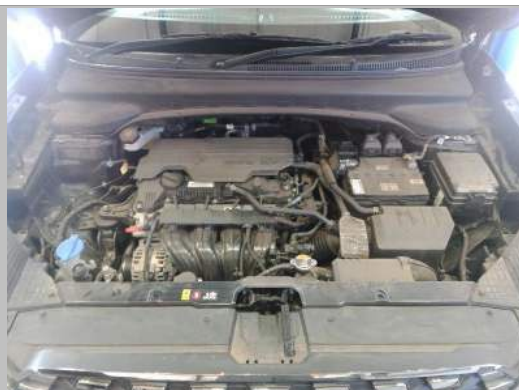
ENGINE 1

General Comments: SIGNS OF SPRAY WORK DONE ON SOME BODY PANELS. BOTTOM OF ENGINE IS FULLY COVERED. ACCORDING TO THE AGE AND MILEAGE OF THE VEHICLE, NORMAL WEAR AND TEAR MARKS ARE VISIBLE ON THE INTERIOR, EXTERIOR, ELECTRICAL AND MECHANICAL PARTS.

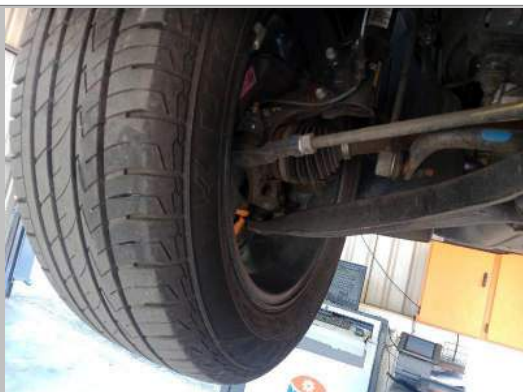
| | Size | Load/Speed Index | Manufacture | Model | Type* | Production Date | Tread Depth (mm) |
|---|---|---|---|---|---|---|---|
| Front Left | 215/60R17 | 96H | Jk tyre | Royale | V | 4622 | 5 mm |

LF TYRE TREAD

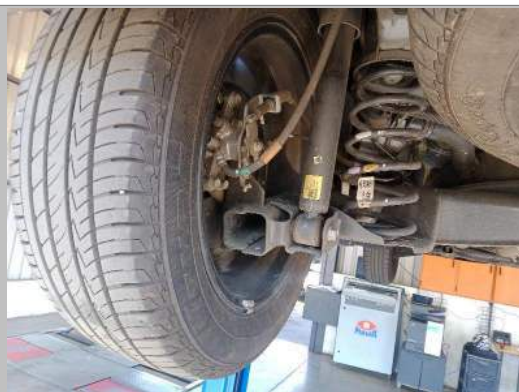
| | Size | Load/Speed Index | Manufacture | Model | Type* | Production Date | Tread Depth (mm) |
|---|---|---|---|---|---|---|---|
| Rear Left | 215/60R17 | 96H | Jk tyre | Royale | V | 4622 | 5 mm |

LR TYRE TREAD

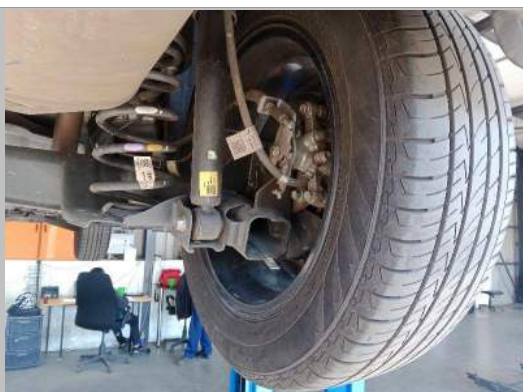
| | Size | Load/Speed Index | Manufacture | Model | Type* | Production Date | Tread Depth (mm) |
|---|---|---|---|---|---|---|---|
| Rear Right | 215/60R17 | 96H | Jk tyre | Royale | V | 4622 | 5 mm |

RR TYRE TREAD

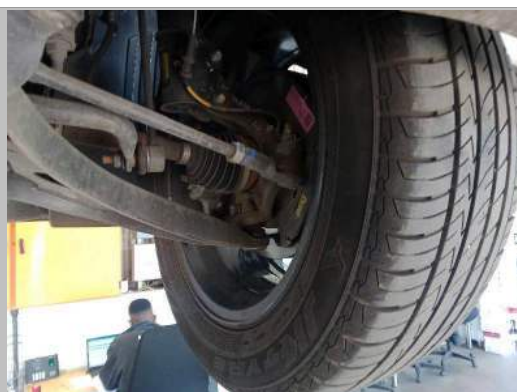
| | Size | Load/Speed Index | Manufacture | Model | Type* | Production Date | Tread Depth (mm) |
|---|---|---|---|---|---|---|---|
| Front Right | 215/60R17 | 96H | Jk tyre | Royale | V | 4622 | 5 mm |

RF TYRE TREAD

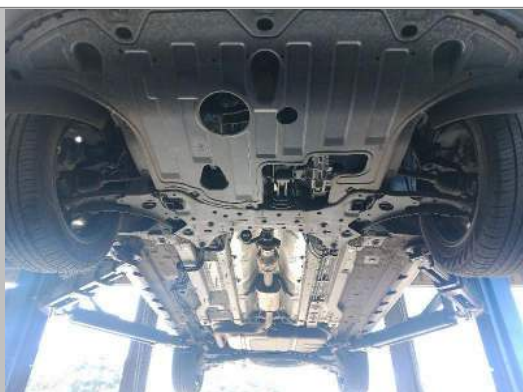
CHASSIS

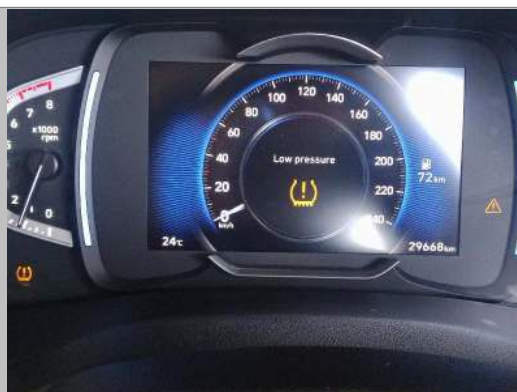
Warning lights

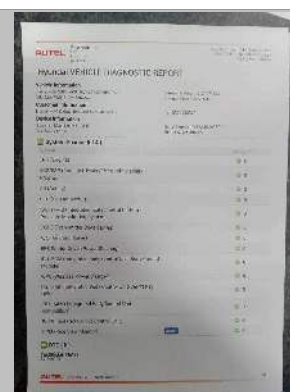
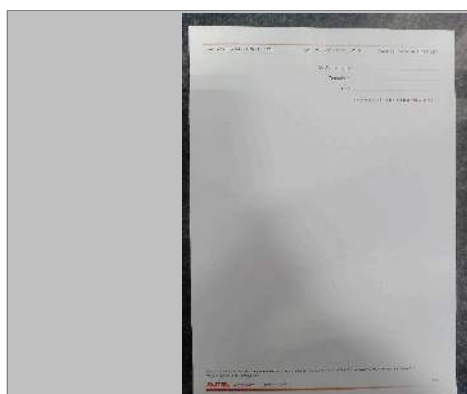
During the diagnostic no active error messages were detected. (See also attached Diagnostic Report. For more information regarding the Fault Codes (DTC) and the recommended rectifications please contact the workshops of the vehicle manufacture).

Diagnostic test

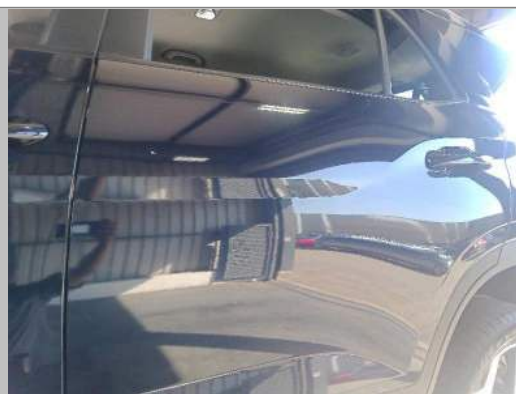
Door Rear Left

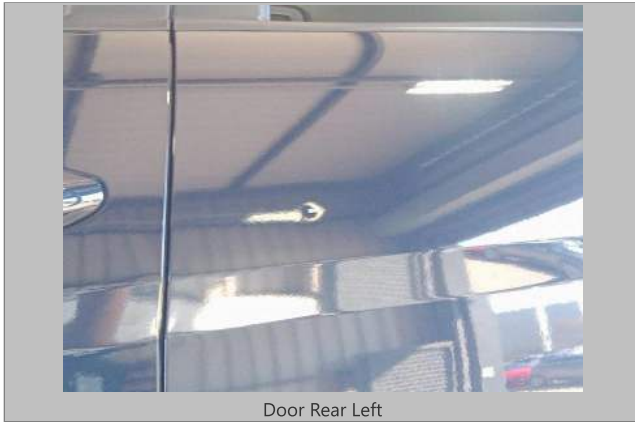
Door Rear Left
