## CONDITION REPORT

Report No:  
2016994659  
DATE  
28/08/2025

Vehicle Type	PASSENGER VEHICLE	Registered Owner	MFC AUCTION HOUSE
Manufacturer	SUZUKI	Registration Number	LF55CZGP
Model	DZIRE 1.2 GL MC AMT [2020-ON]	Register Number	
VIN	MBHCZF63S00370234	Date Of First Licensing	
Engine Number		Last COR	
Doors	4	License Expiry Date	
Color	WHITE	Power / Displacement	
Year Model	2023	Paint Finish	TWO COAT UNI
Km Reading	62,398 KM	Fuel	PETROL
Cab / Body Type	SEDAN	Transmission	AUTOMATIC

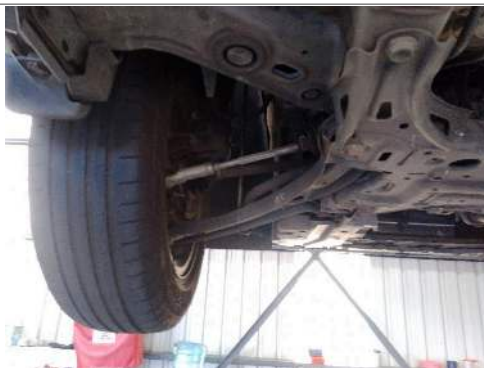
LF TYRE TREAD

Size	Load/Speed Index	Manufacture	Model	Type*	Production Date	Tread Depth (mm)
Front Left	185/65R15	88H	Apollo	Radial	V	4922	4 mm
Front Right	185/65R15	88H	Apollo	Radial	V	4922	5 mm
Rear Left	185/65R15	88H	Apollo	Radial	V	4922	4 mm
Rear Right	185/65R15	88H	Apollo	Radial	V	4922	4 mm

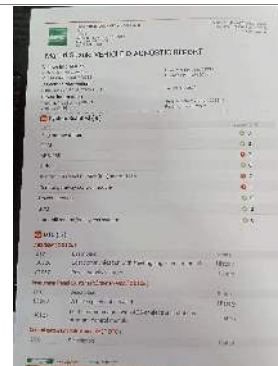
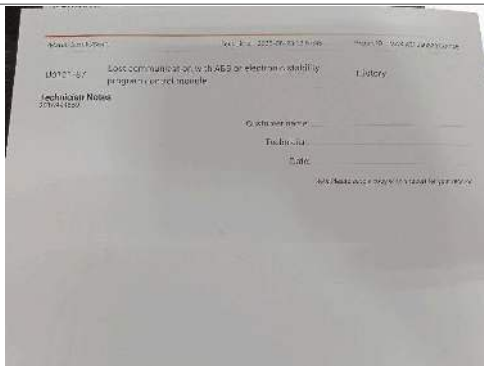
DIAGNOSTIC REPORT PAGE 1

No	System	Code	Description	Status
1	ABS/ESP	U0126	LAST COMMUNICATION WITH STEERING ANGLE SENSOR MODE

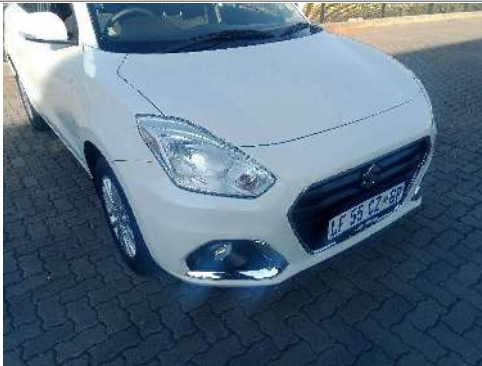
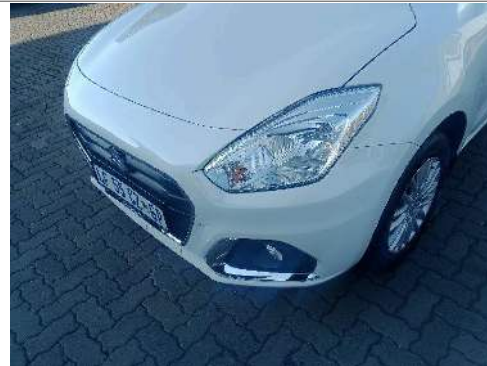
Damage	Repair Way
Front Bumper Damaged	Repair
Bonnet Damaged	Repair
Front Fender Left Damaged	Repair
Rear Fender Left Damaged	Repair
Rear Fender Right Damaged	Repair
Door Front Left Damaged	Repair
Door Rear Left Damaged	Repair
Boot Lid / Hatch door Damaged	Repair
Rear bumper Damaged	Repair
